## Technical Bulletin #968

**Transmission:** 4T60/4T60E/4T65E

**Subject:** Driven Sprocket Support  
Interchange/Lube Problems

**Application:** GM FWD

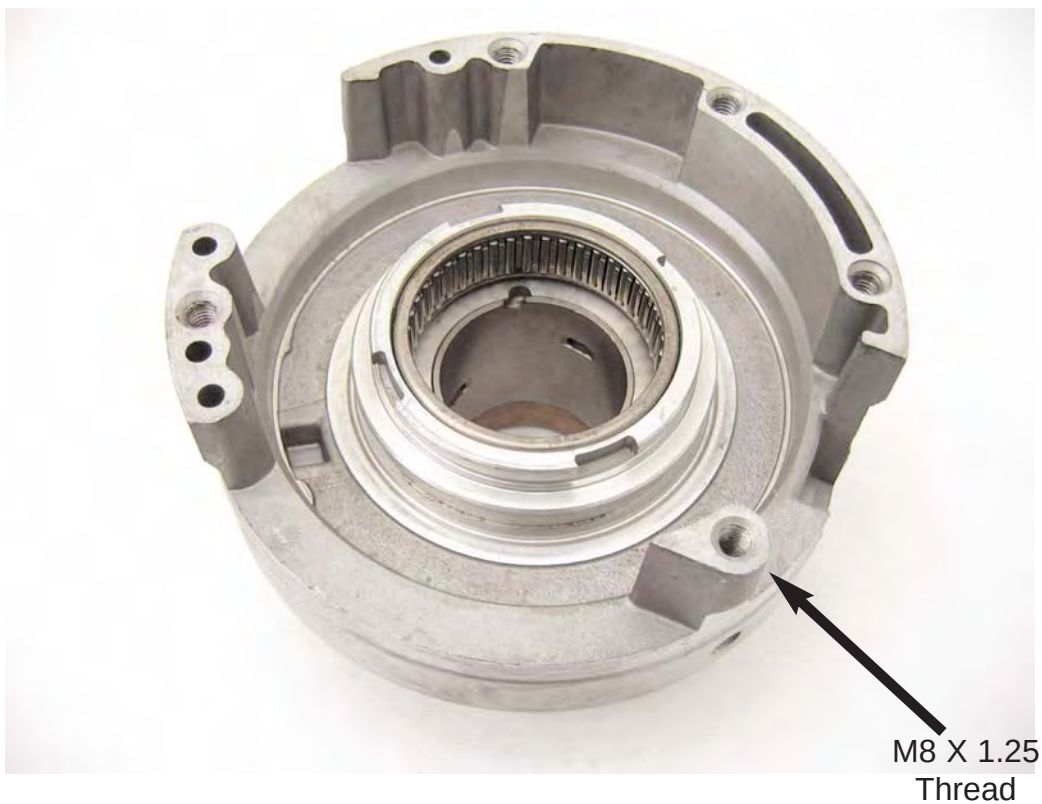
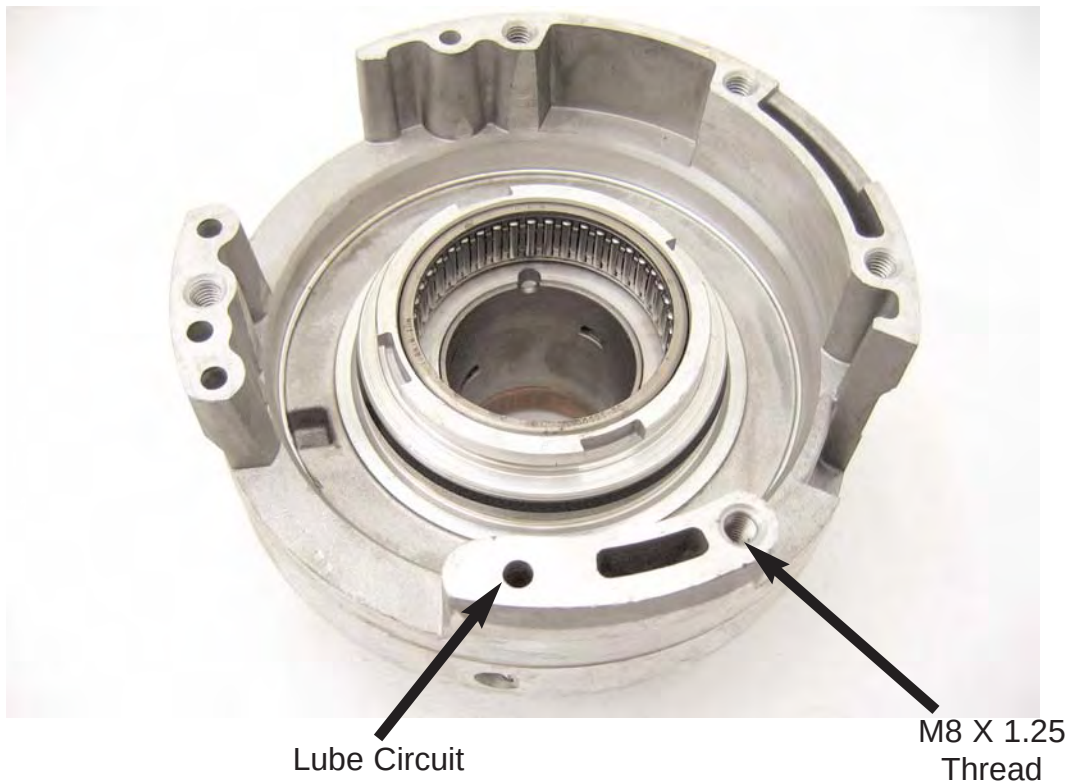
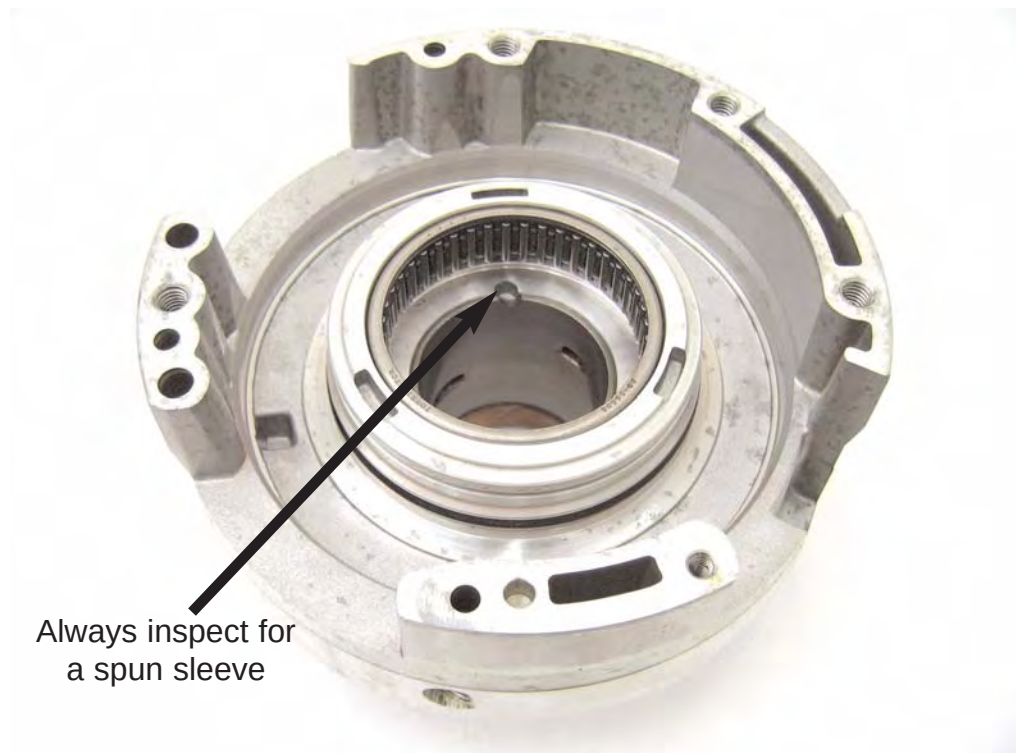
Driven supports for the 4T60 / 4T60E / 4T65E are different and cannot be interchanged. Use the following illustrations to help identify driven sprocket supports. Using the wrong driven sprocket support will cause lube problems.

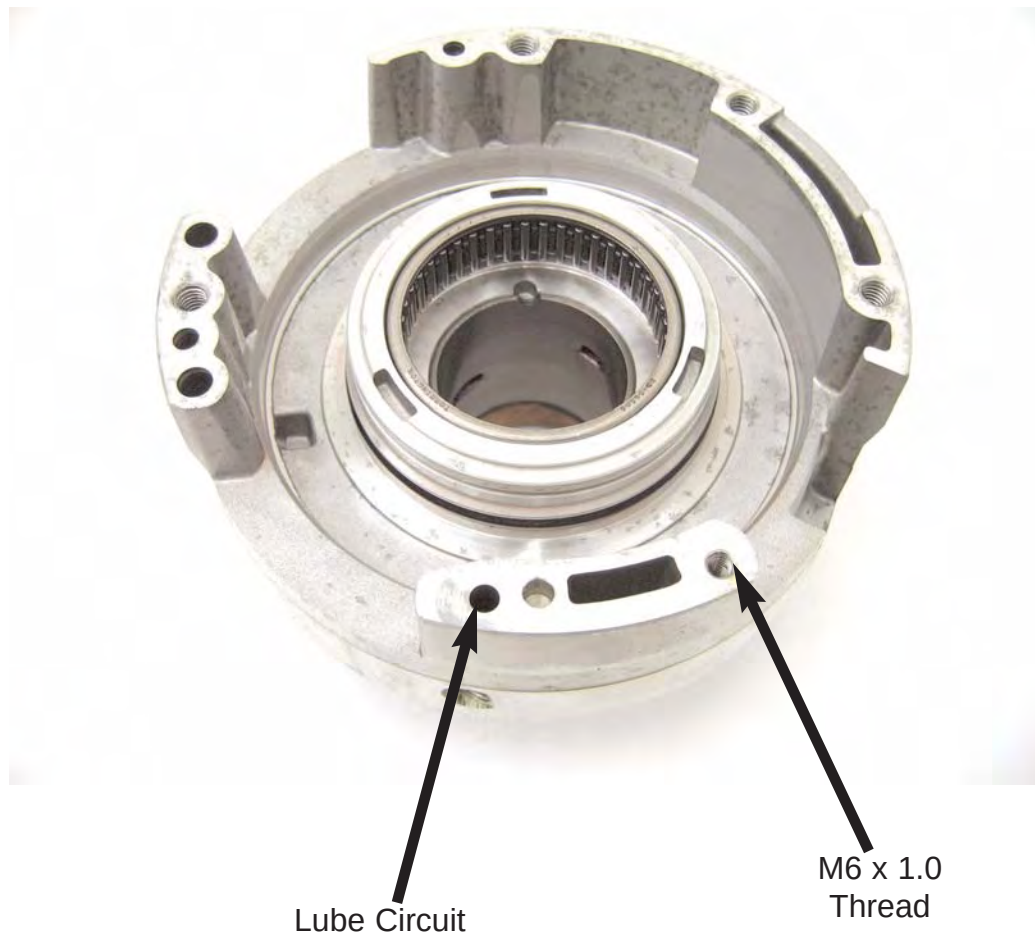
Vehicles with one or more of these symptoms may have a sleeve that has spun in the driven sprocket support. This blocks feed holes and creates leaks in the input 2nd and 3rd clutch apply circuits. Always inspect for a spun sleeve and replace the driven sprocket support when necessary.

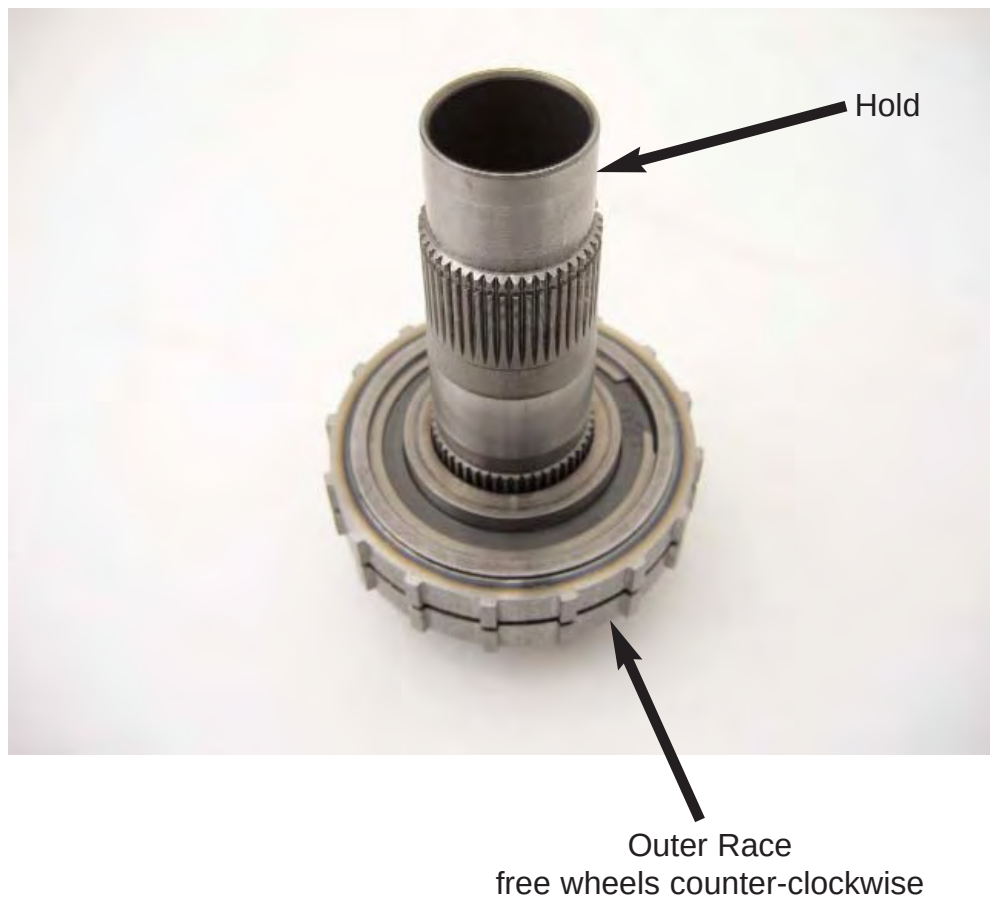
Use the photo below for proper sprag rotation. If the input sprag is installed wrong a no forward condition will occur.

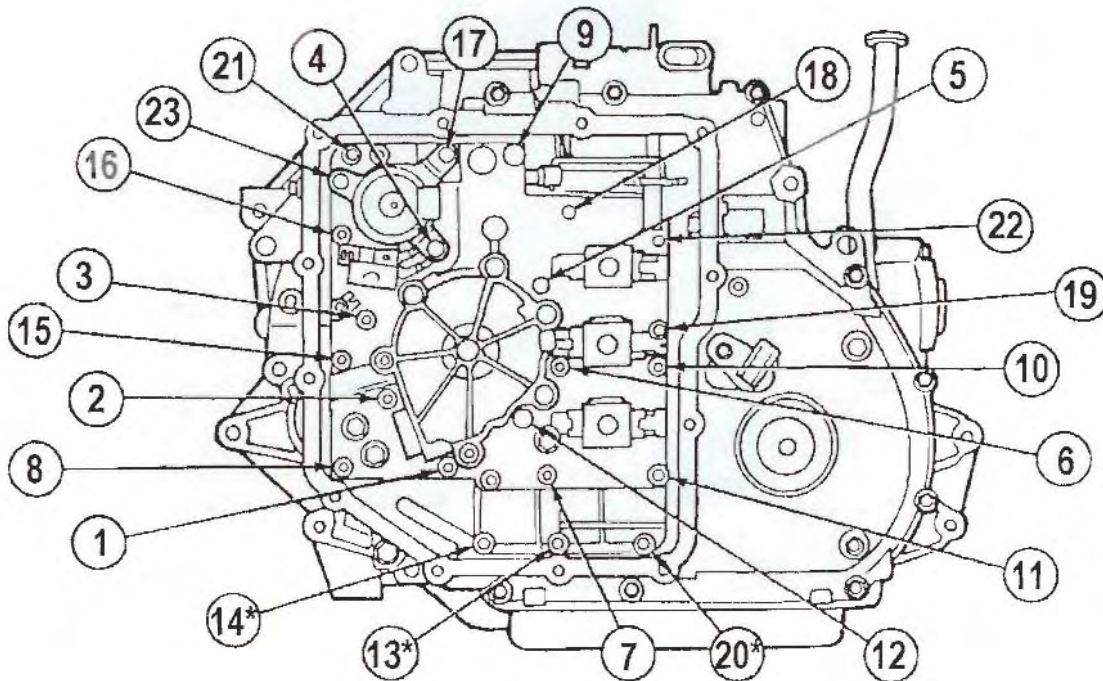
Many shift concerns are caused by valves that do not switch in a timely manner caused by dragging. Use the proper torque sequence when servicing any of these transmissions (AXOD-AXODE/AX4S-AX4N). The bolts marked with (\*) are the three short bolts. Torque the bolts in 3 stages.

30 in. lbs.

60 in. lbs.

90 in. lbs.

Final torque must be between 9-12 N.m ( 7-9 ft. lbs. which converts to 84-108 in. lbs.).

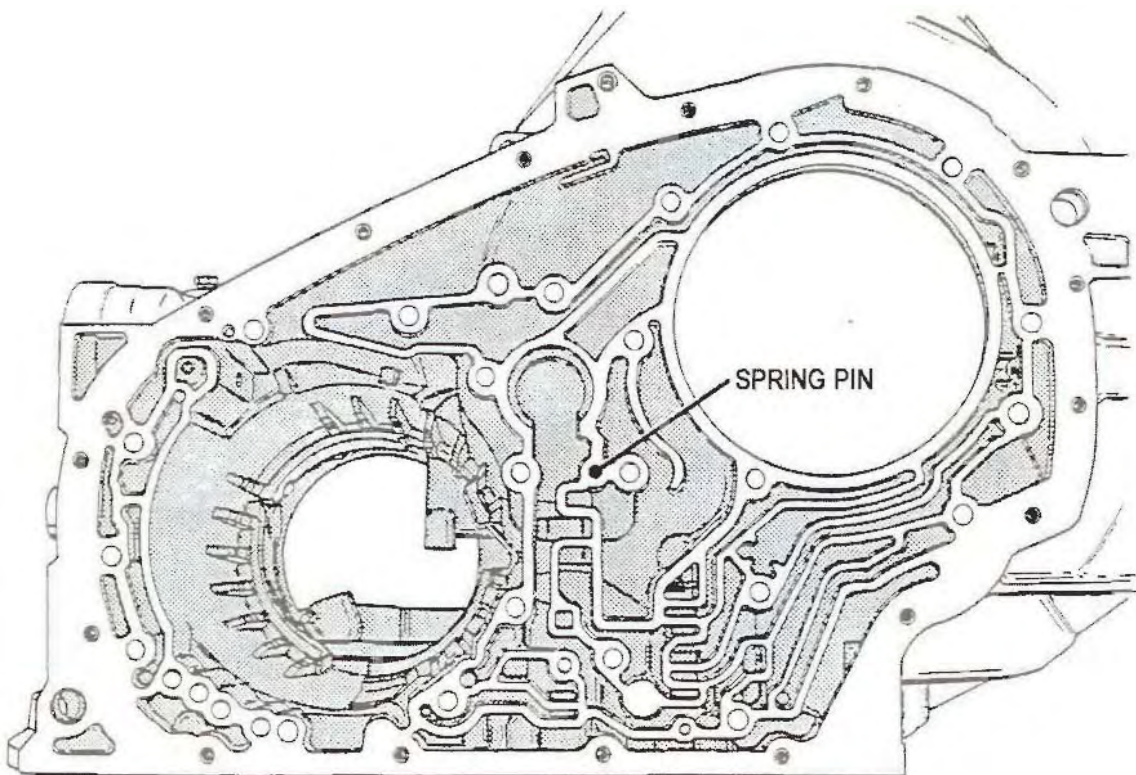
The pin is used for preventing the PR Bushing from rotating off location is located in this illustration. If the pin is lost the **replacement pin from GM Part# 9437415 is no longer available**. The pin measurements are 5.6 x 2.85 mm long.

**Note:** Make sure the bushing bore is clean and no burrs are present. When installed, the flat portion of the bushing will be indexed to the pin. Make sure the pin sets 0.3mm below the case surface and that it does not fall out before assembly.

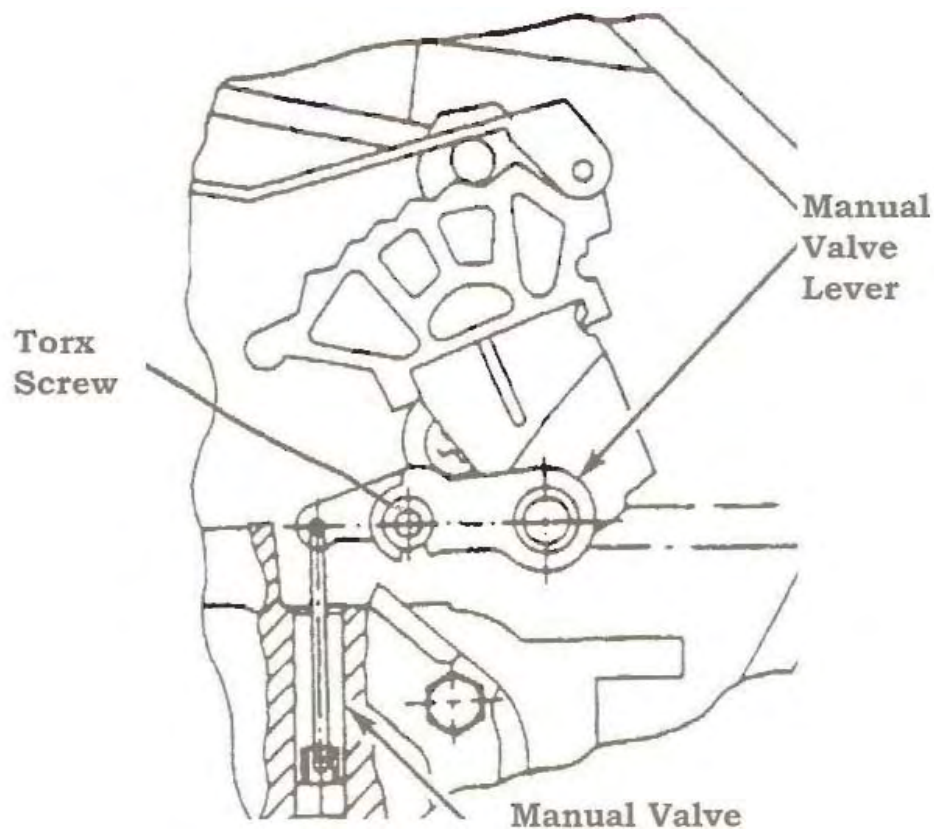
### Adjusting the Manual Valve

If the line pressure in D is low, but correct in Manual 3, suspect a misadjusted manual valve. To Adjust the manual valve properly you must first:

1. Select the Park position
2. Loosen the Torx screw
3. Bottom out the Manual Valve in the Valvebody
4. Tighten Torx Screw
