Transmission: 4L80E
Subject: Updates
Application: Chevrolet
Issue Date: 1995

4L80E

Updates

Technical Bulletin #266

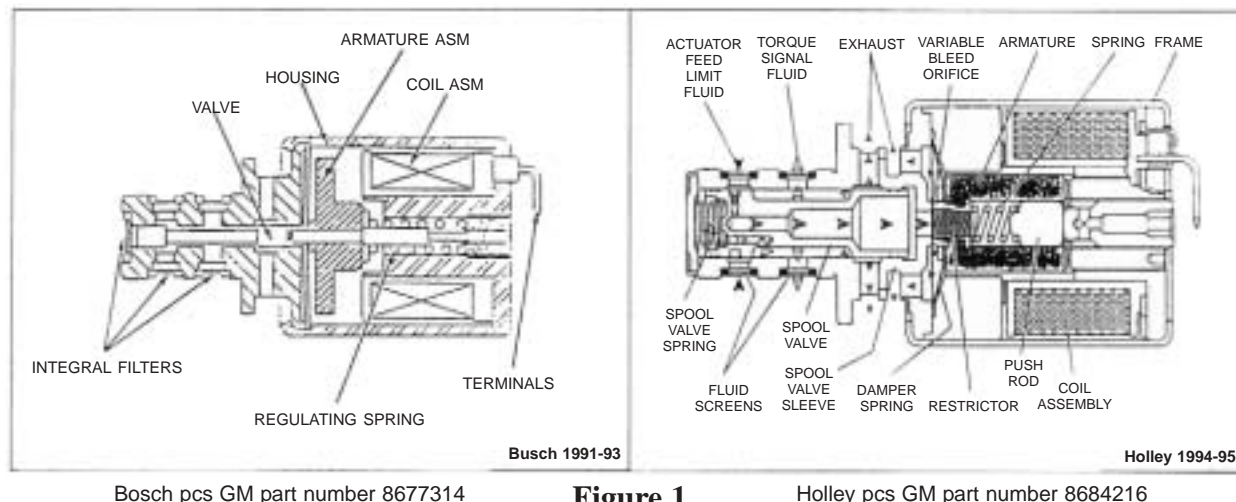
Figure 1

Beginning with the start of production for the 1994 model year all 4L80E models were equipped with a new designed pressure control solenoid (force motor). 1991-93 model units were equipped with a unit built by Bosch, which can be identified by its silver colored exterior. The new pressure control solenoid is manufactured by Holley and can be identified by its black

colored exterior. Internally, the solenoids vary greatly. The size of the spool valve has been increased and a spring was added to eliminate the need for the 10-second cleaning pulse. (Figure 1)

To accommodate this change, the oil channeling for the solenoid has been changed. This change removes the balance oil from the end of the solenoid, which means the Bosch unit must not be used to replace a Holley solenoid or high line pressure will result. In addition, the resistance of the new solenoid is slightly higher at 3-8W. With this slight increase in resistance, you will notice the duty cycle reading on your scanner or meter is also slightly higher while the amperage/pressure values remain the same as the Bosch Units. The duty cycle values for the Holley will normally read about 50 to 70% at idle and decrease as load is increased.

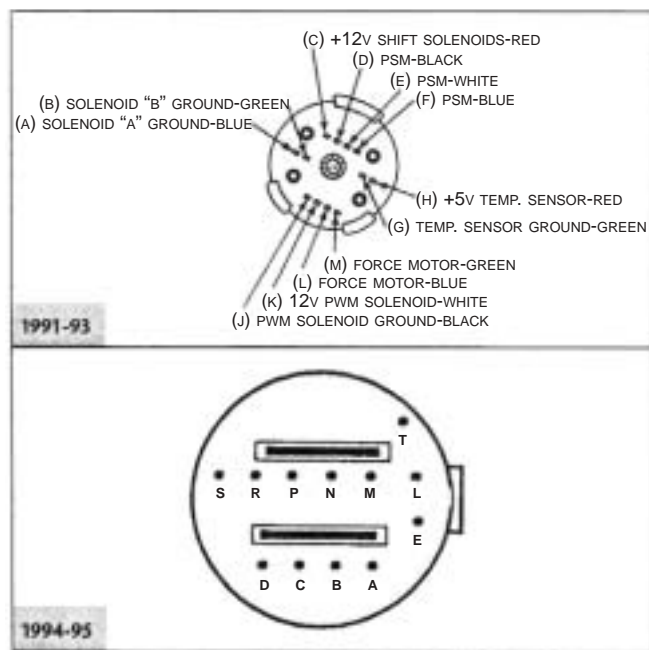
Figure 2

To reduce the possibility of leakage and multiple code storage a new connector was added to all 4L80E models. (Figure 2).

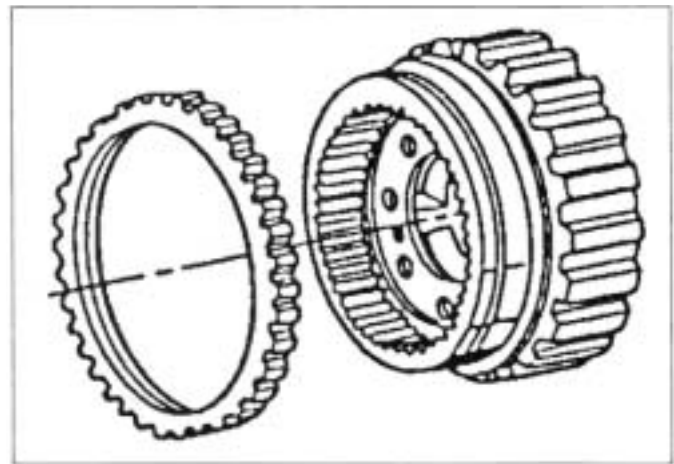
Figure 3

All 4WD units now use only output speed sensor (located at the transfer case) rather than sensors at the transfer case and the transmission output shaft. Since the output toothed wheel was also dropped (Figure 3), care must be taken not to interchange output planetary carrier assemblies between output VSS and non output VSS equipped units. Attention must also be given when replacing a unit with a rebuilt transmission to assure the transmission is properly equipped with or without a toothed sensor wheel.

If the wrong transmission part number or a carrier unit without a toothed wheel is installed in a 1991-93 vehicle, late/no upshifts may result.

NOTE: Late upshifts may result due to the sensor picking up a 21 pulse per rotation signal from the machined slots cut in the output planetary assembly, rather than the normal 40 pulse per rotation signal the PCM/TCM experts to see.

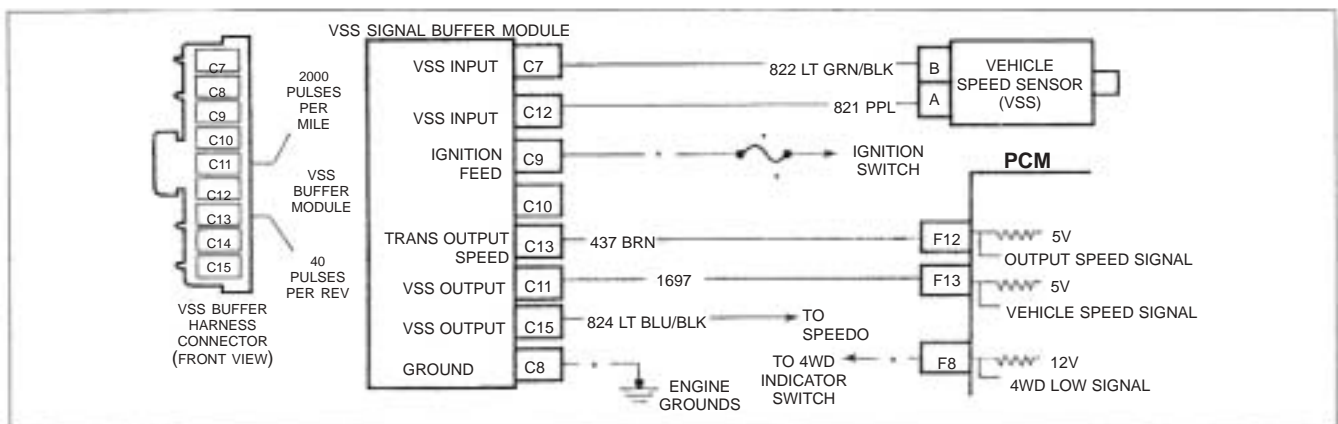
Figure 4

Both 1994-95 4WD and 2WD vehicles use the same wiring layouts for their output vehicle speed sensor circuits. (Figure 4)

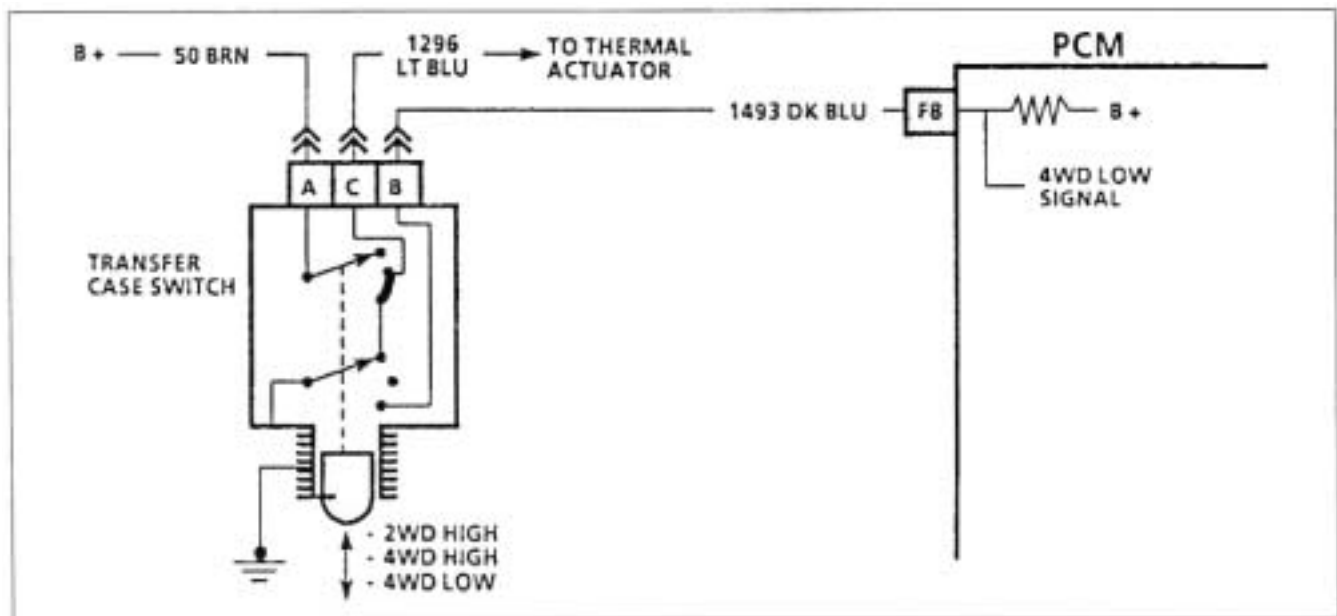
Figure 5

To accomplish this, the switch at the back of the transfer case, which was used to energize the front drive axle thermal actuator, has an additional set of contacts and an additional wire which signals the PCM when the 4WD LOW range is selected. (Figure 5)

During ranges other than LOW, the switch remains open and the PCM feed circuit 1493 remains at battery voltage.

As the Low range is selected, the transfer case switch grounds circuit 1493. This pulls the signal voltage at the PCM low and signals the PCM to change the vehicle up/down shift points to accommodate the change to 4WD LOW range. 4WD LOW switch position is indicated as a scan tool parameter on 94-95 vehicles.

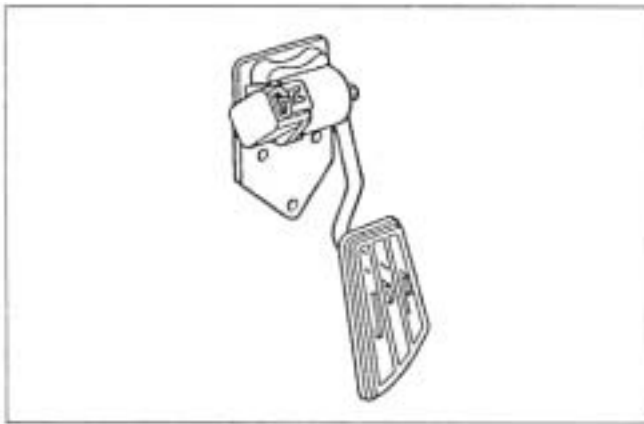
Figure 6

The APP sensor is mounted inside the passenger compartment and has the accelerator pedal attached to it. (Figure 6)

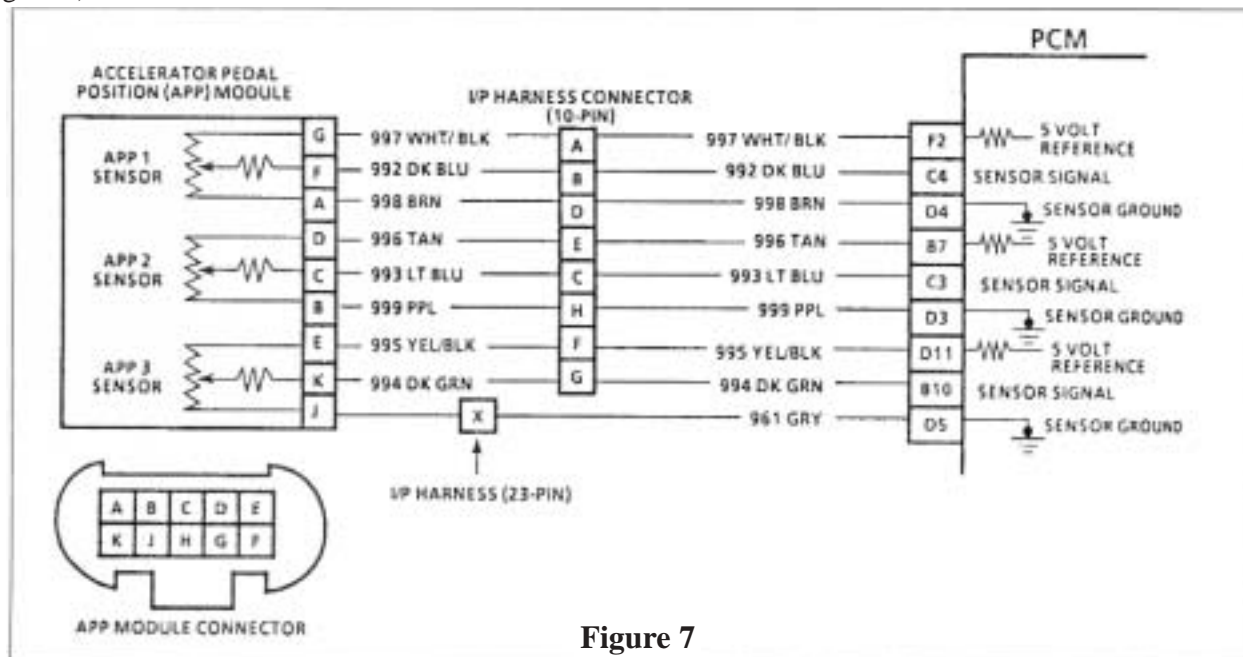
Figure 7

The APP sensor houses three potentiometers which are used to measure the percentage of throttle opening. (Figure 7)

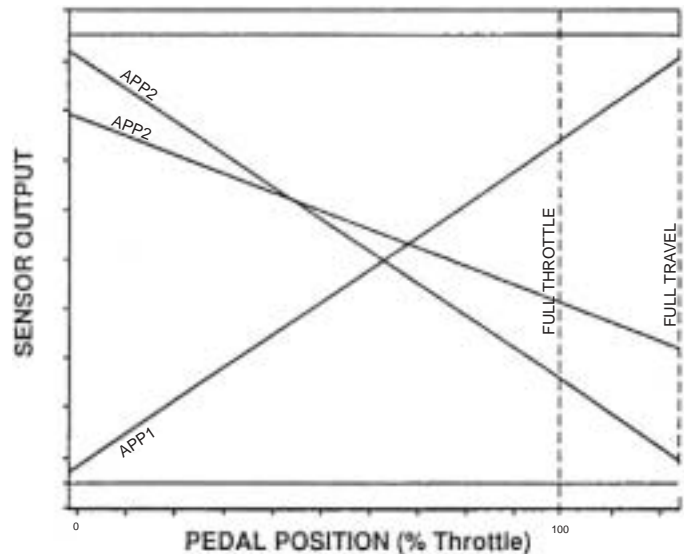
Figure 8

APP #1 reads approximately .5 volts at idle and climbs steadily to approximately 4.0-4.25 volts at wide open throttle.

APP #2 will produce a signal of approximately 4.5 volts at idle and decrease steadily to about 1.25 volts or less at wide open throttle.

APP #3 provides a signal of approximately 4 volts at idle which decreases steadily to approximately 2.25-2.0 volts at wide open throttle. (Figure 8)
