Transmission: 4L60-E

Subject: Code 72 diagnostics (1993-95 applications with a PCM)

Application: GM

Code 72 Diagnostics (1993-95 Applications with a PCM)

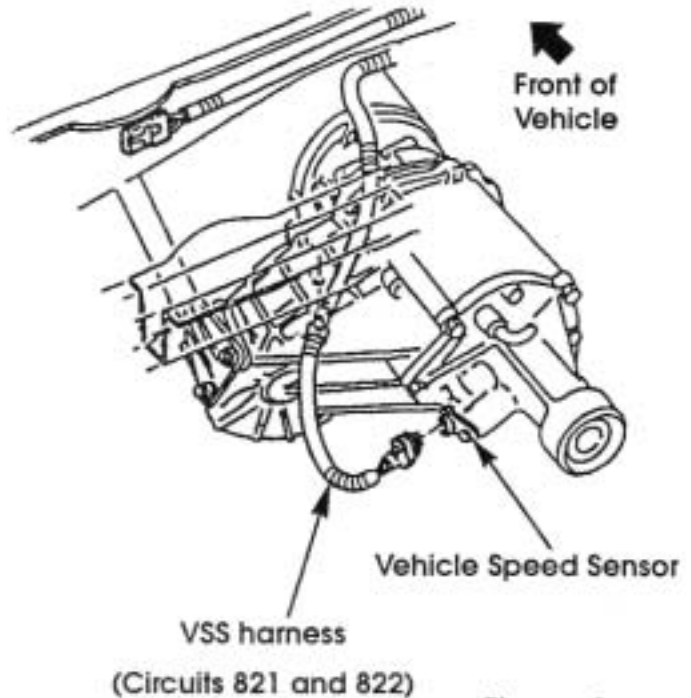
Figure 1

- Short to ground in VSS sensor circuit 821 or 822, on all steel drive versions. The problem is usually at the transfer case where the wiring harness is routed over the top. The harness generally rubs through on one of the flanges of the transfer case (figure 1).
- Short to ground in circuit 821 or 822 at the wiring clamp, behind the exhaust shield.
- Circuits 821 or 822 shorted at the engine cover bracket or valve cover.
- Water intrusion into the PCM connector C-240, causing terminal corrosion. Connector C-240 is mounted under the passenger side of the dash, next to the PCM (figure 2). Water intrusion into this area is usually due to a windshield leak in the right corner of the dash.

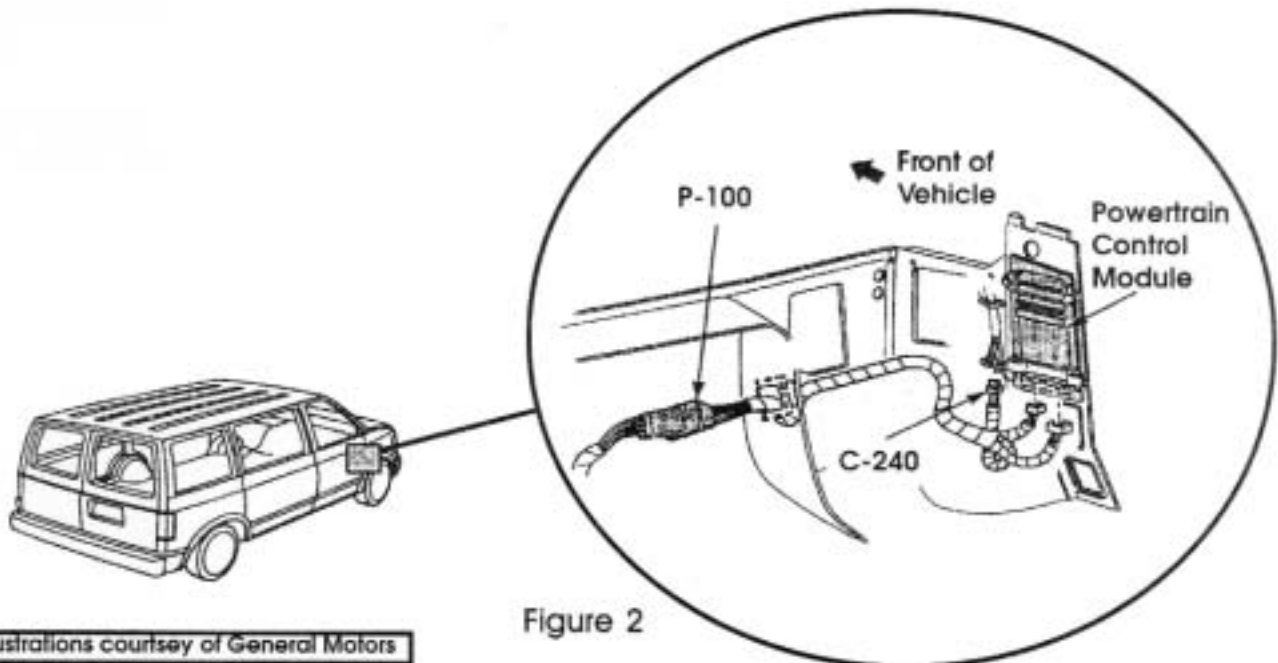
Figure 2

- Extension housing or output shaft bushing loose.
- The vehicle speed sensor circuits are routed with the main vehicle harness. This harness travels along the bellhousing and enters the cab on the passenger side. If the harness is too close to any spark plug wires, a code 72 will result due to EMI. Reroute the plug wires away from the P-100 (pass through connector) area (figure 2, page 10).

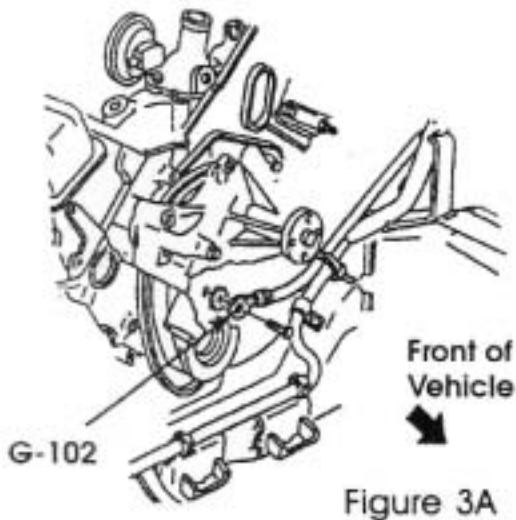
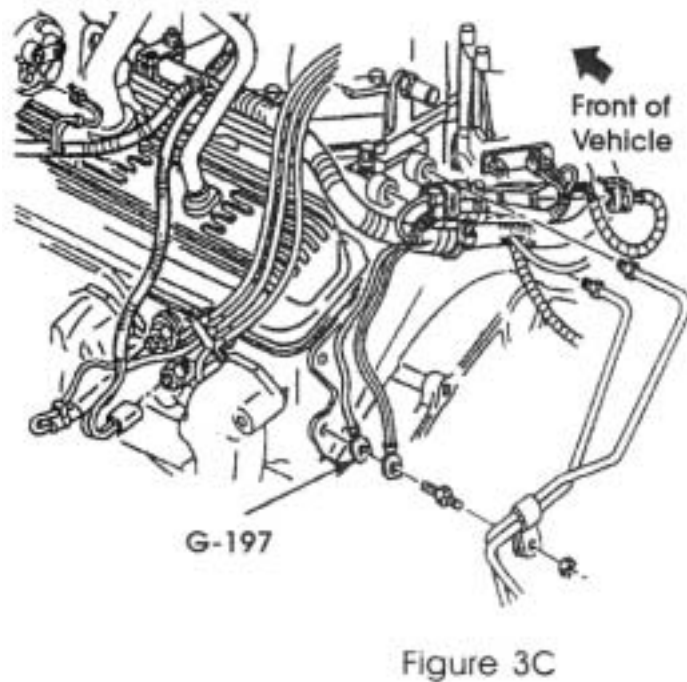
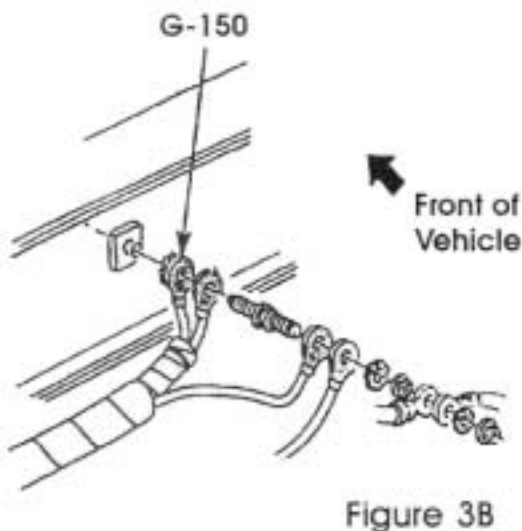
- A loose or corroded battery ground bolt. This problem is generally ground G-102 (figure 3A) which is mounted under the water pump/power steering pump area of the block, or G-150 (figure 3B) which is mounted to the radiator core support. If these grounds are not corroded or loose, inspect ground G-197 (figure 3C) for a possible problem. A problem with G-150 may also cause the dash lamps to be dim.

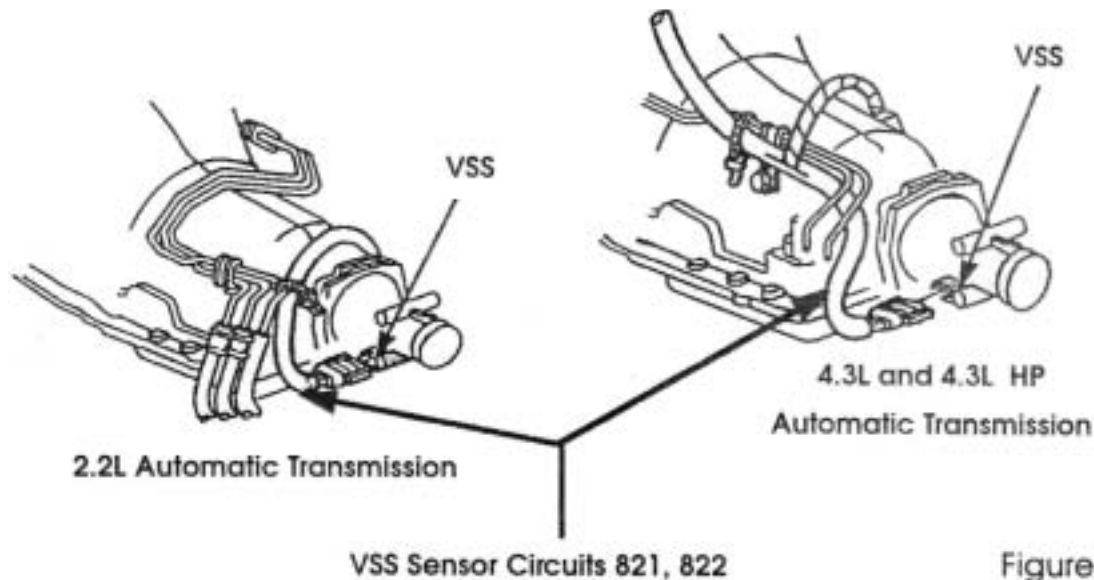
Figure 4

- Circuit 821 or 822 shorted to ground at the metal bracket below the distributor or as it crosses the top of the bellhousing (figure 4).
- Circuit 821 or 822 shorted to ground at the right hand valve cover area, heat stove or dipstick tube area.

- Circuits 821 or 822 shorted to ground at the top of the bellhousing on one of the *P* style mounting clips or at one of the studs that are protruding from the cowl area (figure 4, page 12)

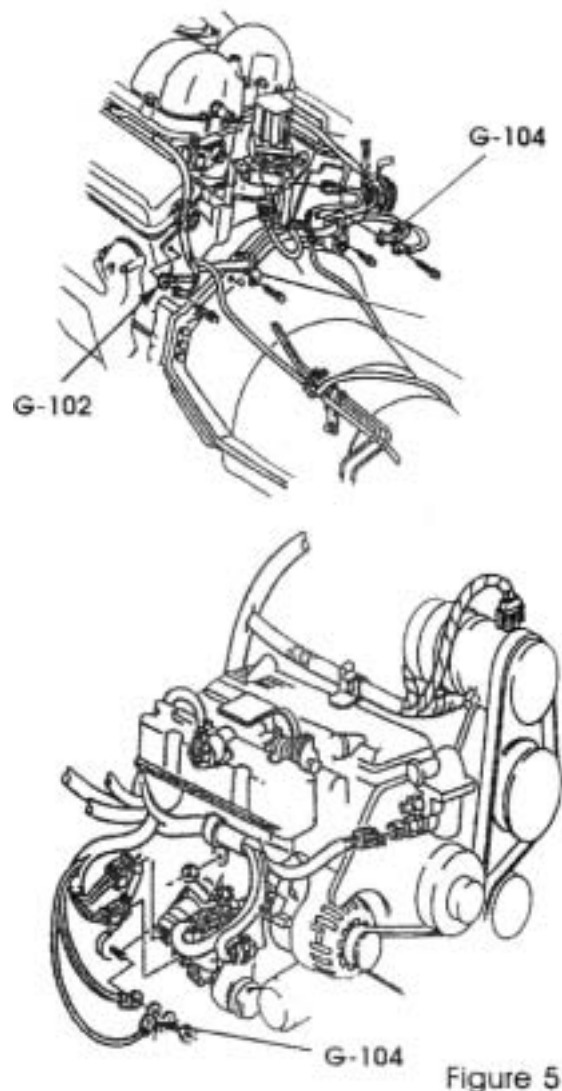
Figure 5

- Ground G-104 or G-102 loose or corroded (figure 5). (G-104, G-102 are located at the rear of the cylinder head on 4.3L applications, and on the passenger side, at the lower corner of the bellhousing on 2.2L applications).

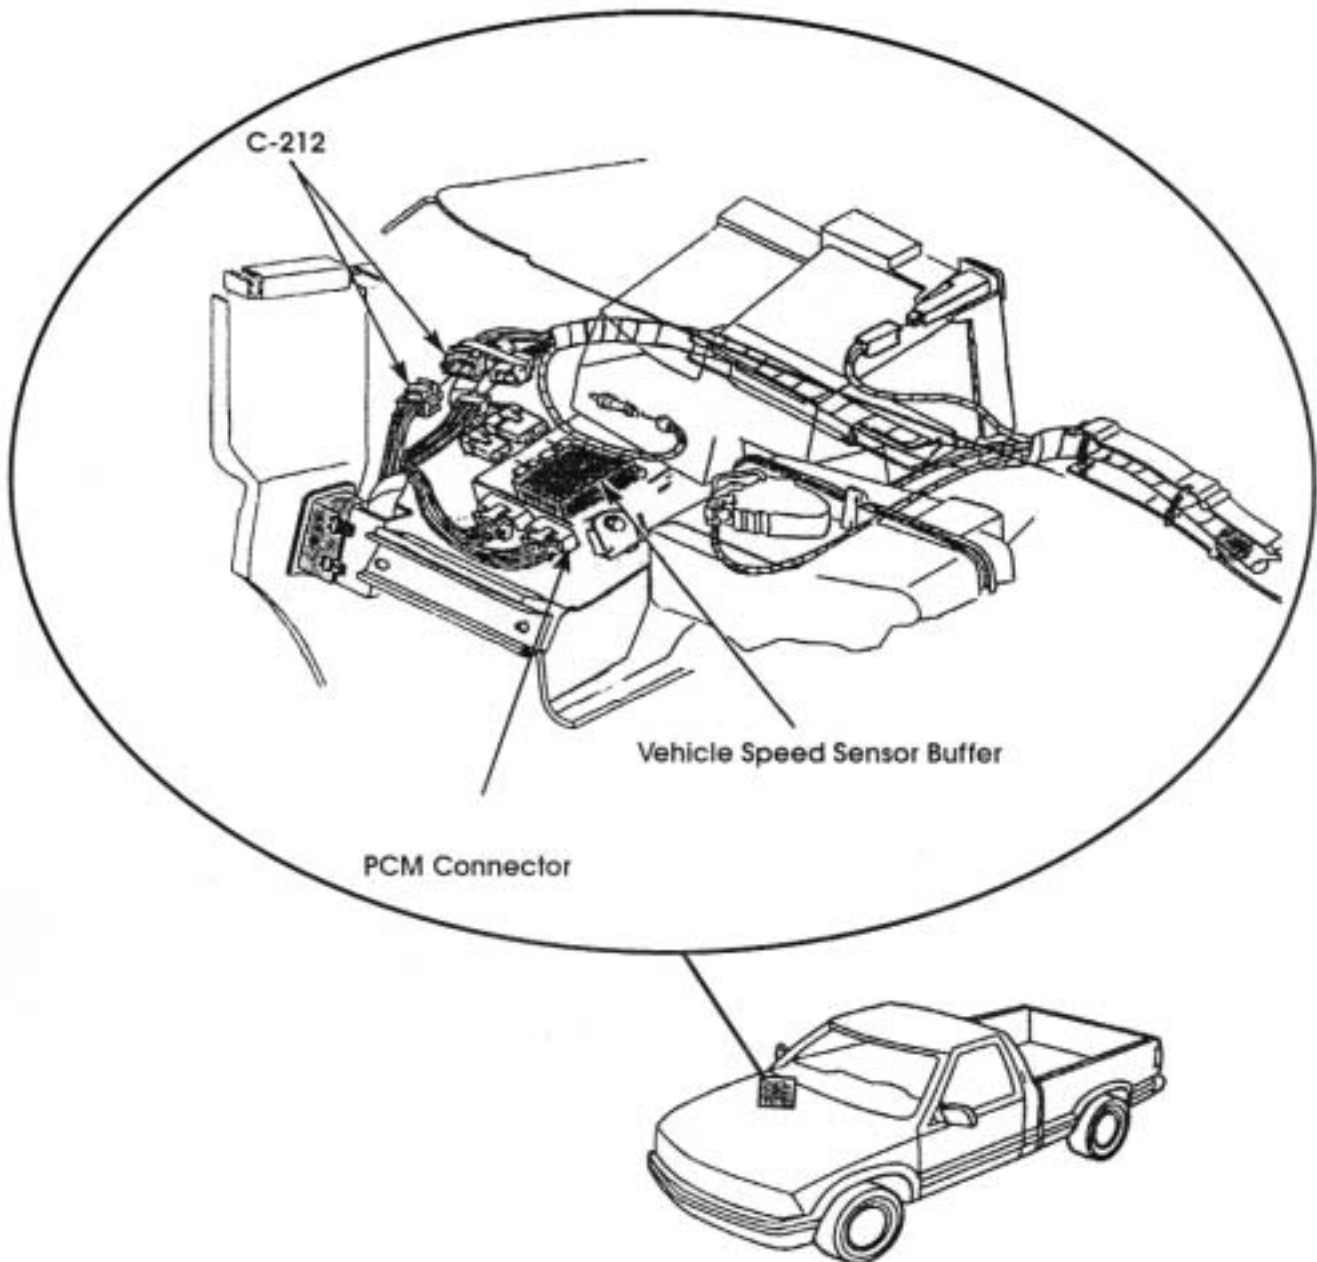
Figure 6

- Connector C-212 is not fully connected or it's terminals are damaged. C-212 is a 10-pin connector mounted next to the PCM (figure 6).
- The 4WD low-input circuit 1694, which feeds pin F-8 of the PCM may be intermittently shorting to ground. This will change the PCM's ratio calculation for the VSS, which may result in setting code 72.

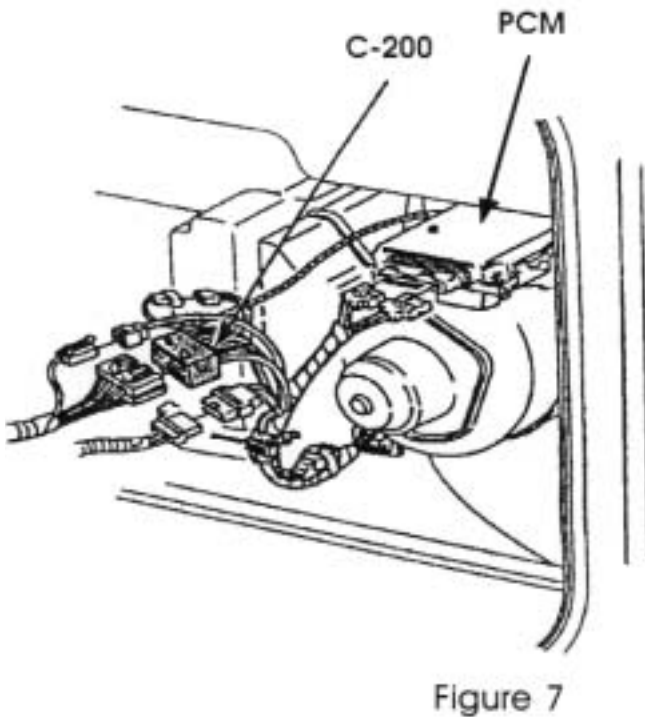
- Connector C-200 not fully seated or its terminals may be damaged. C-200 is located behind the right side of the instrument panel in the area of the blower motor (figure 7).

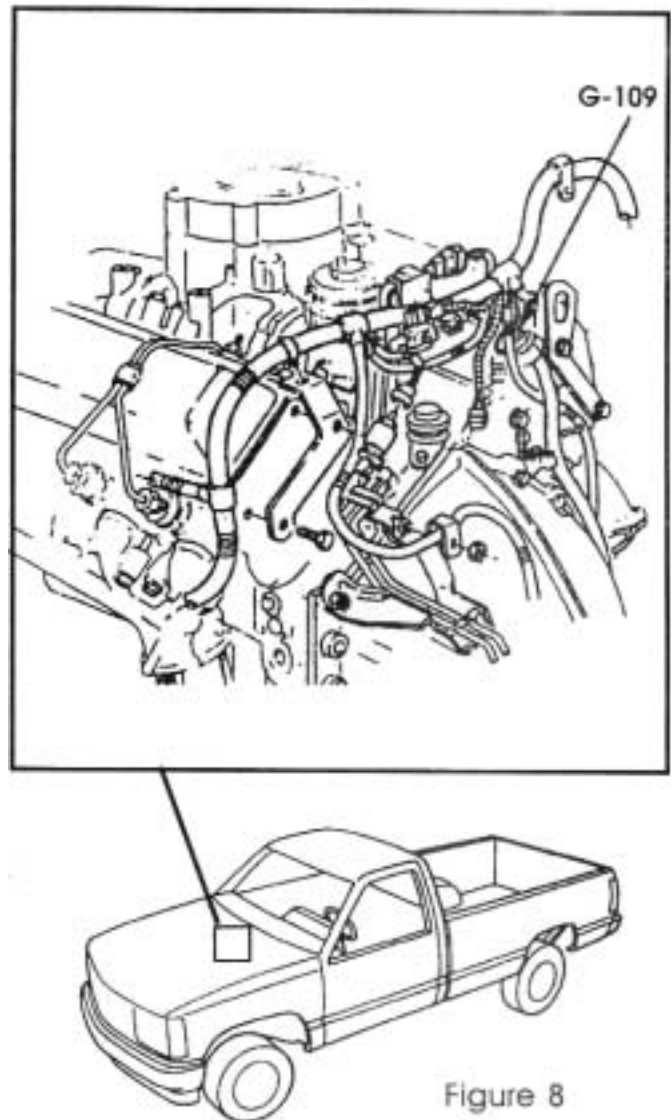
- Ground G-109 is corroded or loose. G-109 is located on the thermostat housing on gas engines (figure 8, diesel application shown.)
- Connector C-365 not fully seated or its terminals may be damaged (C-365 is connected to the vehicle speed sensor, at the sensor).

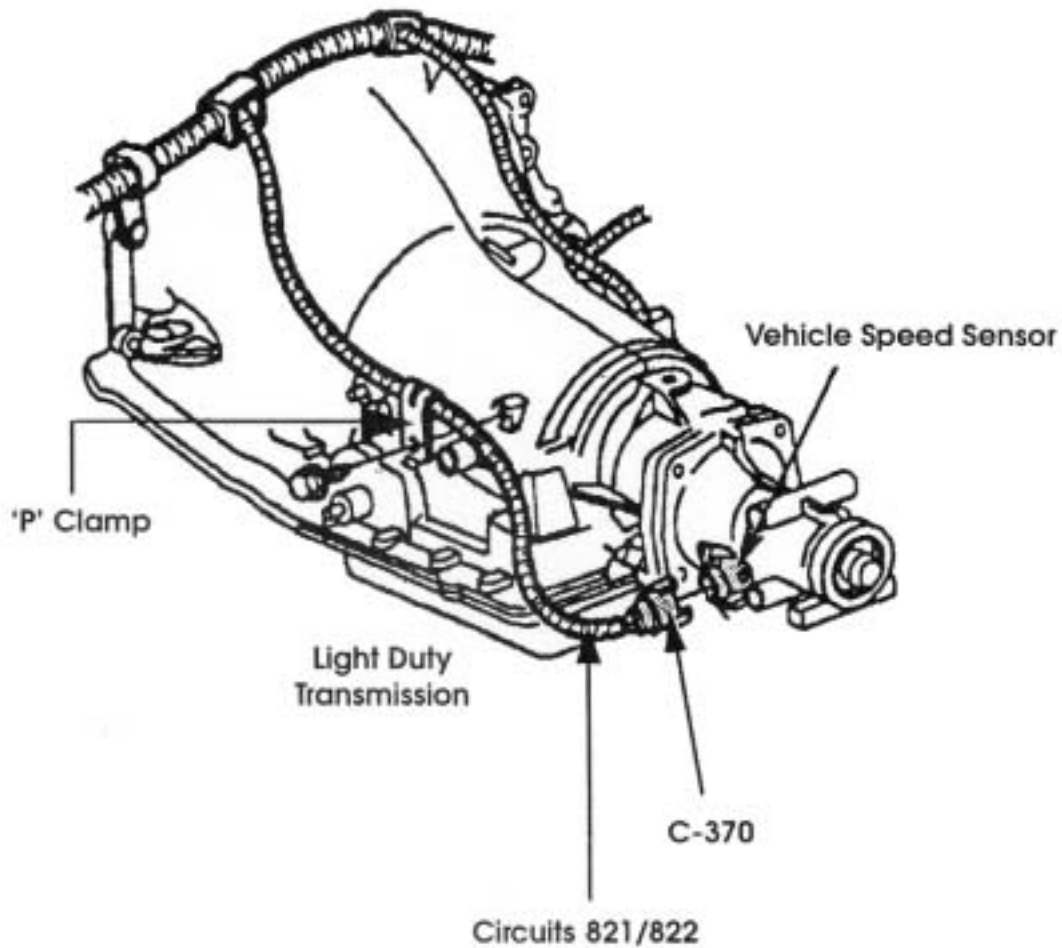
Figure 9

- Circuits 821 or 822 are shorted to ground at the *P* style hold-down clamp on the side of the transmission (figure 9). These circuits have also been known to short to ground on the underdash bracket near the DRAC. The DRAC is located on the driver's side under the dash (figure 10, page 16).

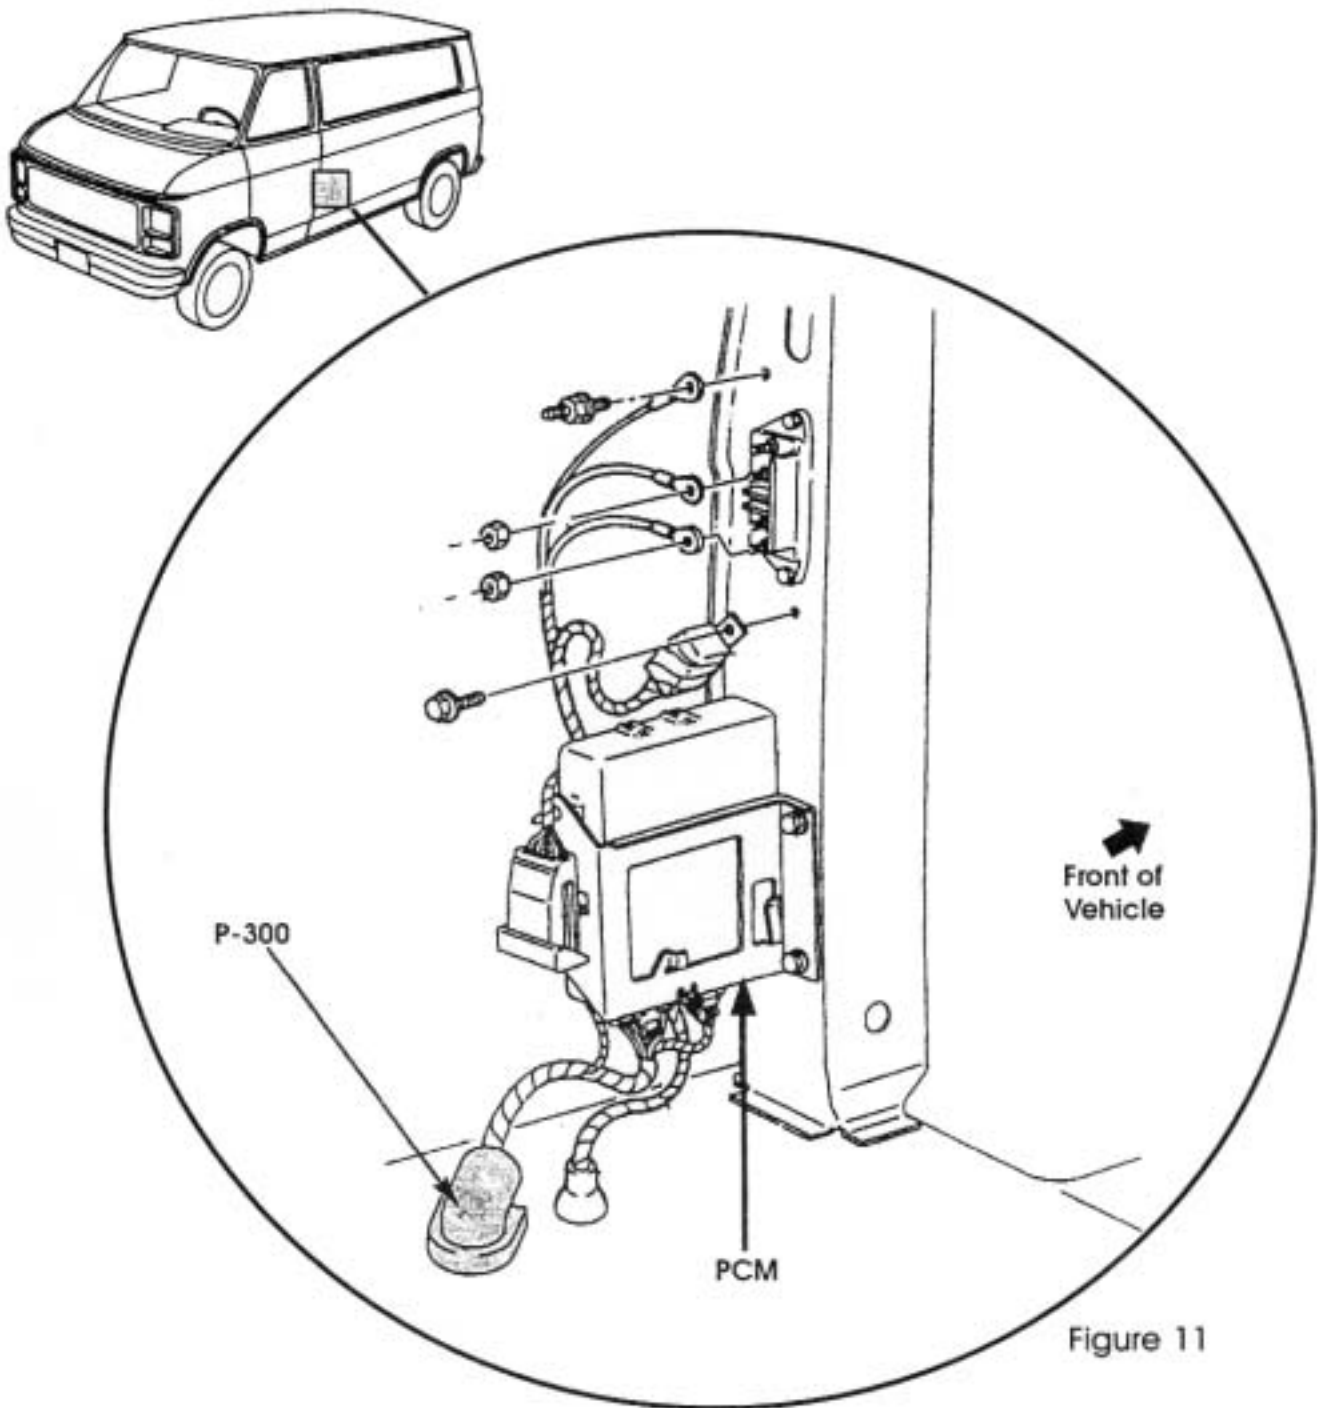
- Grounds G-124 and G-125 are the braided ground cables between the vehicle body and the engine. If one of these straps are loose, corroded or not installed, many symptoms may result including a code 72. It is imperative that these grounds be in place and in good condition.
- Circuit 437 shorted to ground by a sheet metal screw in the vicinity of the PCM (figure 11).

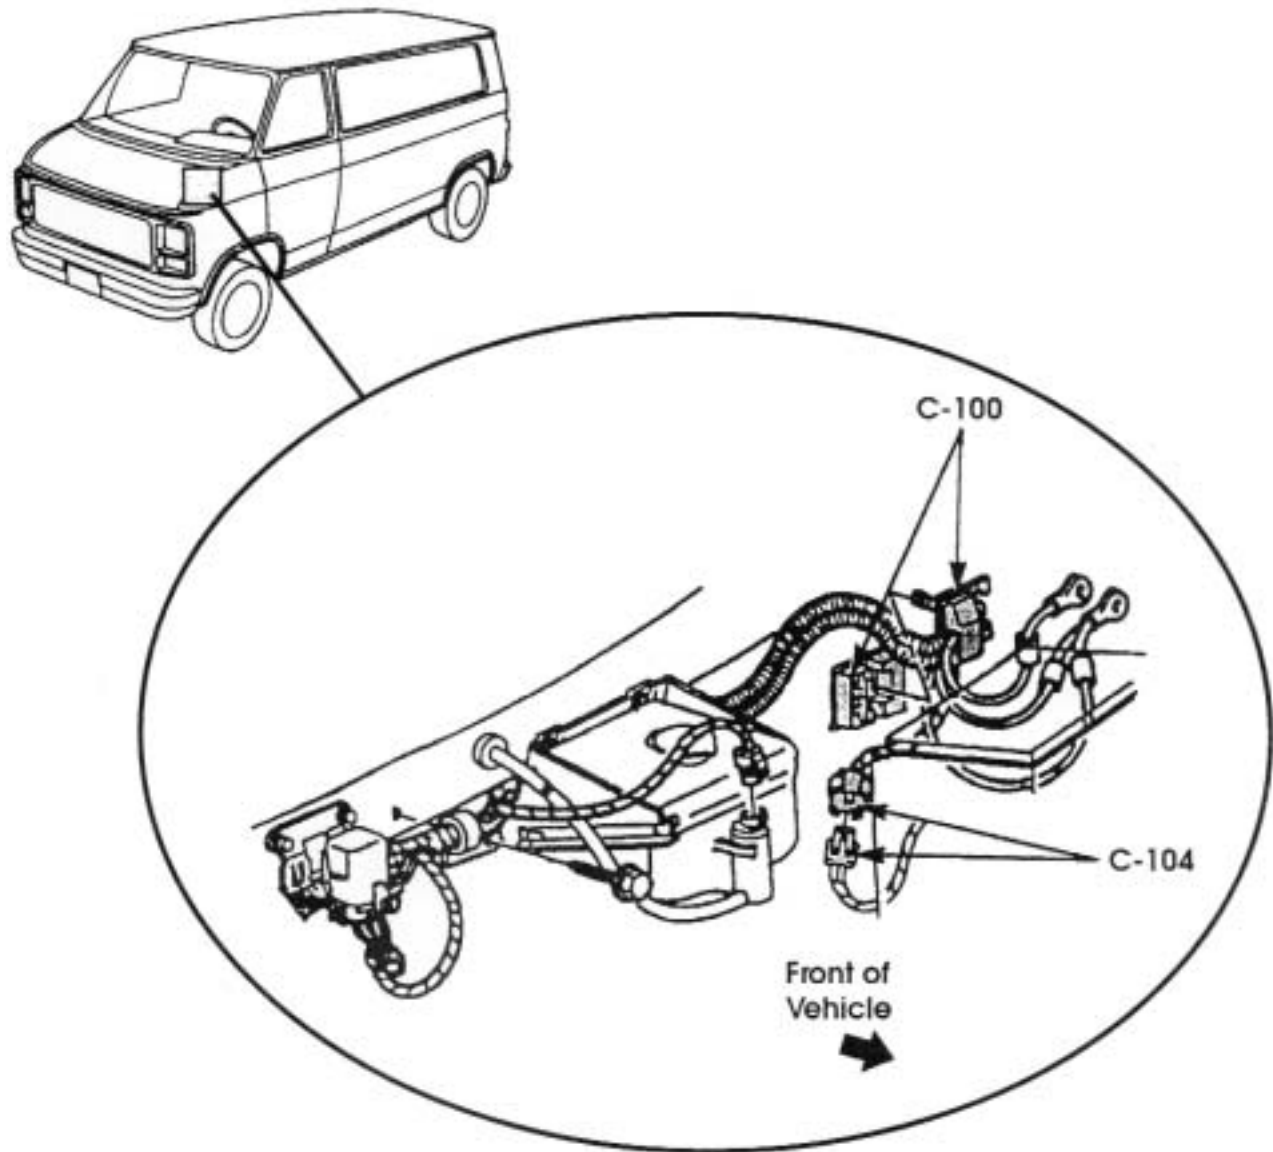
Figure 12

- Connector C-104 may be coated with undercoating, causing poor terminal contact. C-104 is a two-wire connector mounted on the driver's side of the cowl area, engine compartment side, near the bulkhead connector (figure 12).
- Connector C-100 is damaged or loose. C-100 is mounted on the driver's side of the cowl area, engine compartment side, and serves as the bulkhead connector. C-100 has been known to corrode from battery acid or fumes if the connector is not properly sealed.
