Transmission: 41TE / 42LE
Subject: Torque converter clutch failure
Application: Chrysler
Issue Date: August, 1997

Torque Converter Clutch Failure

Technical Bulletin #429

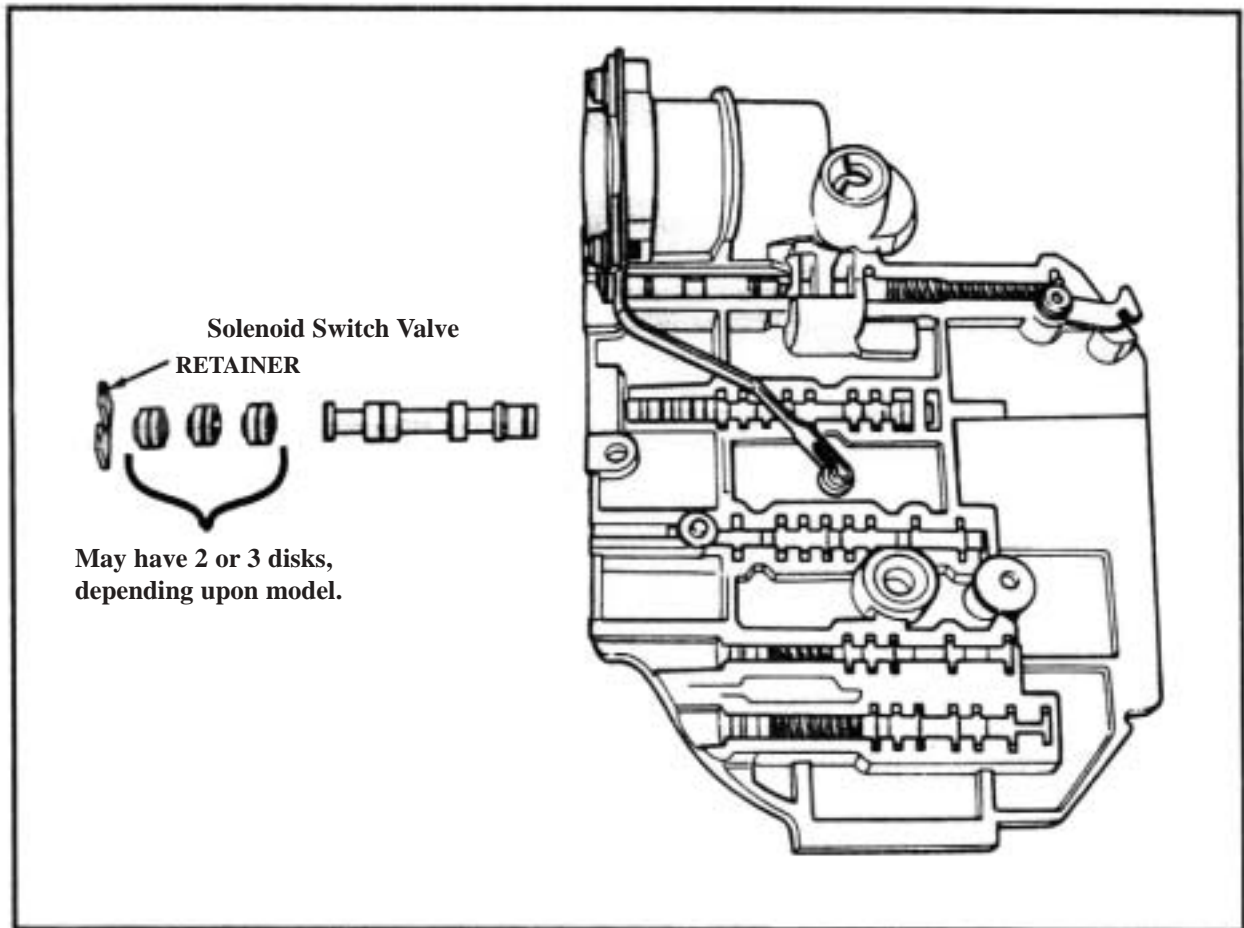
Figure 1

One of the more common 41TE/42LE problems is a failure of the torque converter clutch piston and friction material. Several factors can contribute to this failure, such as restricted cooler systems, poor engine tune, restricted filters and line pressure fluctuations. One other cause of this problem that can be difficult to understand is a sticky valve problem in the valve body. A sticking solenoid switch valve can cause this, and can be responsible for repeat failures of the converter clutch piston in a short amount of time (figure 1).

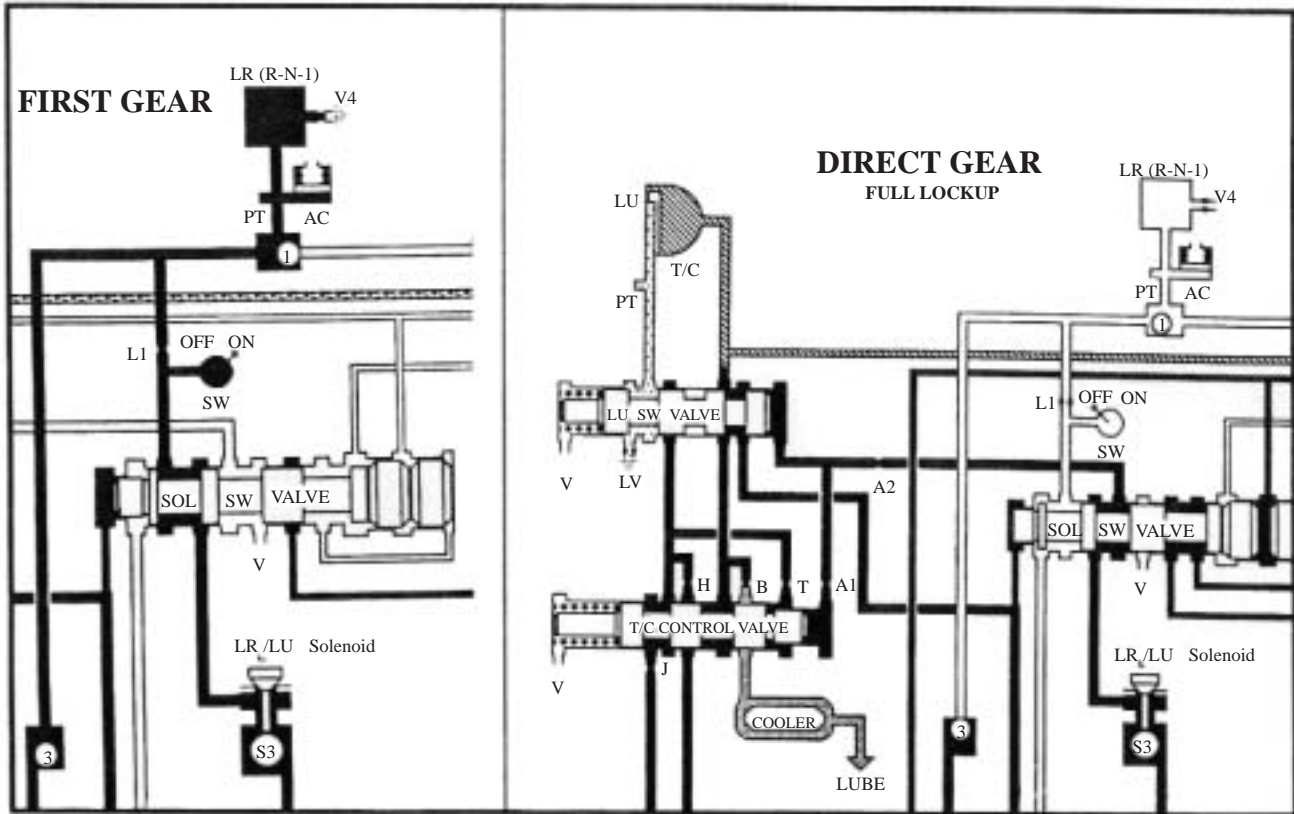
Figure 2a and 2b

The solenoid switch valve determines whether the low/reverse lock-up solenoid is going to operate the low/reverse apply circuit or the lock-up apply circuit (figure 2). Since this valve spends almost all of its time in the lock-up operating position, a ridge tends to build up in the valve bore that can hold the valve in this position. When the vehicle is brought to a stop, the underdrive solenoid is momentarily pulsed on, sending a small burst of pressure to the solenoid switch valve. This burst is supposed to place the solenoid switch valve into the low/reverse apply circuit operating position. However, if the valve does not immediately move to this position, remaining in the lock-up control position, the transaxle will not be able to engage the low/reverse clutch, effectively being in neutral when the vehicle comes to a stop.

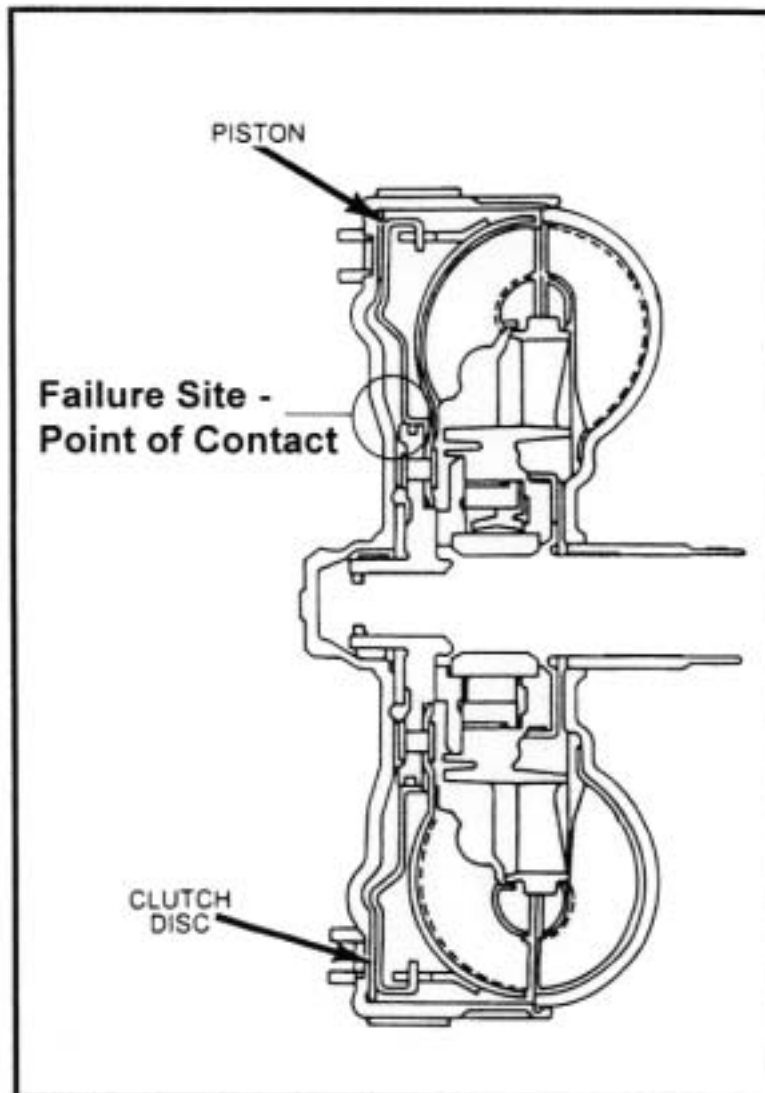
Figure 3

The TCM senses that the transaxle is still in a forward range through the PRNODL and neutral safety switches, and watches output speed come to a stop. However, since the transaxle is not engaged in any gear as a result of the low/reverse clutch being released, turbine speed is still roughly the same as engine RPM rather than showing zero RPM as it should. In response, the TCM commands a momentary 'Full On' signal to the low/reverse lock-up solenoid in an attempt to apply the low/reverse clutch. This high volume burst of 120-145 psi is inadvertently sent to the lock-up control valves instead of the low/reverse clutch. This smashes the converter clutch piston into the converter cover with much more force than it was designed to tolerate, bending the inner diameter of the piston (which has no friction material lining) forward until it contacts the surface of the converter cover (figure 3). This immediately generates metal particles from the contact, causing immediate, and sometimes total, damage to the torque converter. Make certain that all 41TE and 42LE valve bodies are thoroughly cleaned and serviced to avoid sticky valve problems that can result in costly failures of this type.
