Technical Bulletin #583

Transmission: 4L60E, 4L80E
Subject: Possible no shifts or codes P0740, P0753, P0758, P0785, P1860
Application: General Motors
Issue Date: December, 2000

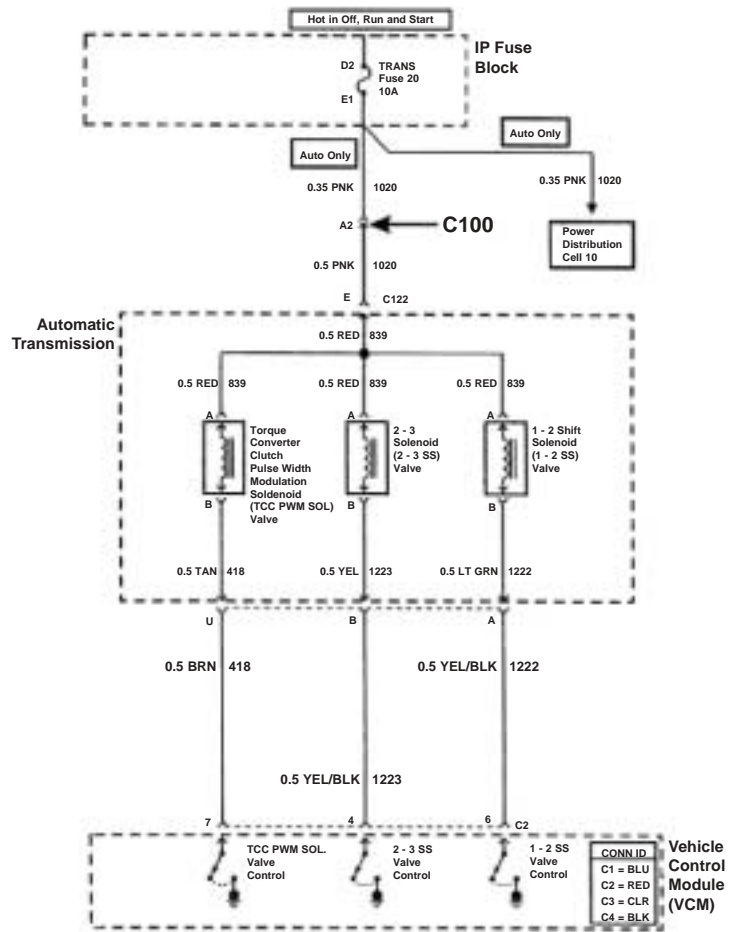
This problem is caused by a poor crimp on one of the terminals for circuit 1020.

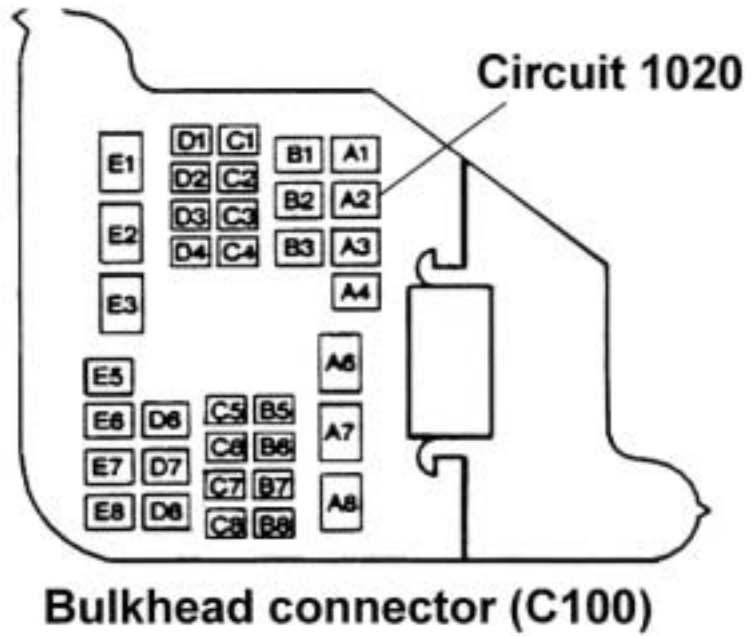
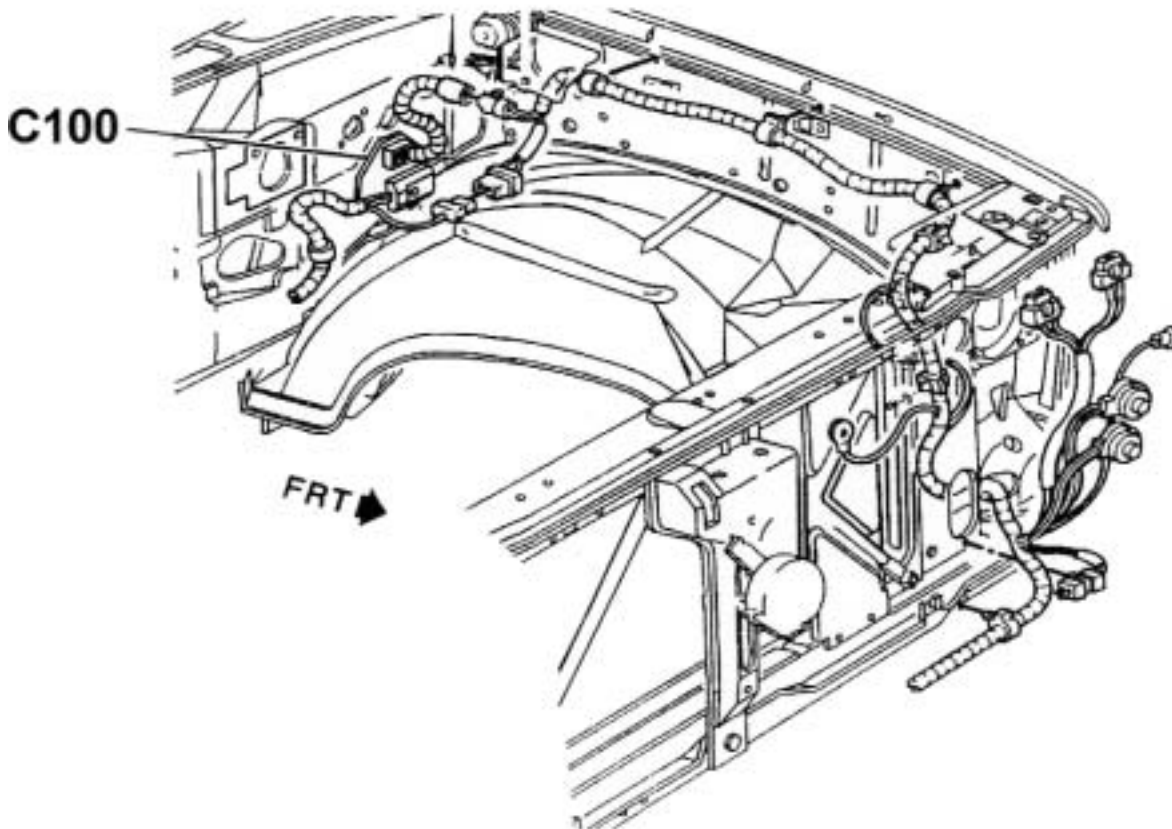
Generally the crimp concern is cavity A2 at the bulkhead connector (C100).
