Technical Bulletin #723

Transmission: 4L60E /4L80E

Subject: Delayed engagement, low fluid level

Application: General Motors

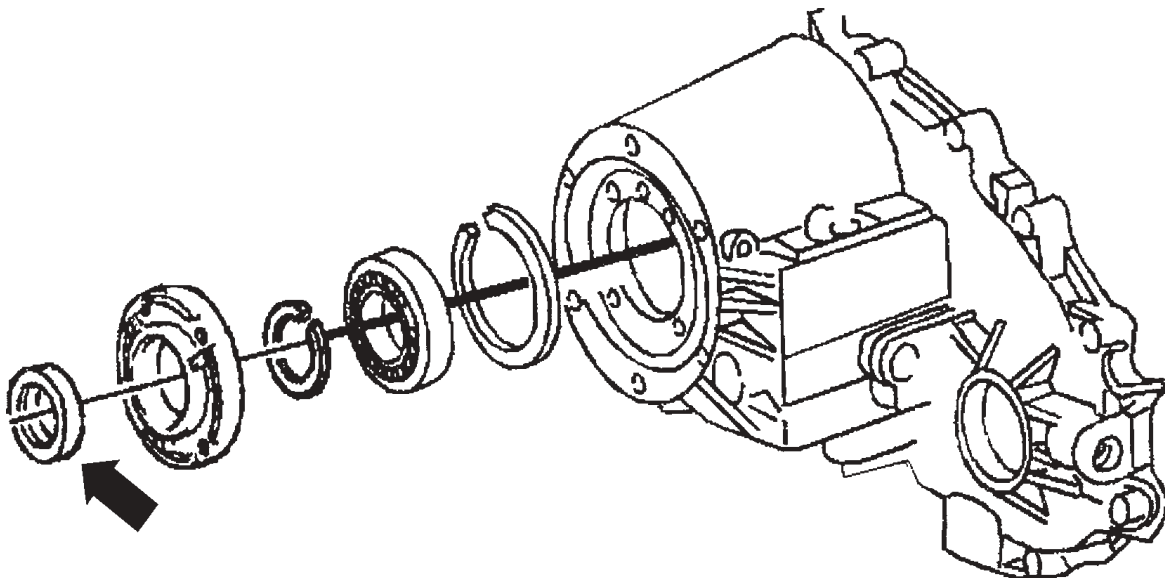
Some 4x4s with the 4L60E or 4L80E may experience delayed engagements, caused by low fluid level in the transmission. This could be due to external leaks, but in some cases may be caused by a leak in the seal that separates the transmission from the transfer case.

If you don't see any signs of major external leaks, check the transfer case fluid level. If it's high, the input shaft seal is probably the culprit.

- External leaks
- Damaged or improperly manufactured transfer housing input shaft seal. Check the transfer case fluid level. If the level is high, inspect the transfer case input shaft seal.

To correct the problem, examine the transfer case housing input gear and bearing carefully. Replace any part that's worn or damaged. Then replace the input shaft seal with part number 14095609. Remember to drain the transfer case, and refill it with the proper fluid.
