## Technical Bulletin #774

**Transmission:** 4T40E, 4T45E

**Subject:** Neutral flare and/or RPM flare while in drive, no 1-2 upshift, service engine soon light illuminated, DTC P1810, DTC P1815 set

**Issue Date:** June, 2003

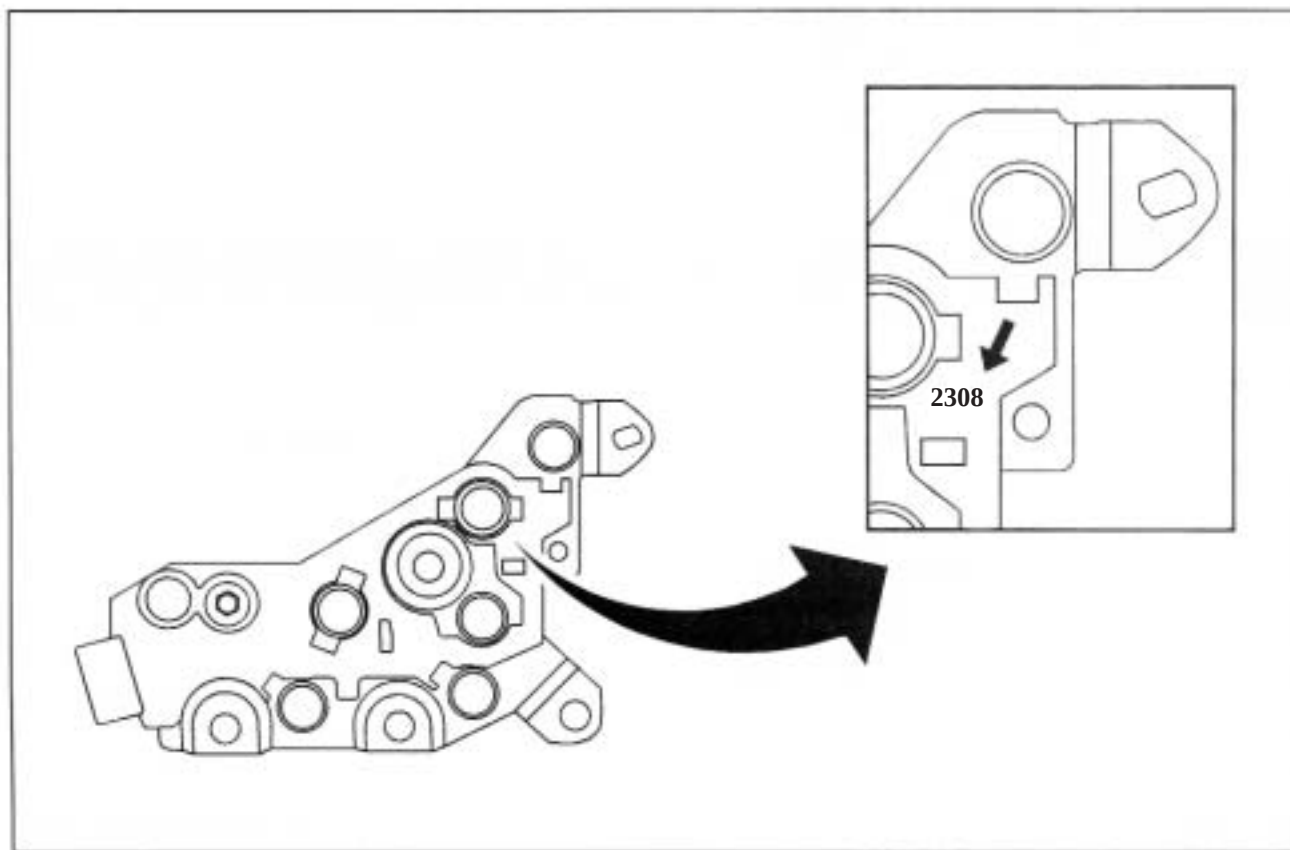
**Figure 1**

The cause may be the transmission fluid pressure (TFP) switch (also known as the pressure switch manifold (PSM)). It will be referred to as the TFP switch in this bulletin.

**Important:** Before installing the new TFP switch, inspect the date code stamped in the switch. The date code MUST BE 2308 or higher. Refer to Figure 1 on the next page.

2. Replace the TFP switch. Refer to Transmission Fluid Pressure (TFP) Manual Valve Position Switch Replacement (SI Document ID #803989).
3. Clear the code and road test the vehicle.
