Technical Bulletin # 1220

Transmission: 6F50

Subject: DTCs P0715, P0717, P0718, P0720, P0721, P0722

Application: Ford, Lincoln, Mercury

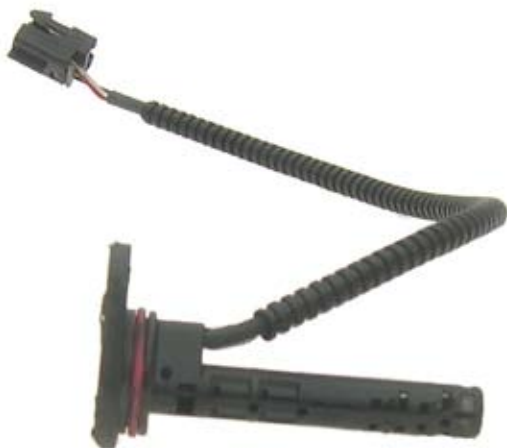
**TSS is located
on the end cover**

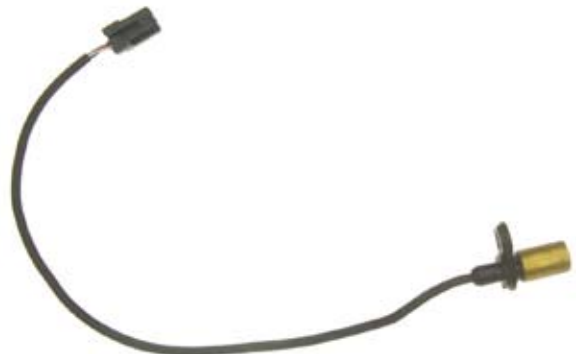
**OSS is located
under the VB**

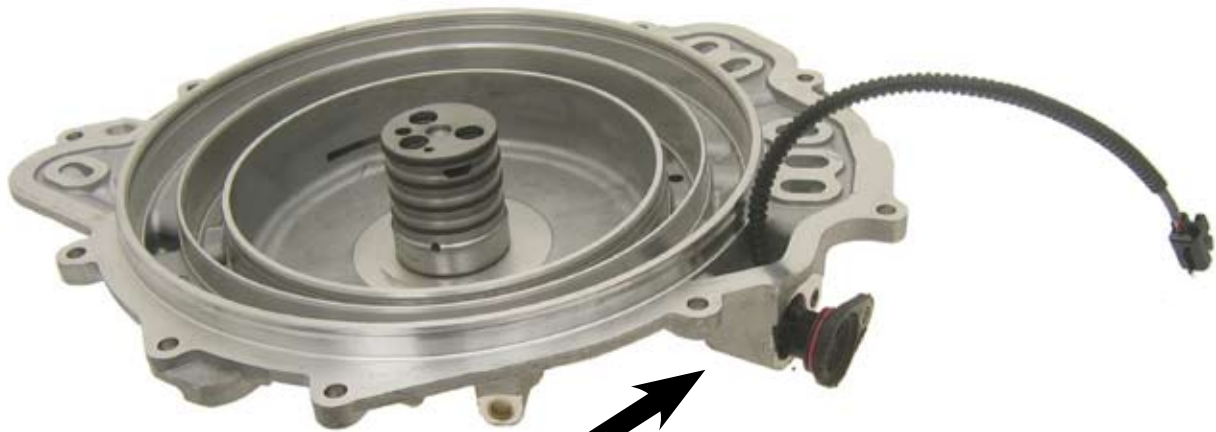
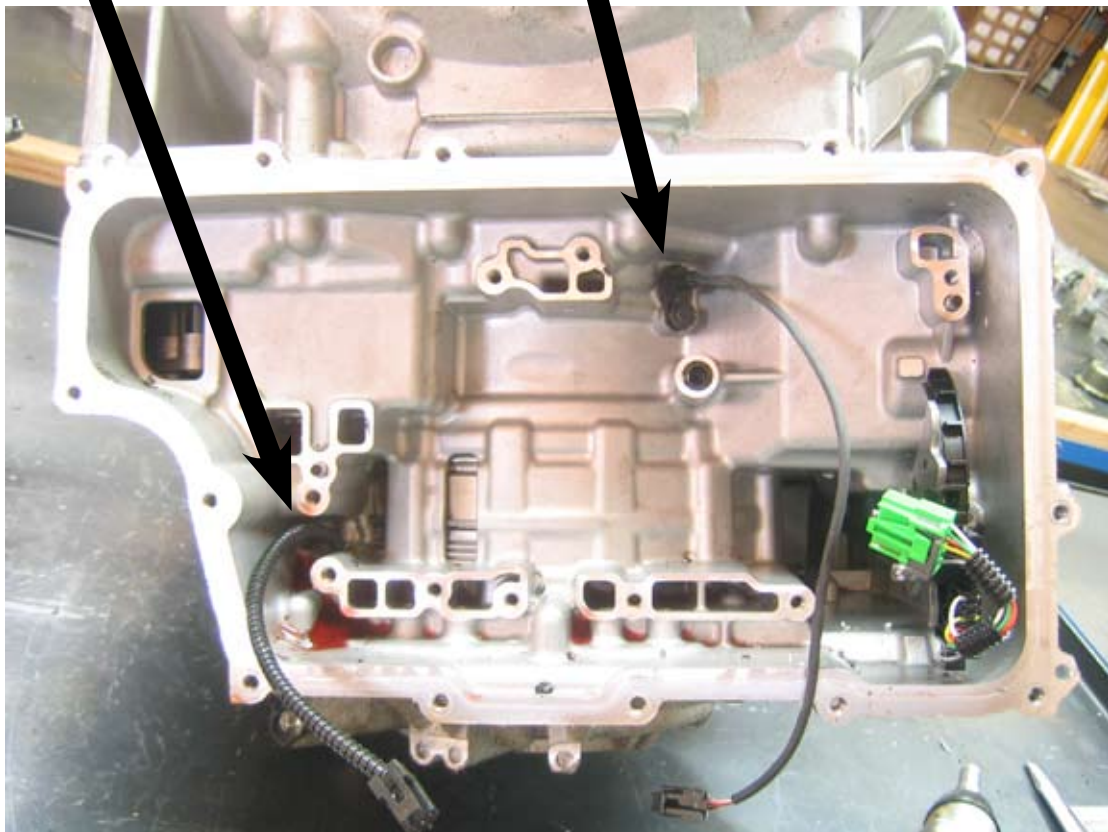
**TSS is located
on the end cover**

**OSS is located
under the VB**
