# ***ATRA Diagnostic Procedures***

## Technical Bulletin # 1150

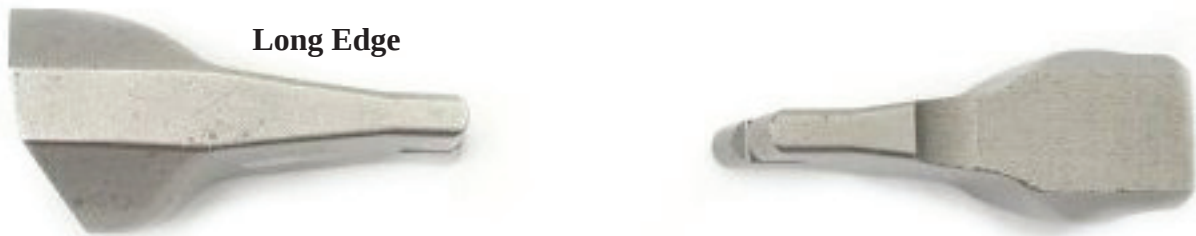
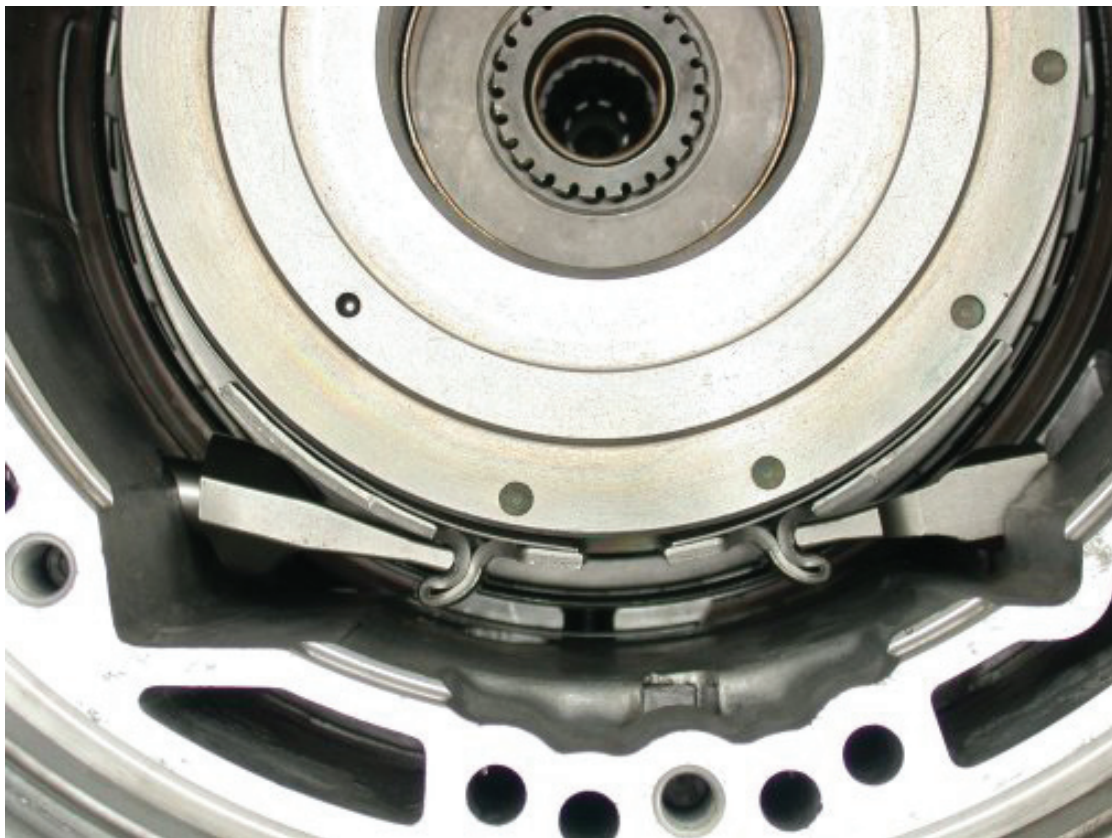
It is important to properly install the band anchor struts. The “Long Edge” faces the band. A soft 1-2 and 2-3 shifts as well as skipped shifts may be caused by incorrect installation of the OD band and Intermediate band struts.

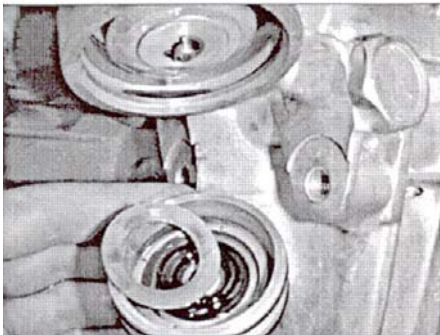
Fig. 1 Broken Washer in B4 Band Servo Cover

Some Volvo models with the 5-speed AW55-50SN (AF33-5) transmission may have a bump or flare on the 2-3 shift. Some owners may also complain about a harsh 4-3 downshift. This can be caused by a broken washer on the B4 band servo cover. See Fig 1. A new cover assembly (30651771) is available to correct this concern.

Install the new band servo cover. No relearn or re-flash is required for this repair. Test drive and make sure no other concerns are noted.

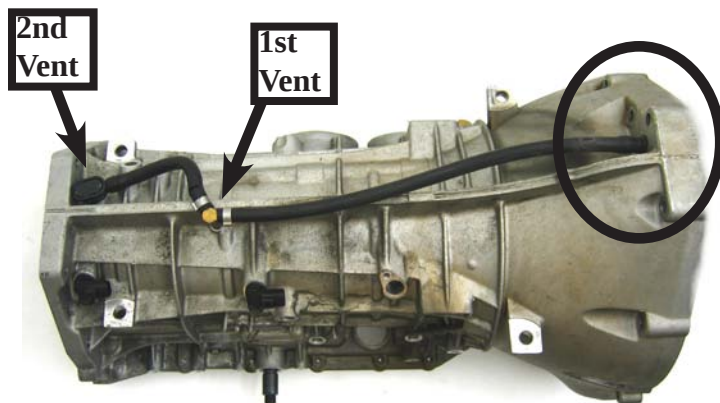
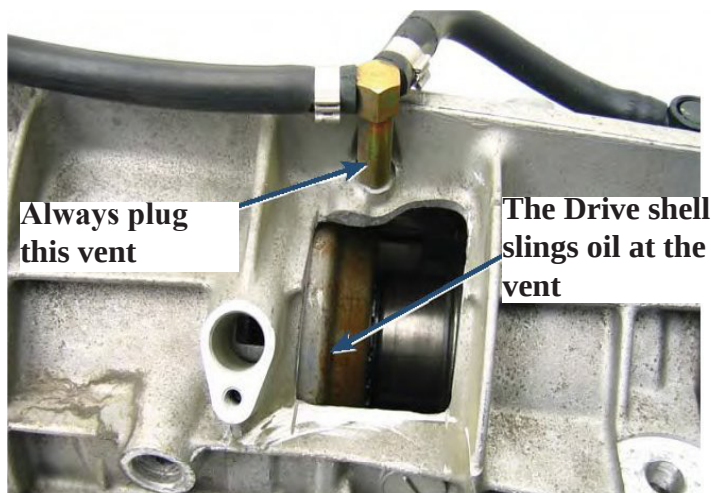
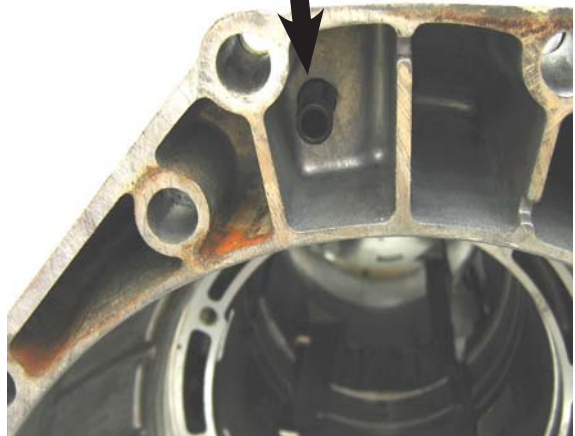
Why Ford put the second vent here is a mystery, because this placed it right above the drive shell which slings a lot of oil right at the vent. The top of the vent hose runs inside the top of the bellhousing. When the vent hose fills with oil, it appears as if the transmission has a front seal leak.

The top of the vent hose runs inside the top of the bellhousing. When the vent hose fills with oil, it appears as if the transmission has a front seal leak.

Since you really don't need two vents, simply use a cup plug or set screw to plug the front vent.

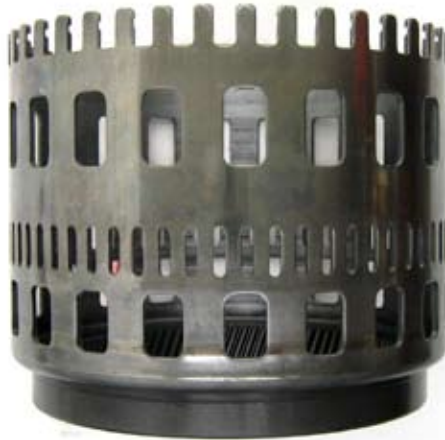
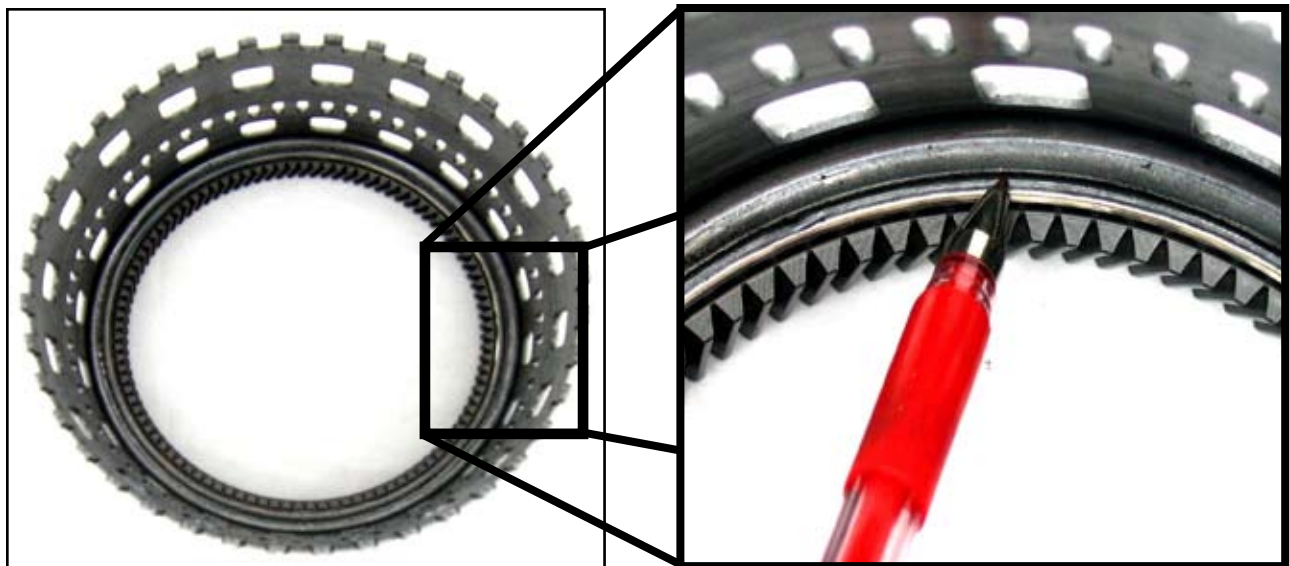
A no movement concern may be caused by the rear internal ring gear weld breaking. When the shifter is engaged in the Drive or Reverse position you can feel transmission engage, but there is no movement. The ring gear is still in the shell but the weld is broken and will not come out .

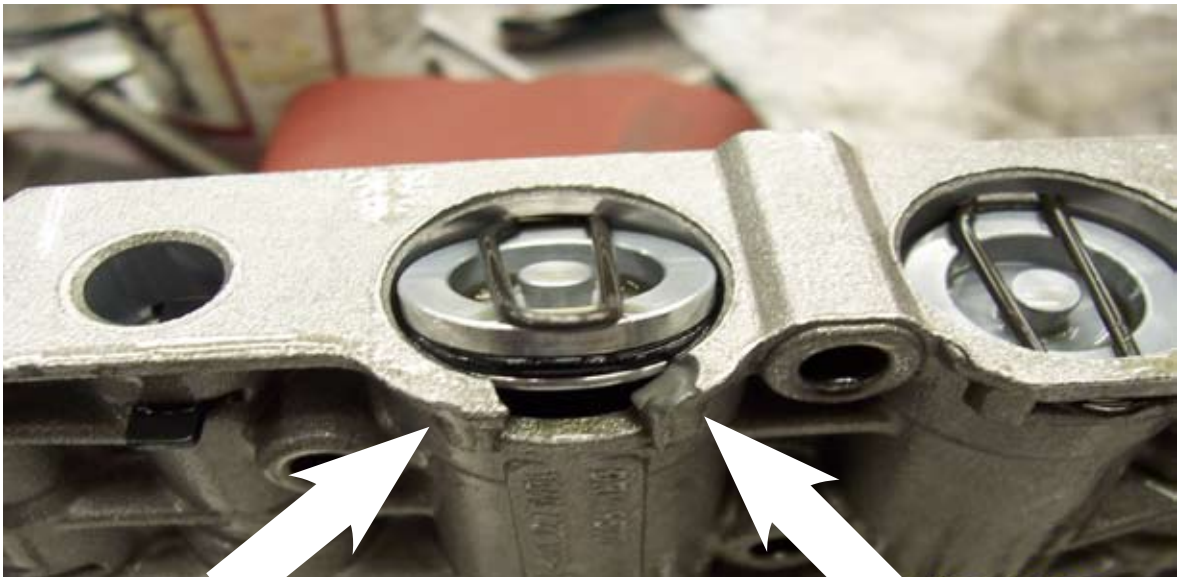
Immediately after the reverse engagement the transmission goes into neutral. This may be caused by a broken keeper in the valve body casting. You can replace the valve body assembly or choose to repair it. To repair the valve body you can drill two small holes where the arrows locate, install the clip 180° from its original position. Install the clip ends into the holes drilled.

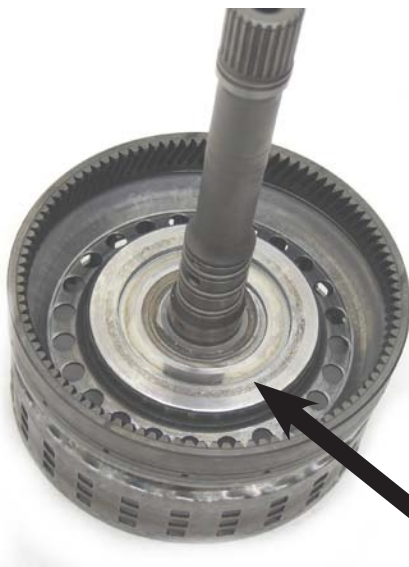
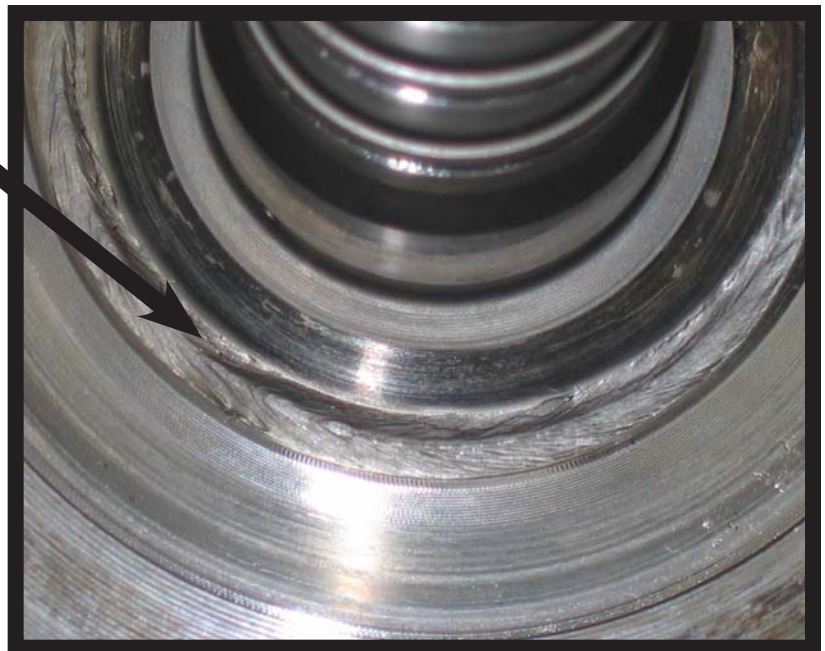
A slipping and/or no fourth and fifth gear may be caused by a cracked weld at the input drum. Pay close attention to the weld area where the shaft meets the drum and look for a fine line crack in the middle of the weld.

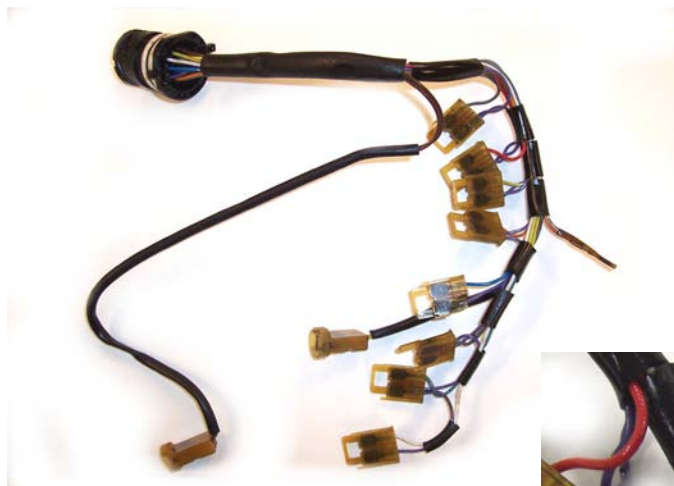
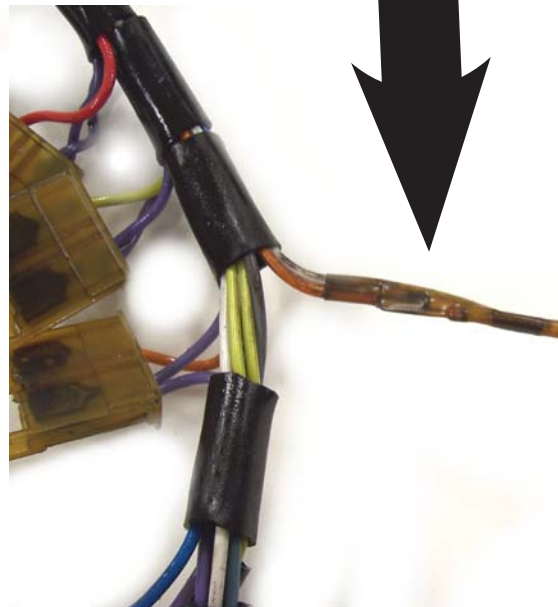
A complaint of erratic shifts and un-commanded downshifts in vehicles using the ZF5HP24 transmission may be caused by A/T Oil temperature sensor wiring being crimped or shorted.

If a code #34 A/T oil temp fault is present, the problem may be located in the crimp on the temp sensor which is integrated into the wiring harness. The wiring harness can be replaced without transmission removal.

Check the  
crimp area  
for damage

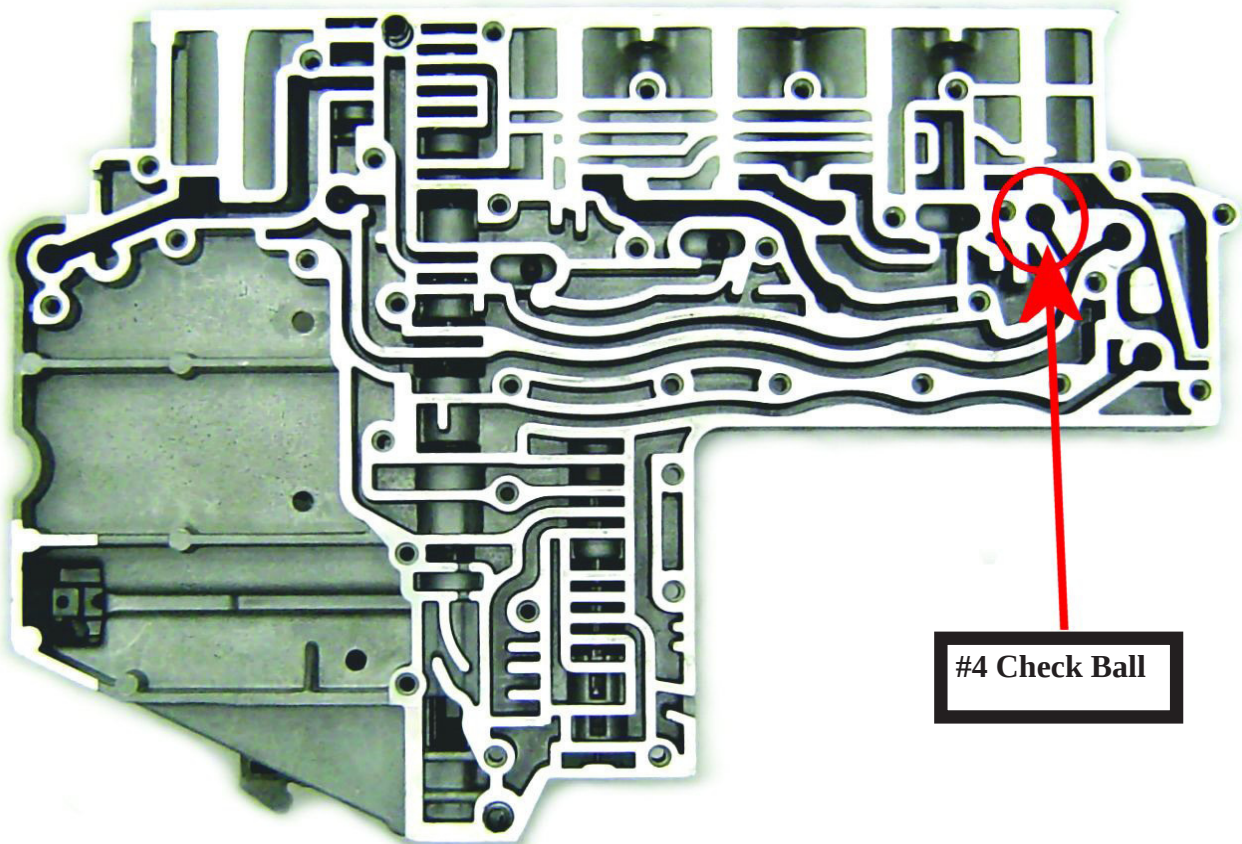
A missing #4 Check Ball will cause the oil in the O/D circuit to leak into the switch valve circuit. From the manual valve, oil that is normally blocked by the #4 check ball feeds into the O/D circuit and ends up between the switch valve pucks, forcing them to separate and move the solenoid switch valve into the TCC position. This causes the L/R solenoid signal to feed the Converter Clutch Regulator valve causing the TCC to apply.

If the #4 Check ball is missing or leaking aggressively, this can cause the solenoid switch valve to be positioned in the TCC apply position. When the L/R-TCC solenoid is engaged in 1st gear this will cause the TCC to engage stalling the engine in Drive.

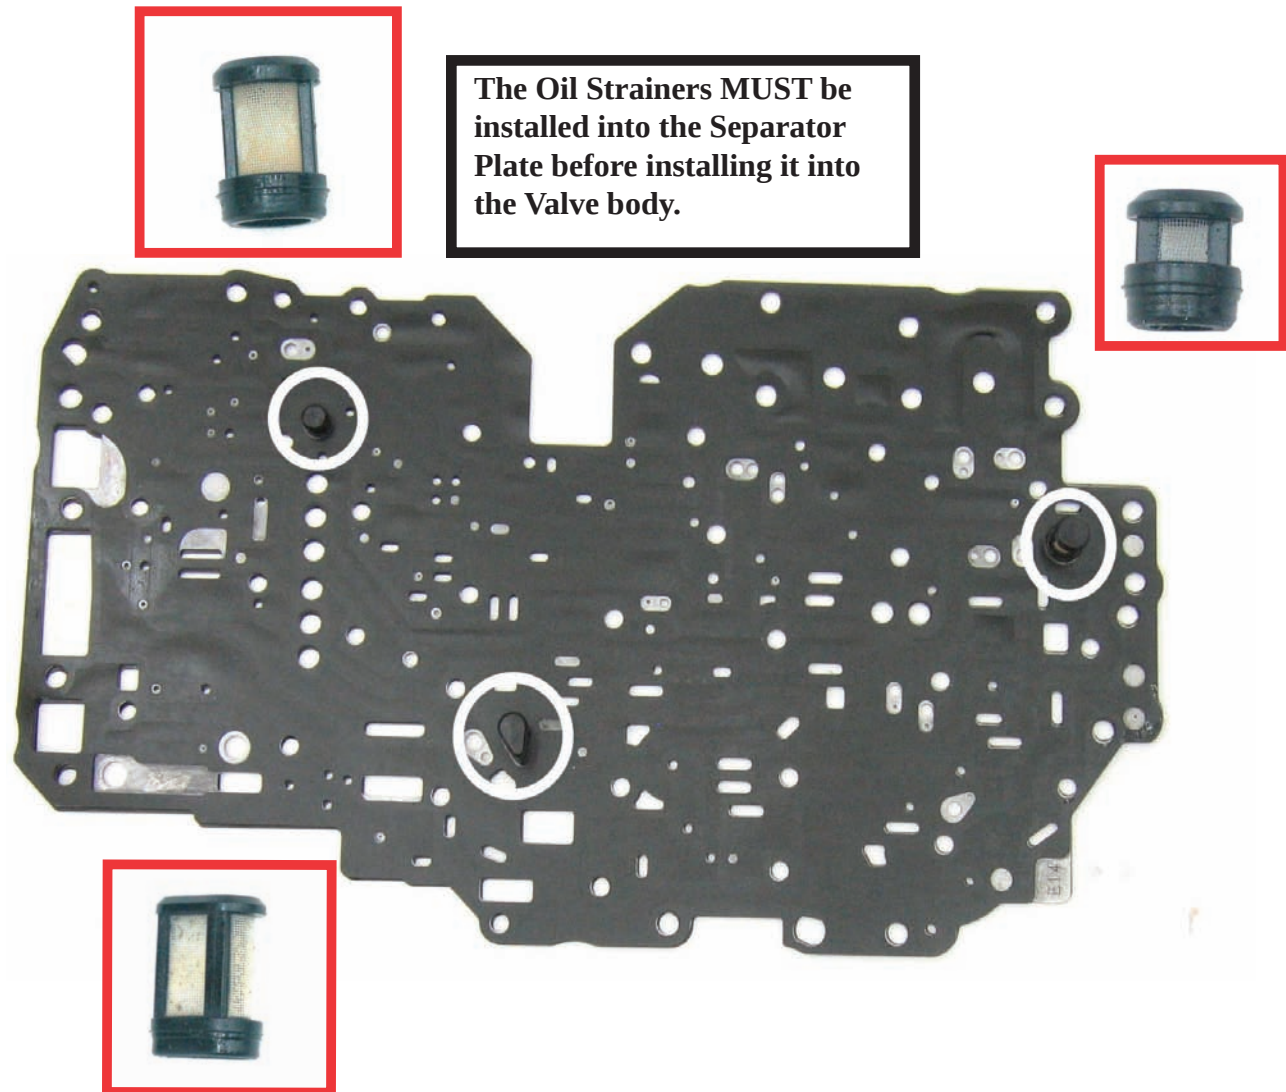
A no reverse or no upshift concern could occur if the strainers are installed into the valve body channel casting and not the separator plate.

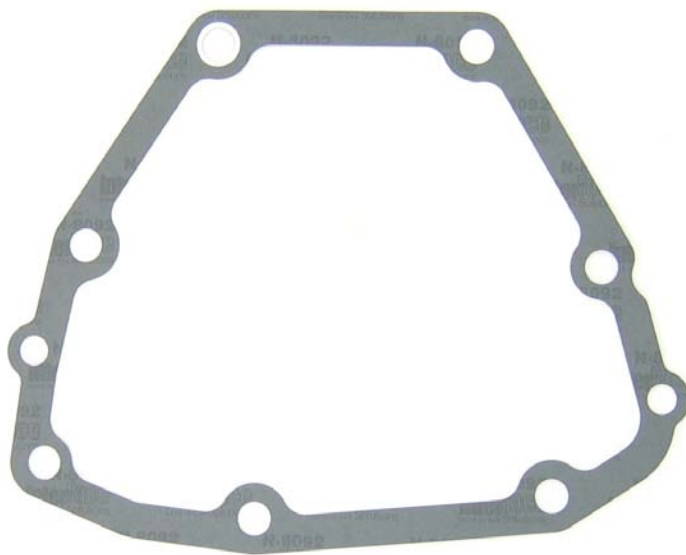
Codes relating to mode switch circuit problems or encoder/motor circuit problems are the most common codes to be set. If the transfer case has been previously removed, this condition may be caused by “not” replacing the transfer case to transmission case gasket. Ford is using a special gasket with a metal ring built into the gasket.

The purpose of this metal ring is to allow the transfer case housing to ground through the transmission case. The bolts that attach the transfer case to the transmission are coated with a special anti-corroding coating and do not allow for a good ground. Installing an early paper gasket or adding silicone to the mating surfaces will interfere with the transfer case grounding through the transmission case. Ford recommends replacing this gasket every time the transfer case is removed. The Ford part # is 4L2Z-7086-AA

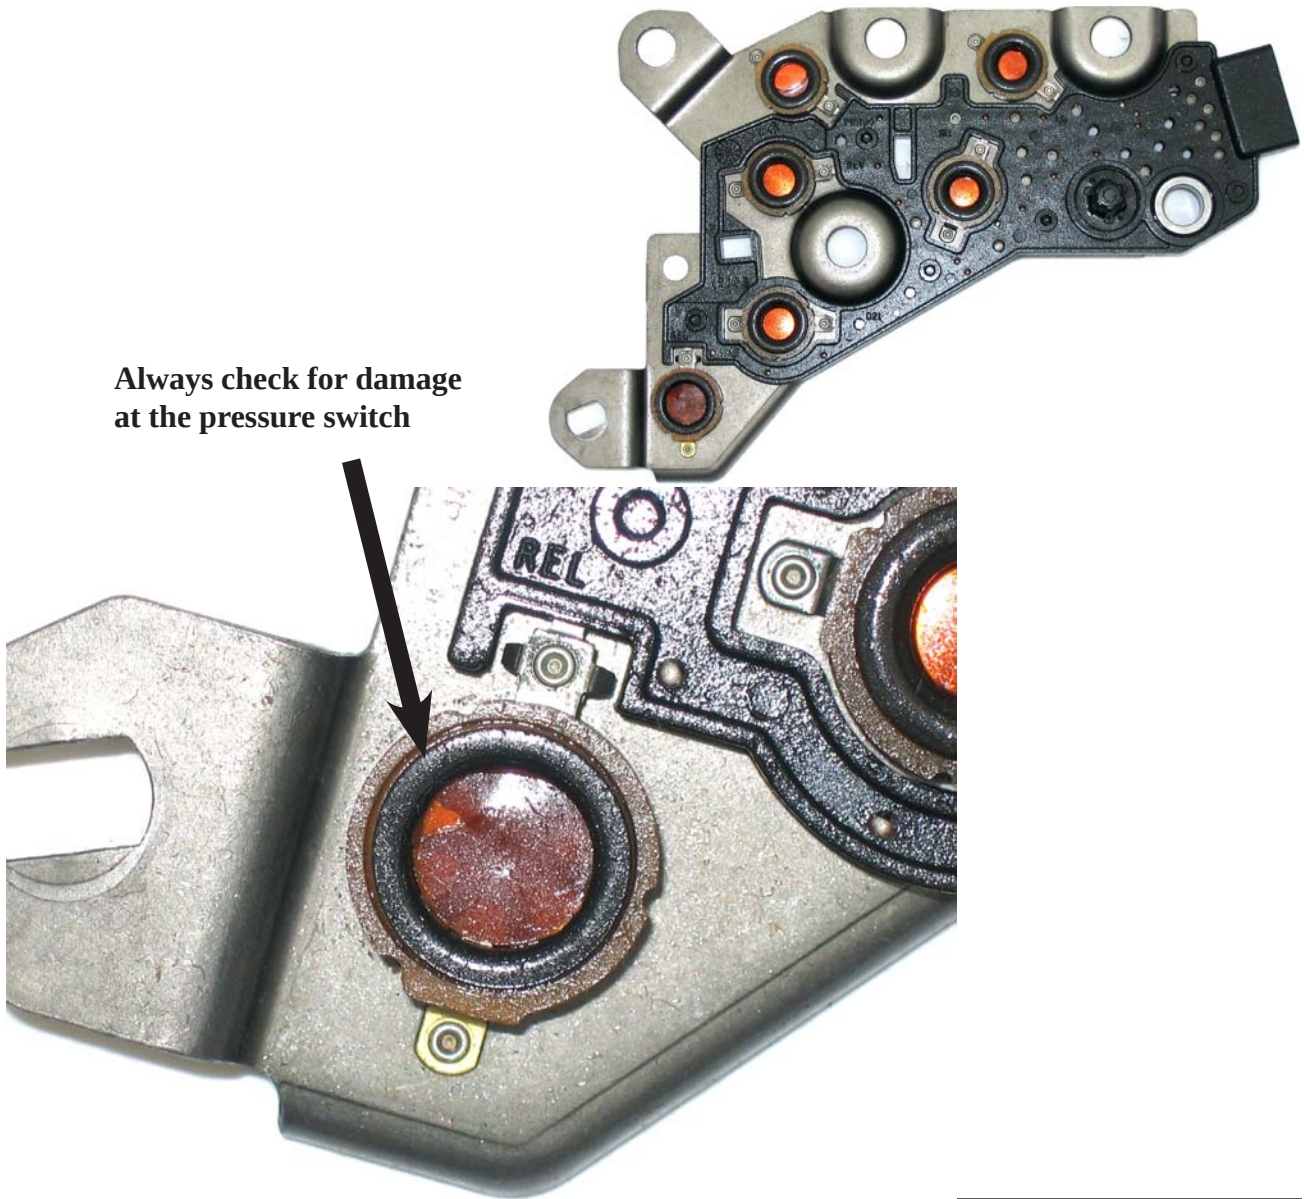
The part that can be confusing is, if the TCC solenoid has mechanically failed, the same code and drivability issue may occur. Use the following diagnostic procedures to accurately separate a bad solenoid or PSM.

**Always check for damage  
at the pressure switch**

1. When the code is set and TCC is engaged in second gear, clear the codes with your scanner. If TCC releases and works again until the code sets, the PSM is faulty.
2. Find the functional test section in your scanner. While driving engage and disengage lock up with the scanner. If TCC responds correctly to the scanner commands, you have tested the entire electrical and mechanical parts of lock up. Replace PSM.
3. Unplug the transmission. Run the engine and put the shifter in drive. If the engine stalls replace the solenoid.

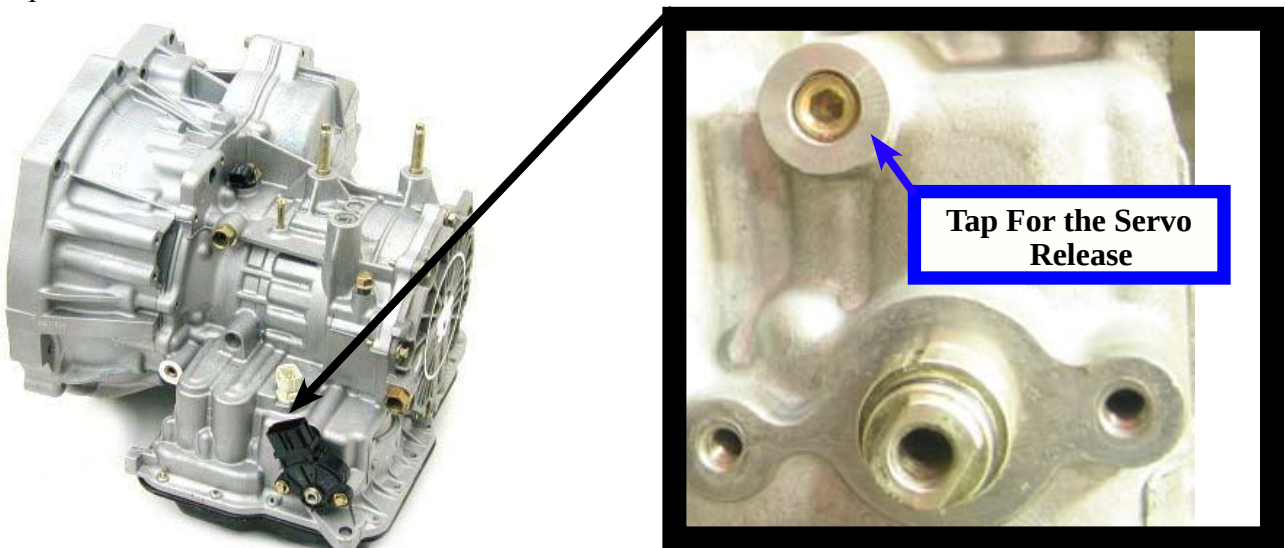
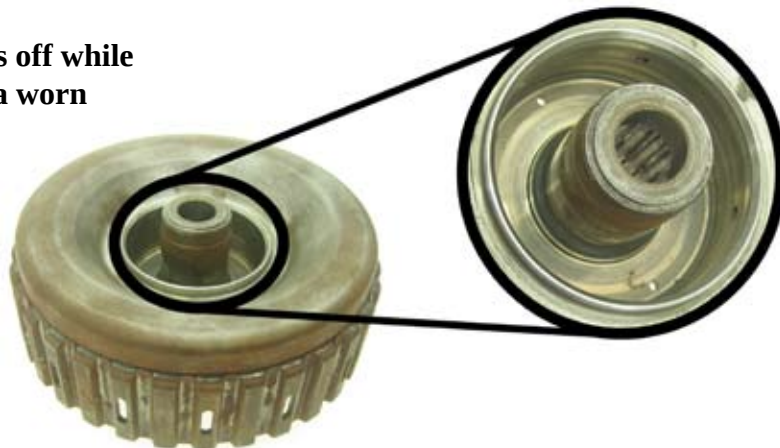
A 2-3 flare or falling out of gear in 4th gear can be caused by a worn direct drum. Always inspect the drum carefully for ring wear. Also, use high quality sealing rings. To diagnose this problem connect a pressure gauge to the servo release pressure tap behind the MLPS. In 3rd and 4th gear the pressure should be between 60-110psi depending on throttle angle. If the pressure drops off while in 4th gear suspect a worn drum.

If the pressure drops off while in 4th gear, suspect a worn drum.

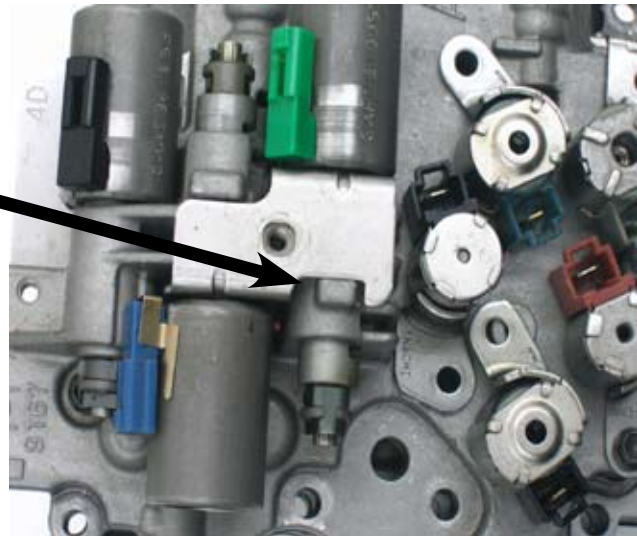
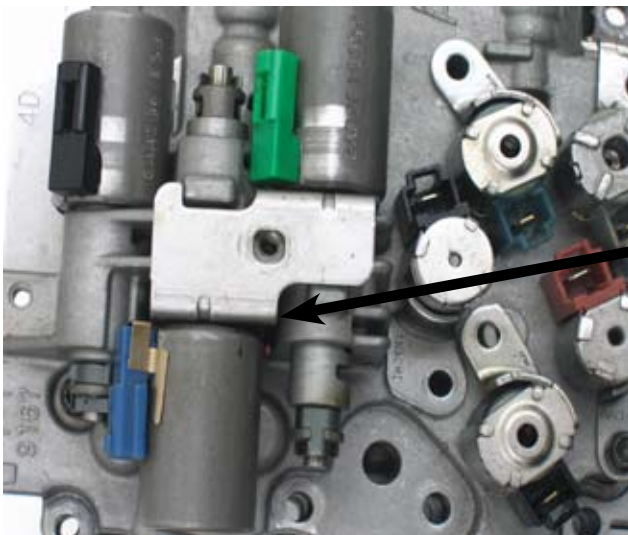
This is the **CORRECT** way to install the bracket. The tab locks to the forged area on the valve body casting

This is the **IN-CORRECT** way to install the bracket. The bracket pushes the EPC solenoid away from its bore causing it to **LEAK**!

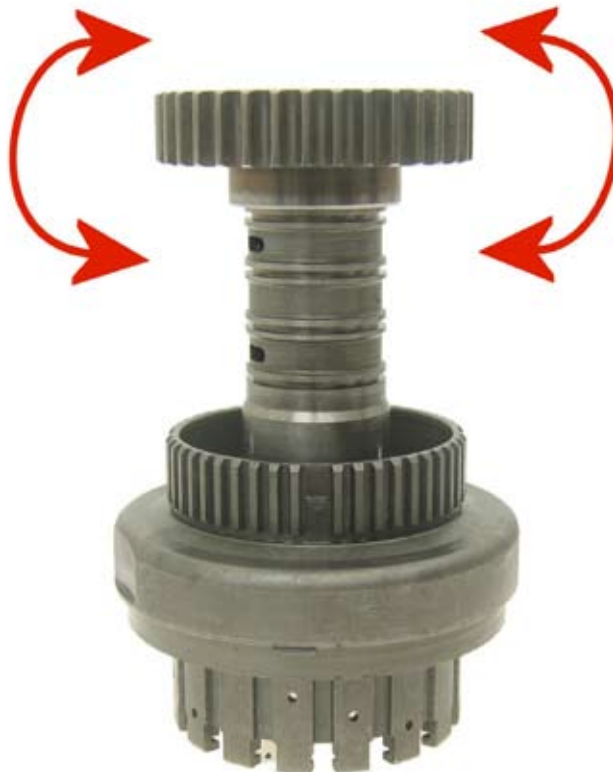
Figure 1 Checking Chain Sprocket Splines for Wear

Some of the listed General Motors built cars with the 4T40/4T45-E transaxle may have oil leaking around the left axle seal. Inspect the seal and axle for wear or damage. If none is found, the problem may be worn chain-sprocket-support splines or the splines on the direct and coast clutch housing. This allows the axle shaft to run out of alignment and cause the front axle shaft to leak. Replace parts as needed.
