## Technical Bulletin #1488

**Transmission:** 4R70W/75E & 62TE

**Subject:** *Transmission Over Heating*

**Application:** *Ford & Chrysler*

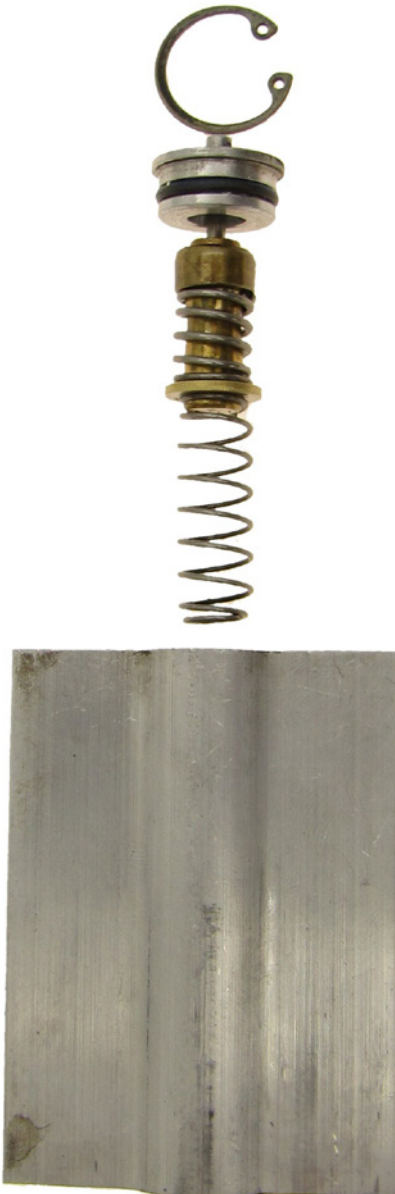
**Figure 1**

Transmission over heating can be caused by a failed cooler bypass. An easy fix for this is to disable the bypass cooling system and modify it for full cooler flow.

1. Remove the snap ring and cooler bypass valve. (Figure 1)
