## Technical Bulletin #831A

**Transmission:** 5L40E

**Subject:** *Fluid Fill Procedure*

**Application:** 2000-2007 BMW, 2003-2009 Cadillac

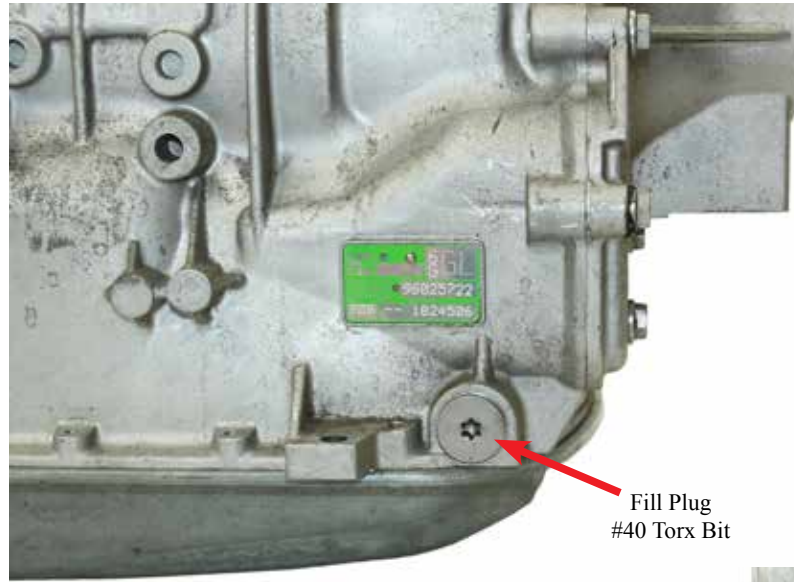
Driver Rear

Fill Plug  
#40 Torx Bit

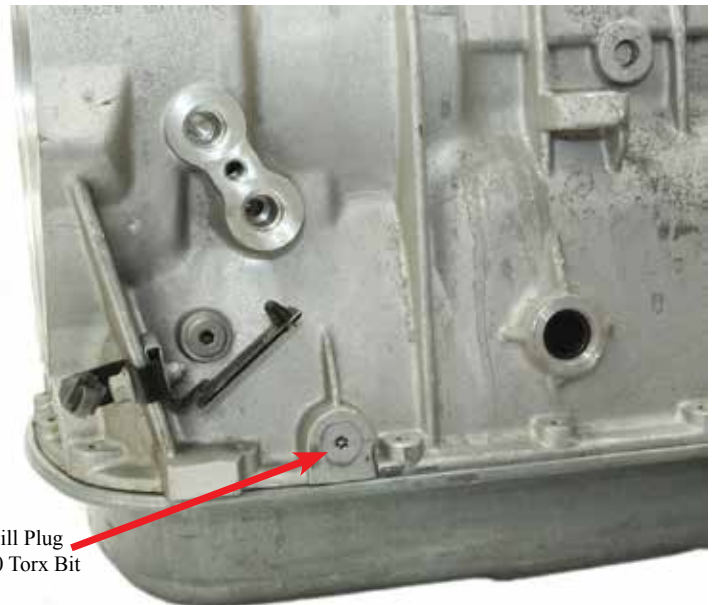
Driver Front

Fill Plug  
#40 Torx Bit

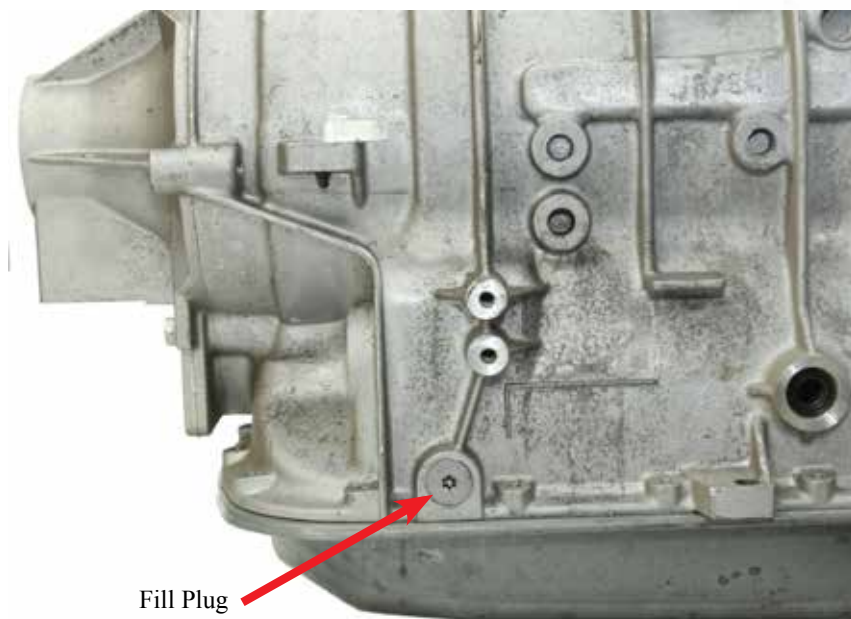
Passenger Rear

Fill Plug  
#40 Torx Bit

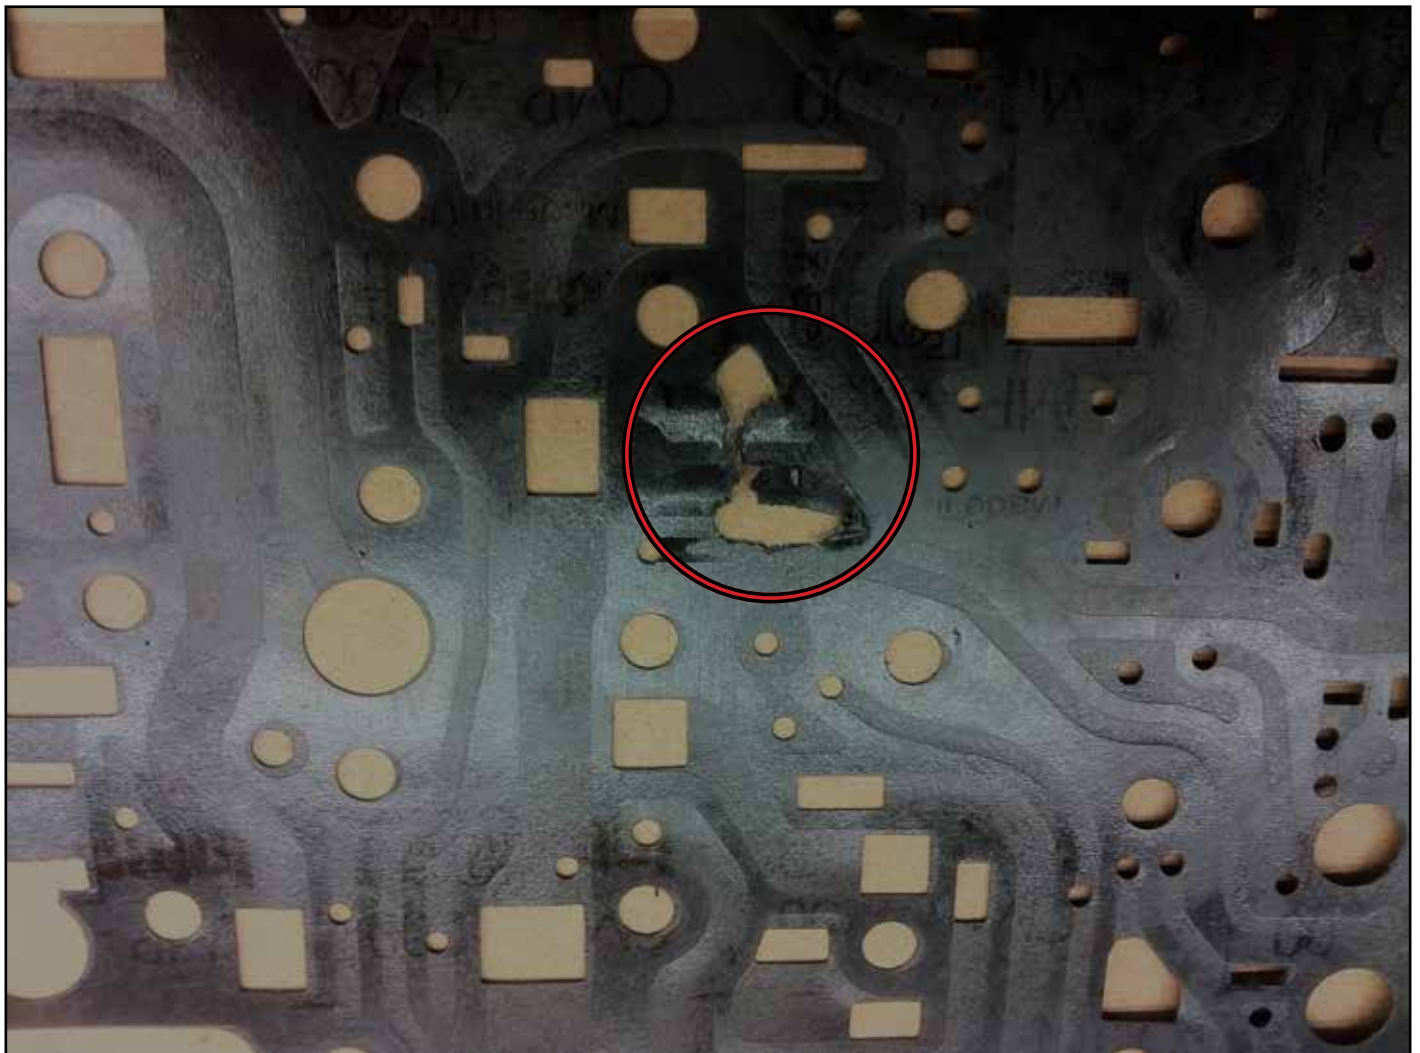
A blown valve body gasket can cause a P0868 pressure code on this transmission. The CFT-30 transmission has no provision for pressure testing with a gauge. All pressure testing is scanner based. Use your scanner to verify this concern. Replace the gasket and resurface the separator plate as necessary.

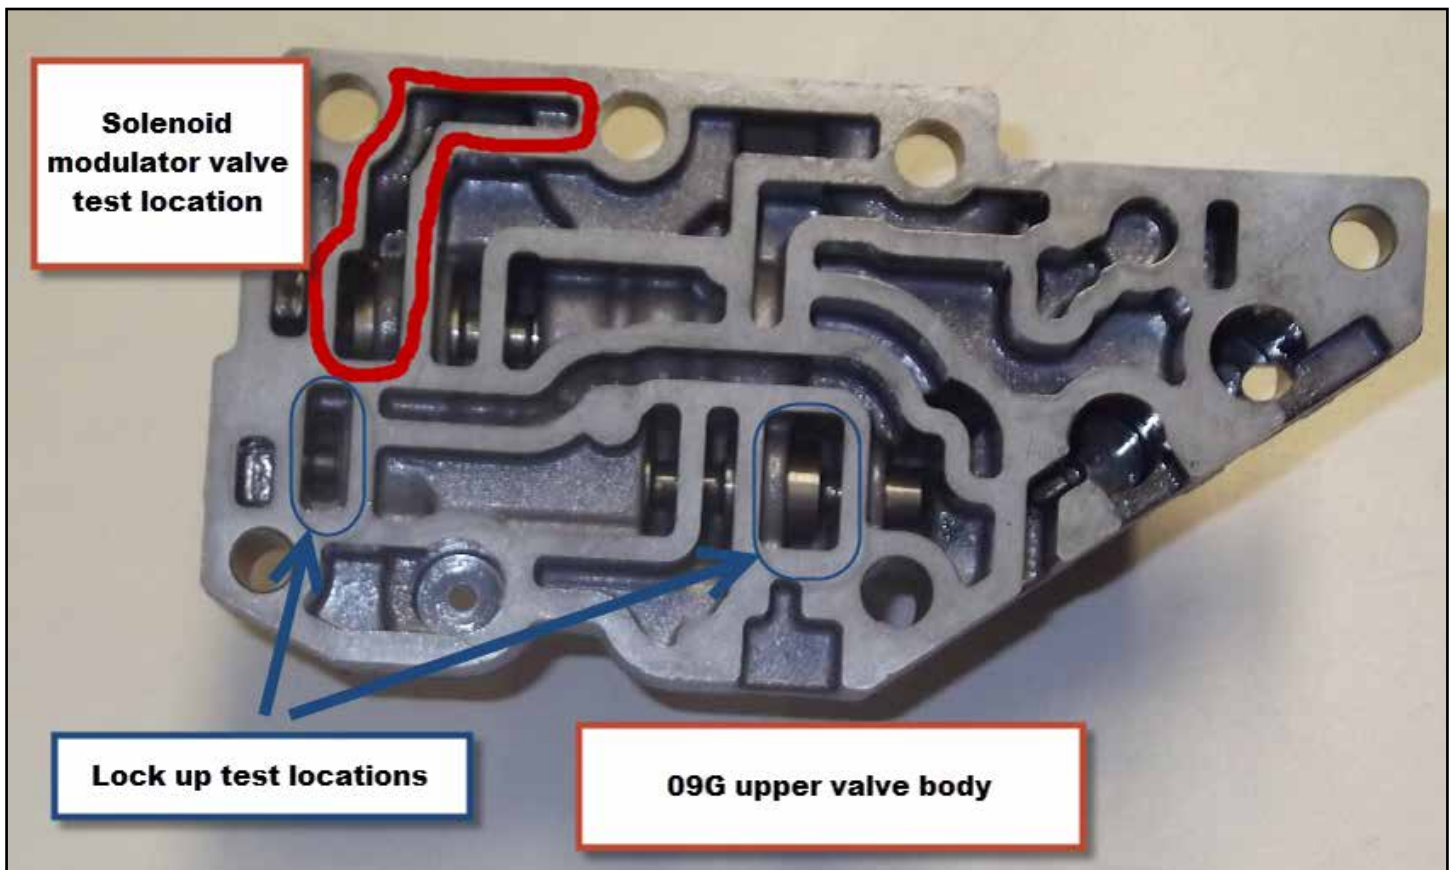
**Figure 1**

Erratic/harsh shifts and lock-up concerns are often causes for an overhaul. If you have and or all of these concerns there are some common areas to check during the rebuild. The solenoid modulator valve and the lock up control valve are located in the upper valve body and are common wear areas.

You can perform a wet air test by adding ATF to test location and follow with low air pressure. If oil and air leak past the bore valve land into the next passage the valve is worn and needs to be addressed.

You can also perform a vacuum test at the same locations. Apply a small amount of assembly lube and use vacuum test plate. Start a test log with your test result to determine pass or fail chart.

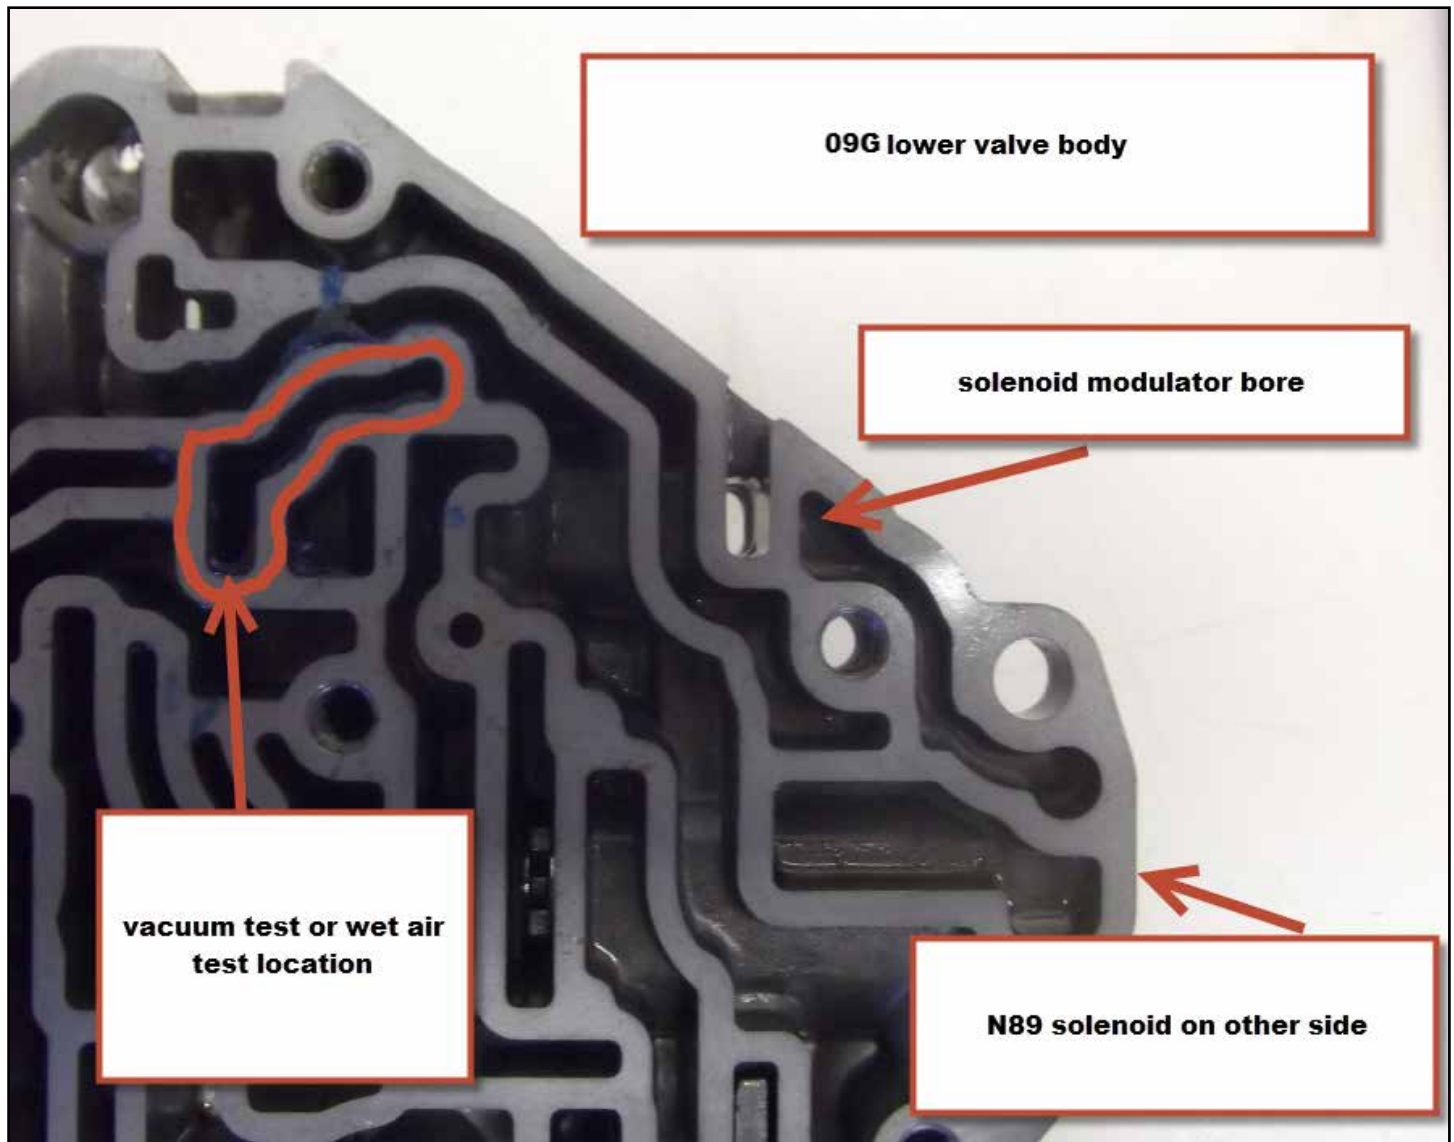
**Figure 2**

There is another solenoid modulator valve that is in the lower valve body that needs to be checked for wear. If these bores are damaged you can repair or replace the valve body.
