Technical Bulletin #1622

Transmission: U660E, U660F, U760E, U760F
Subject: Delayed, Slipping or a No Reverse Engagement
Application: Toyota
Issue Date: June, 2014

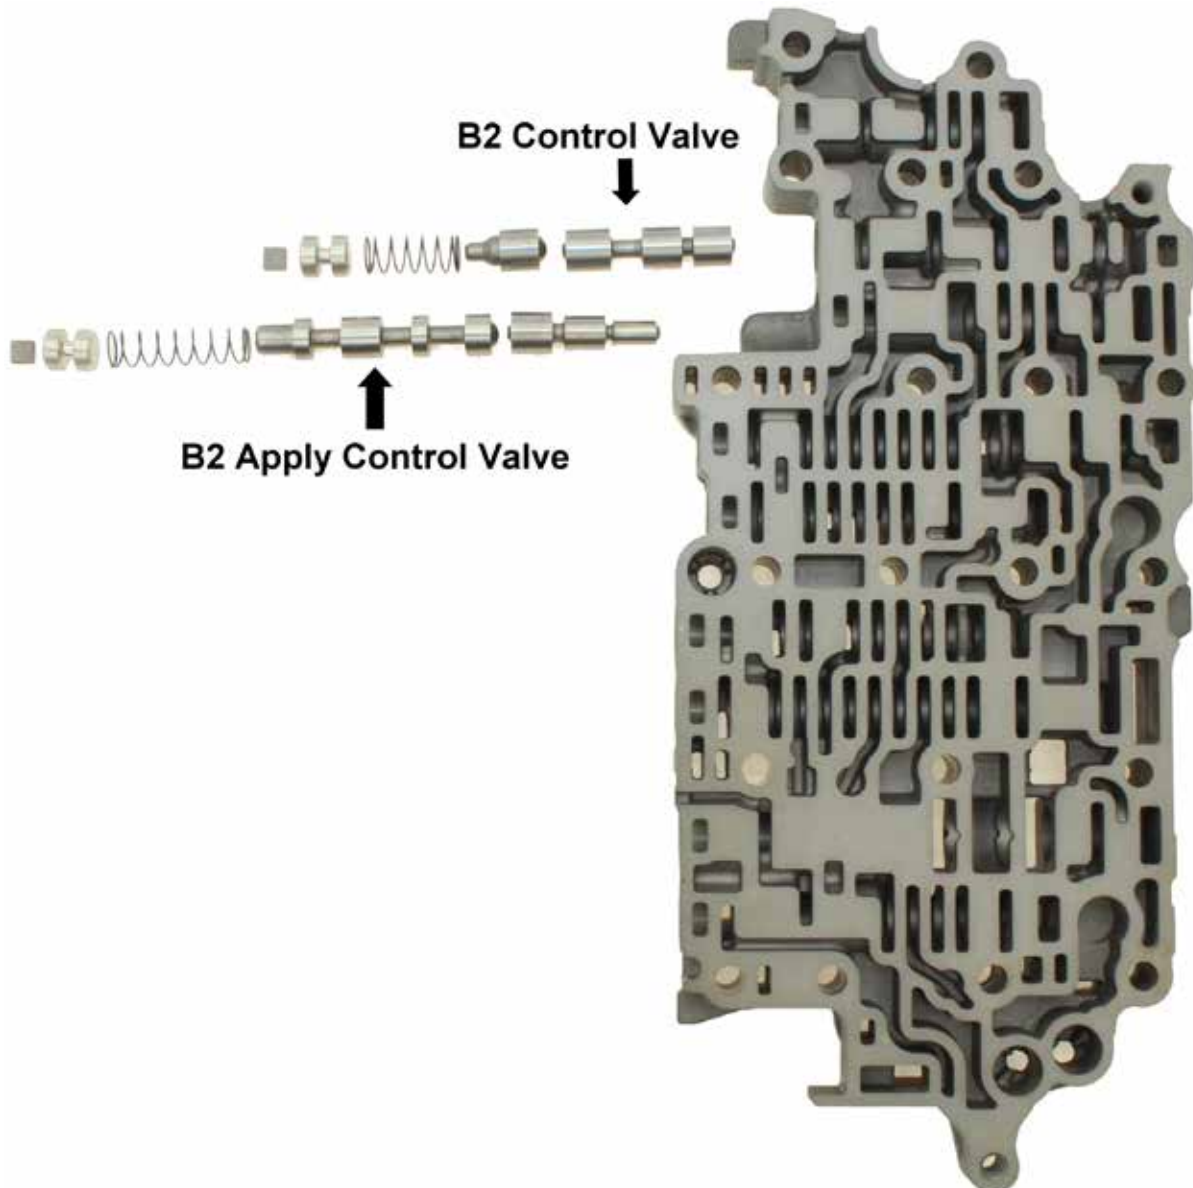
While working on a U650E, U660F, U760E or a U760F transmission, you may encounter a delayed, slipping or no reverse engagement. This concern may be caused by a worn B2 Apply Control Valve and bore or a worn B2 Control Valve and bore. Replacing the B2 Apply Control Valve and B2 Control Valves and repairing the worn bores may be needed to repair this concern.
