## Technical Bulletin #1660

**Transmission:** U660E, U660F, U760E & U760F

**Subject:** Erratic Shift Concerns, Solenoid Performance Codes and Erratic TCC Operation

**Application:** Toyota

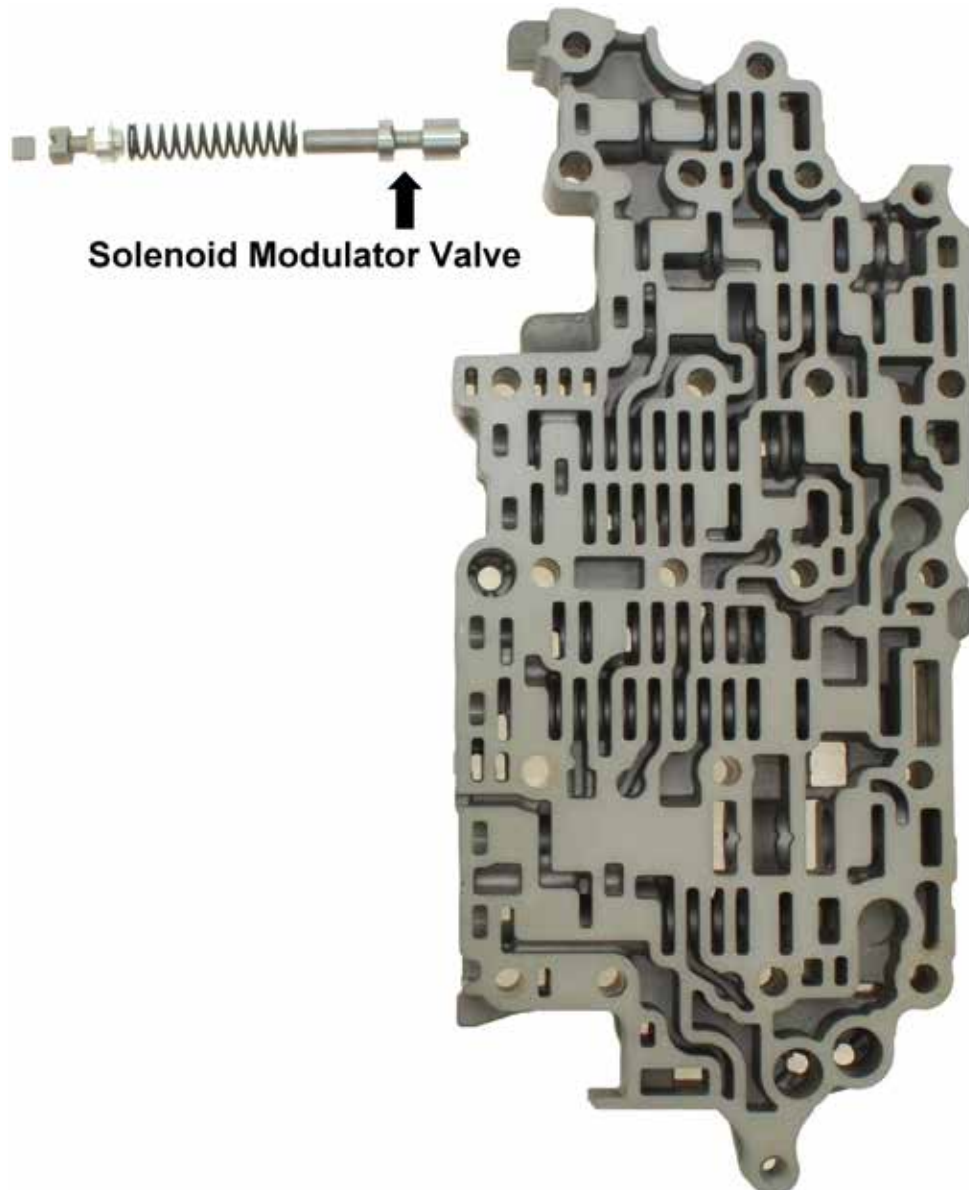
While working on a U650E, U660F, U760E or a U760F transmission, you may encounter erratic shift concerns, solenoid performance codes or erratic TCC operation. These concerns may be caused by a worn solenoid modulator valve and bore. Replacing the solenoid modulator valve and repairing the bore may be needed to repair this concern.

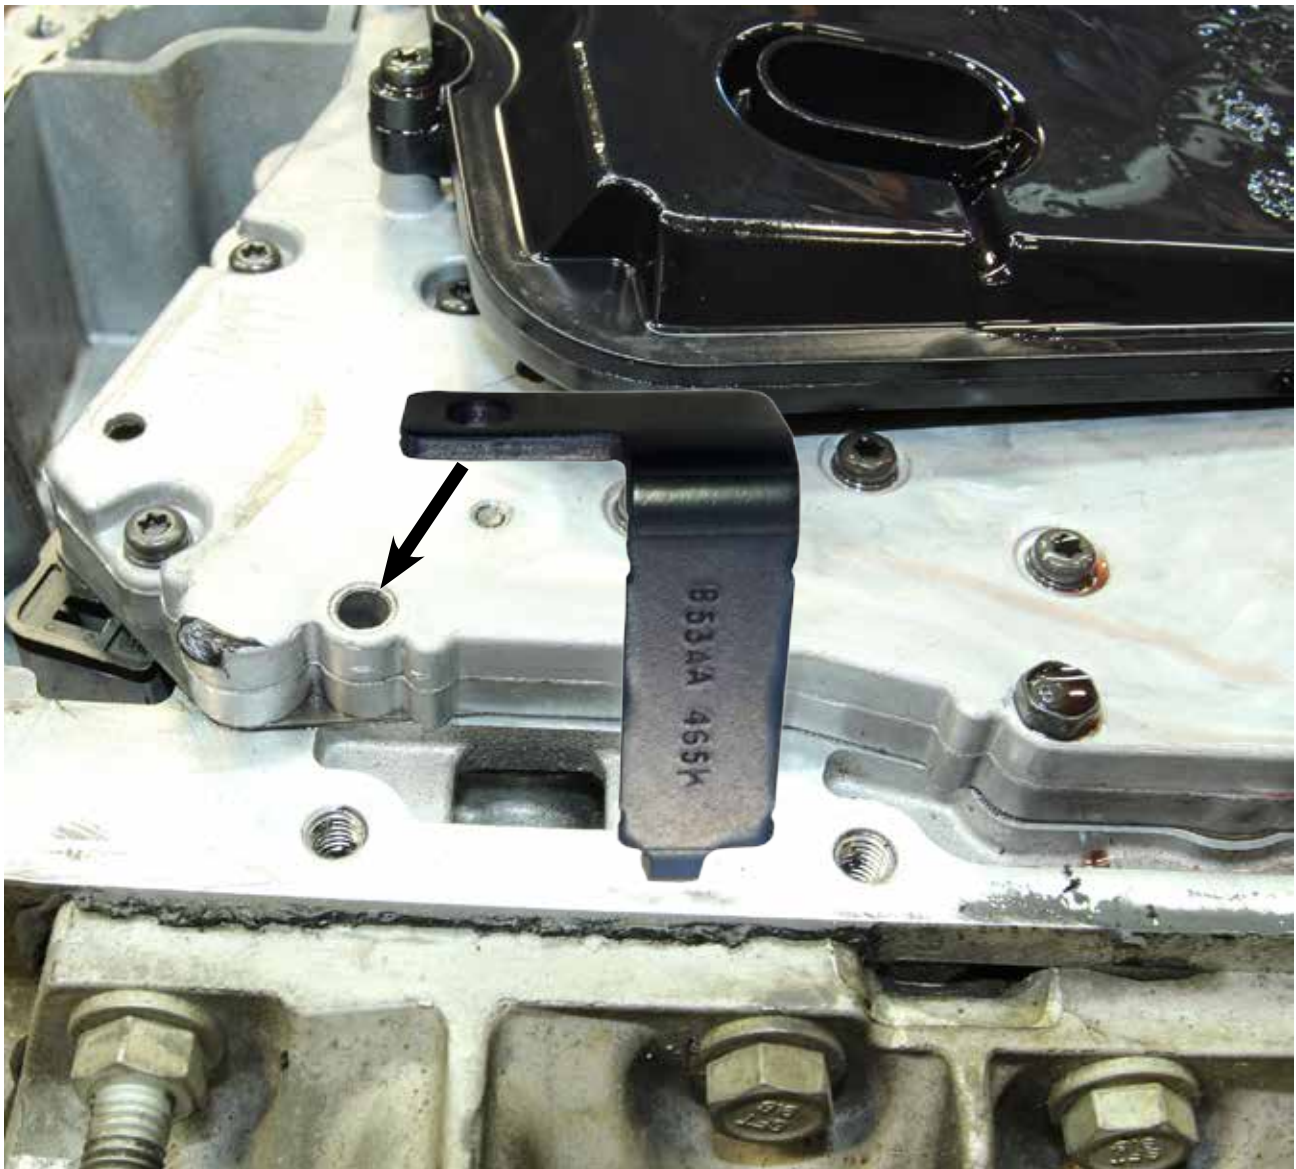
If you ever see this part in your parts basket and ask yourself if it belongs to your transmission, the answer is yes. This is a bracket that is used as a retainer for the parking pawl anchor pin in the rear of the case. It bolts onto the valve body at this location (see figure).

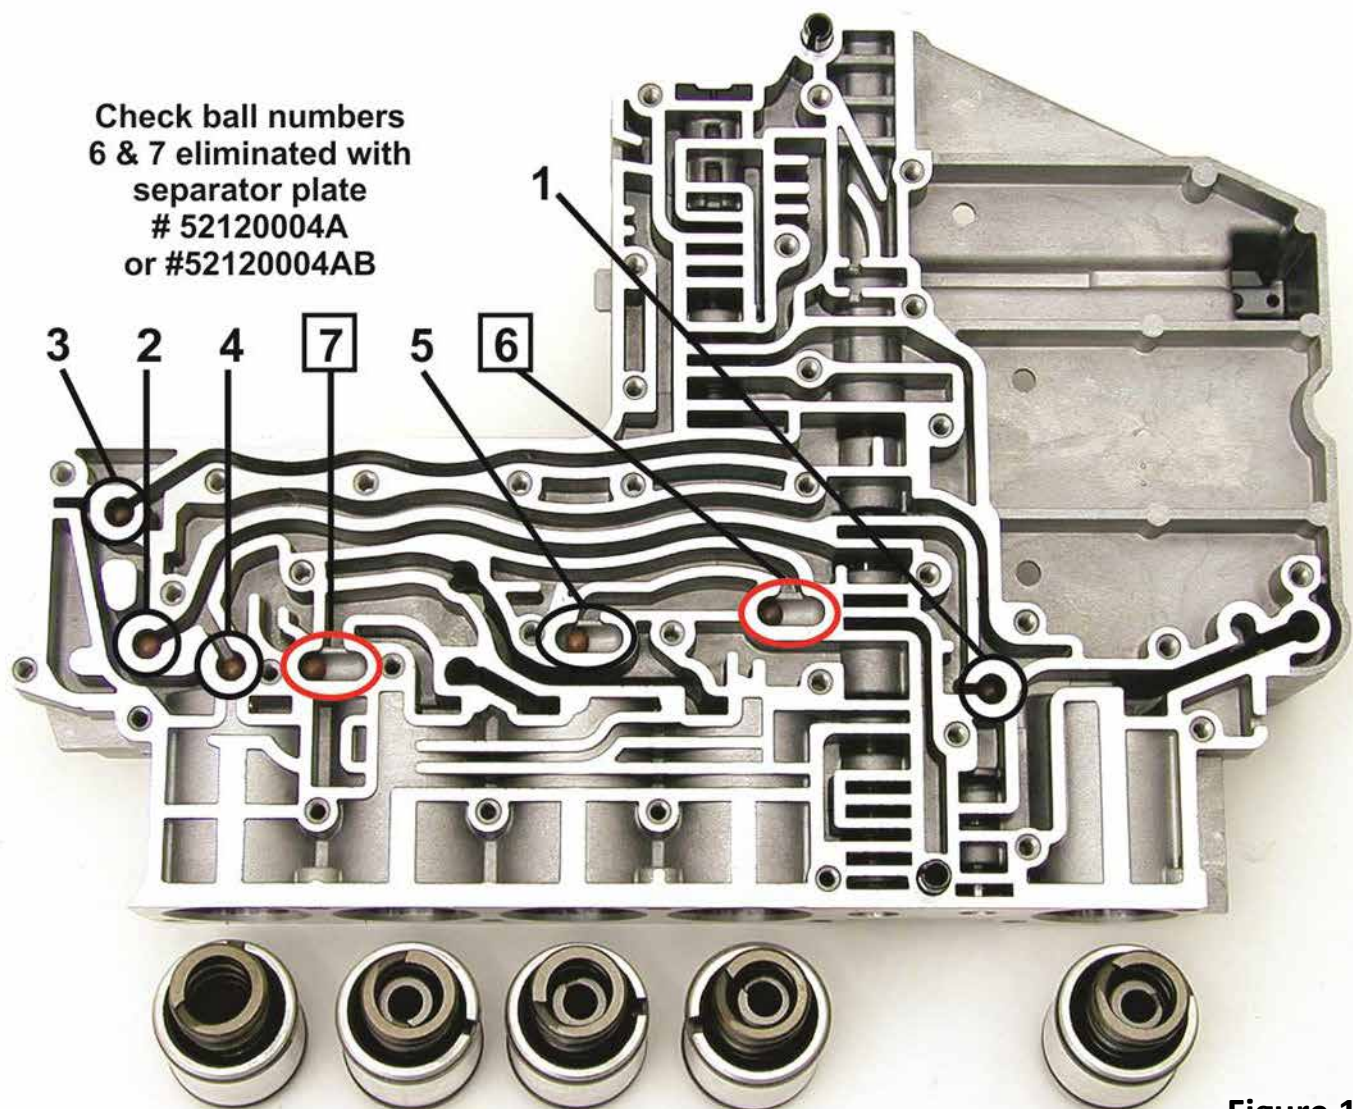
Figure 1

The 2006-to-2008 valve body separator plate (part number 545AB) is shown in figure 1. The 2009-and-later separator plate (part number 52120004A;) (figure 2) identifies the feed holes that were eliminated over check ball #6 and #7 locations.

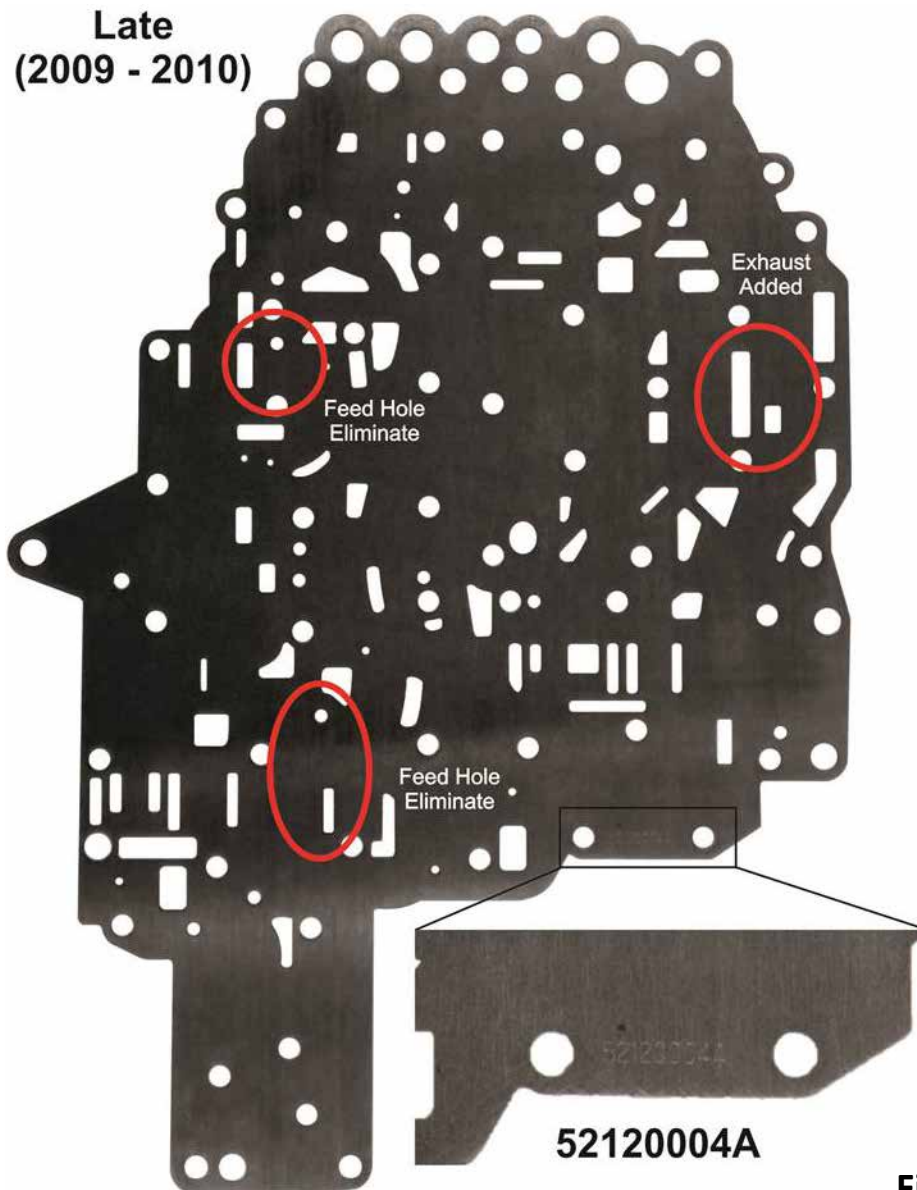
**Figure 3**

Checkball #6 was removed to allow the multi select solenoid to control overdrive clutch apply instead of the overdrive solenoid. This eliminated the need for the overdrive solenoid (figure 3).

Check ball #7 was removed to allow the 2C solenoid to control the 2C clutch apply in the manual 2 range instead of the multi select solenoid (figure 3).

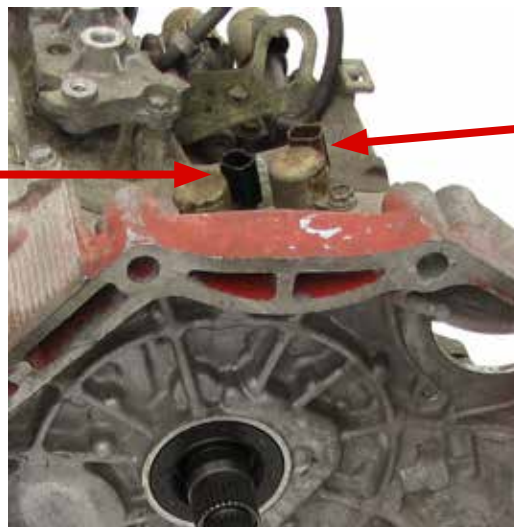
The technician then discovered that the two solenoids were in the wrong location. Shift solenoid B was installed in the location closer to the firewall and the TCC solenoid was installed in the location closer towards the radiator, which is the opposite of where they should be.

The solenoids connections cannot be swapped but the solenoids can be installed into the wrong hole. After correcting the solenoid location mix up the symptoms still seemed to appear. After careful examination of the solenoid connectors it was noticed that one the wires to the TCC solenoid was barely connected. Once the connection was corrected the transmission performed normally.

Someone else may get these codes with the symptom of a bind on takeoff with a 2-3 Flare. Because they just didn't know they have it in the wrong location. Obviously the bind is caused by the TCC solenoid being fired because it was in the solenoid B location. Fixing the pulled wire on the TCC solenoid was the final solution.

TCC Solenoid  
Black Connector

Solenoid B Brown  
Connector

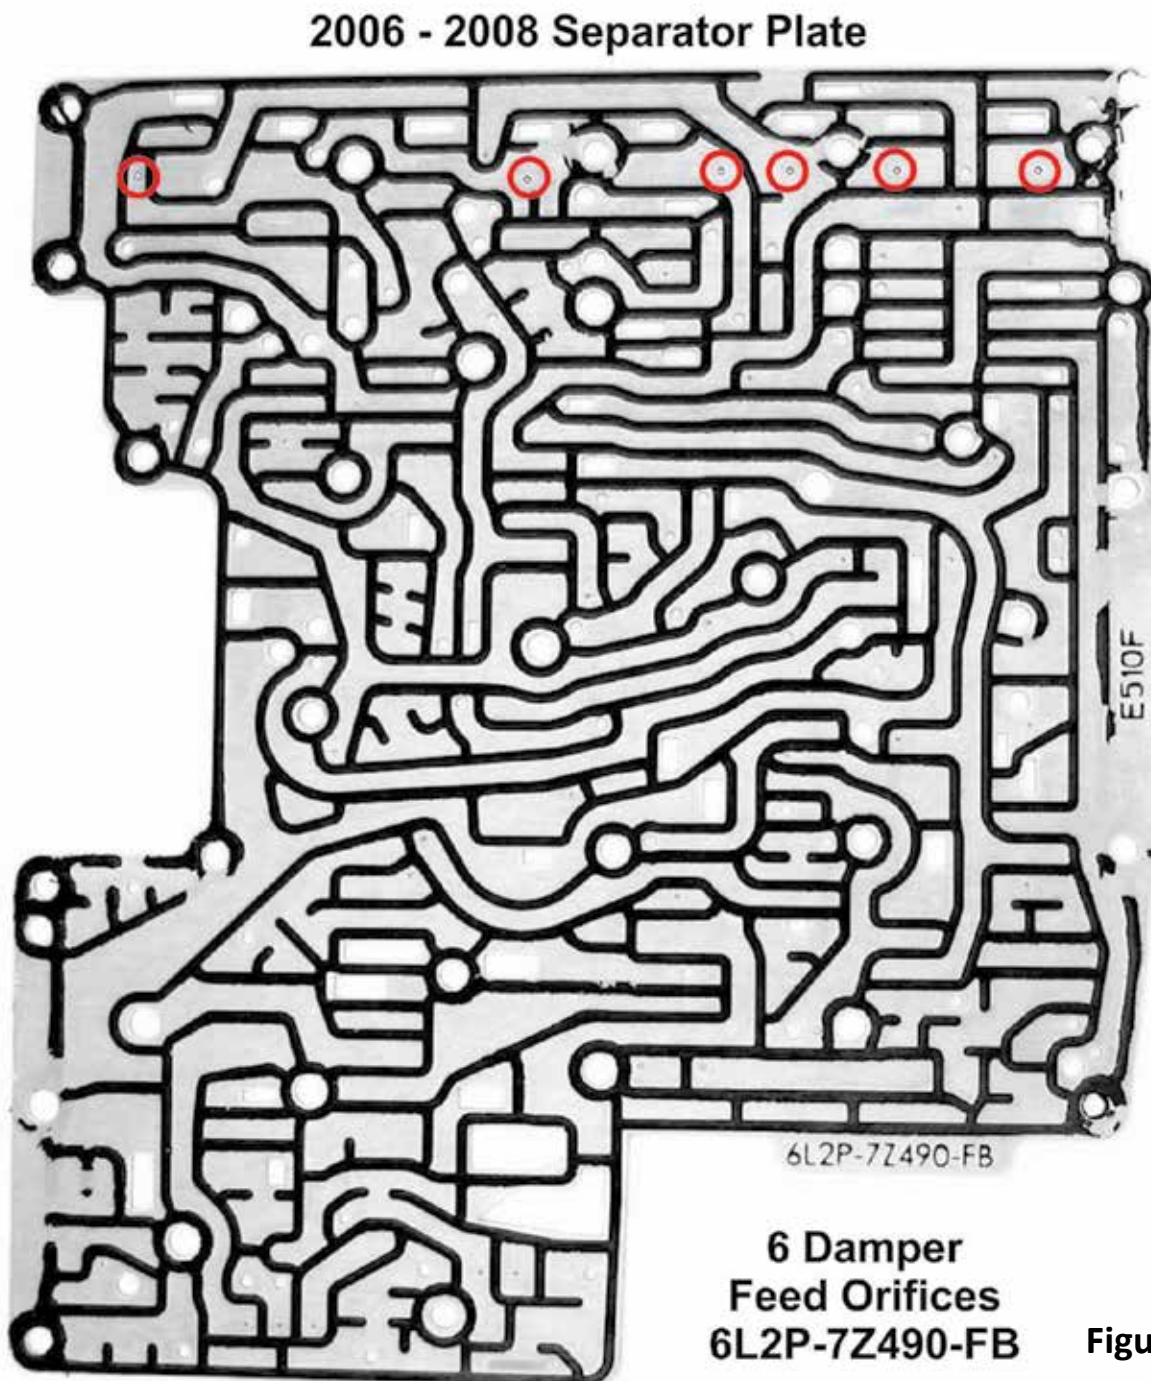
Figure 3

The 6R60, 6R75 and 6R80 are referred to as TCM Driven units, initially released with Bosch solenoids and six dampers (accumulators) for the 6R60 and 6R75 transmissions until 2008 ½ or J1 units. In 2008 ½ (11/16/09 J2 units) during testing Ford learned that only two were required so they eliminated four dampers; A,B,C and TCC (figure 1) along with the feed holes in the separator plate part #6L2P-7Z490-FD (figure 2). The D1 regulator spring bore 201 was removed and added a bleed circuit to the “D” clutch these vehicle required using MERCON SP oil. The ID number on the 2006 to 2008 separator plate is 6L2P-7Z490-FB (figure 3).

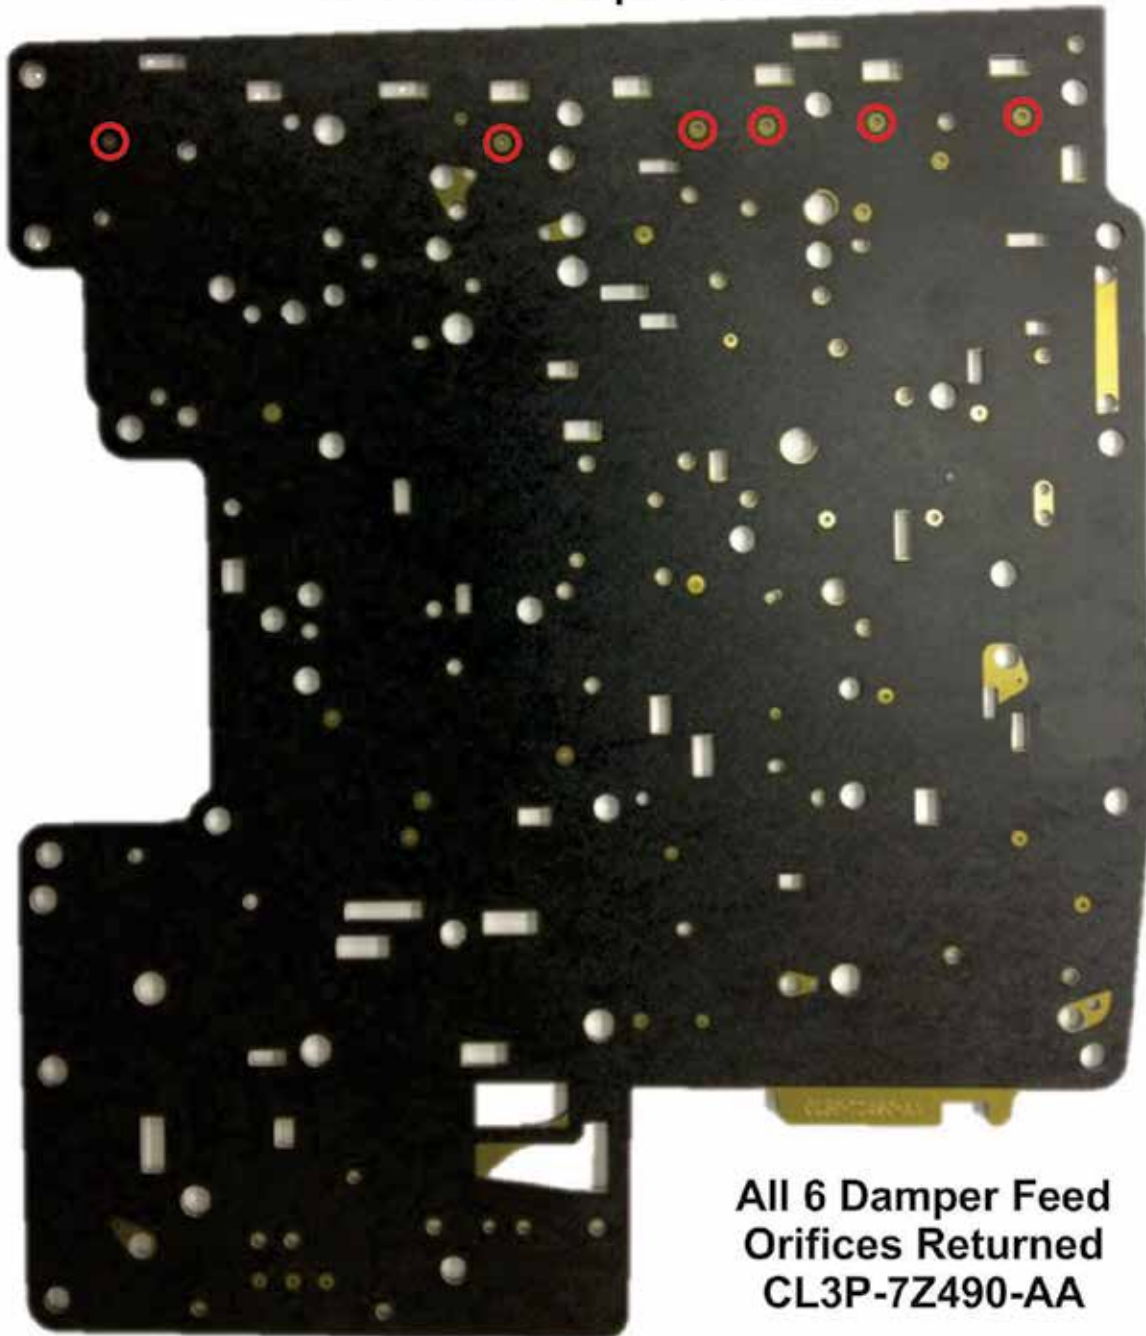
Figure 4

All 6 Damper Feed  
Orifices Returned  
CL3P-7Z490-AA

If you get one of these plates in a rebuild kit and it does not match the one that came out of the vehicle the holes should be drilled to match the original one. These plates are calibrated to the year make and model designation.
