## Technical Bulletin #1929

**Transmission:** 4R70W, 4R75W, 4R70E, 4R75E

**Subject:** ISS Codes, Erratic Reading

**Application:** Ford RWD Applications

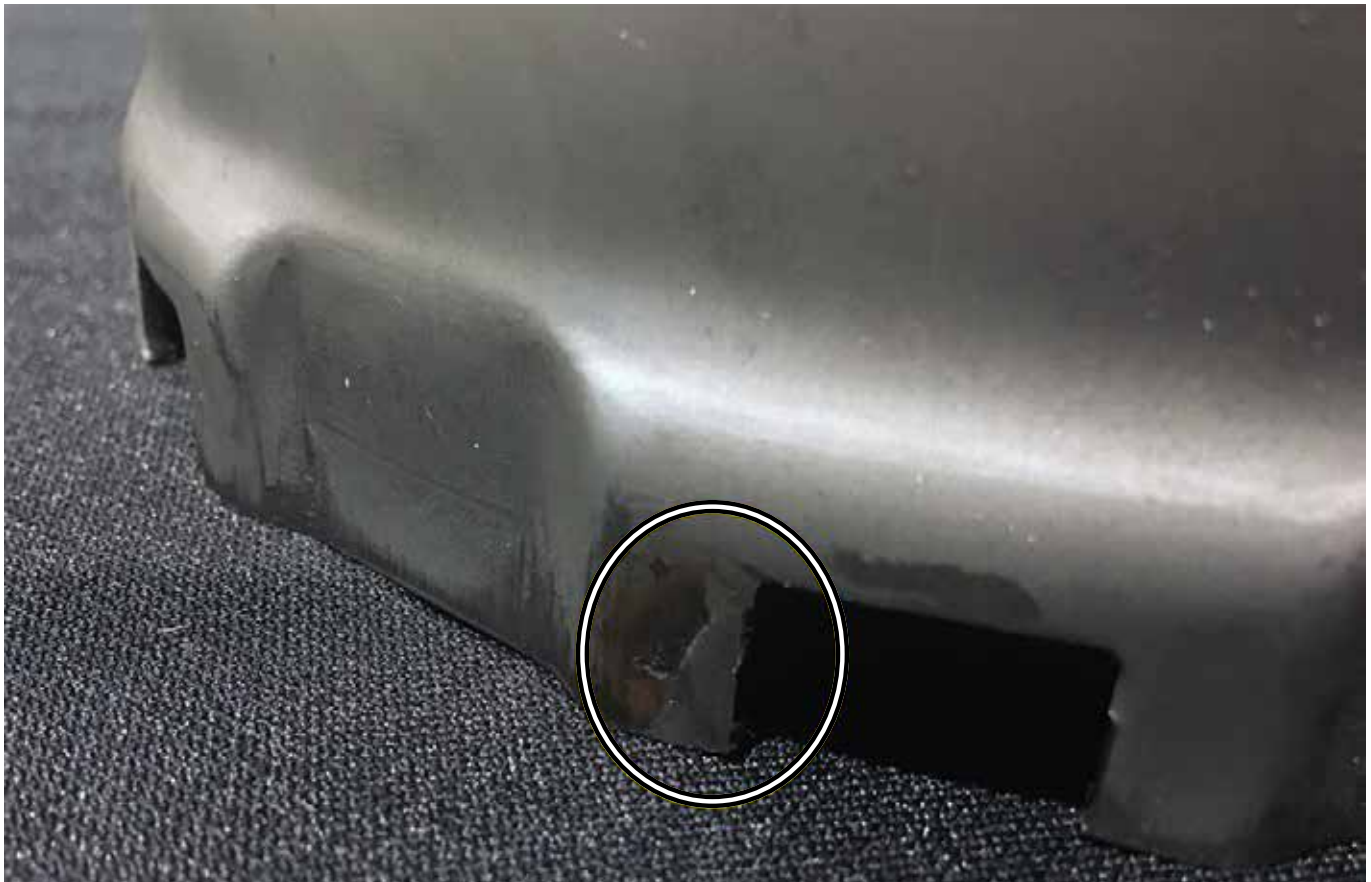
After a rebuild, you may observe the Turbine Shaft Speed sensor reading correctly sitting still in Park, Neutral, Drive and Reverse. Then, once the vehicle is in motion, the signal goes crazy! Before you replace the speed sensor, you may have a sun shell that has been repaired in your unit.

Applications that have a turbine speed sensor require a non-ferrous sun shell. This allows the Turbine Shaft speed sensor to read the forward clutch drum through the sun shell. You can check this by using a magnetic. It should not stick to the shell. However, if someone made a repair to the wear area (as shown), the ferrous material in welding rods will create interference in the Turbine Shaft Speed sensor signal. A magnet will stick to the repaired area.

DO NOT use a repaired sun shell in a unit that has the turbine shaft speed sensor.
