4L30E Band Failure

Since 1991 the 4L30E has been used by many manufacturers, including Isuzu, Honda, Acura, BMW and Cadillac. For the most part it's been a reliable transmission except for one major complaint: repeat band failure. In this edition of *Transmission Therapy*, we'll cover diagnosis, the root causes, and the fixes for this common problem, many of which were developed by Mike Van Dyke right here at ATRA.

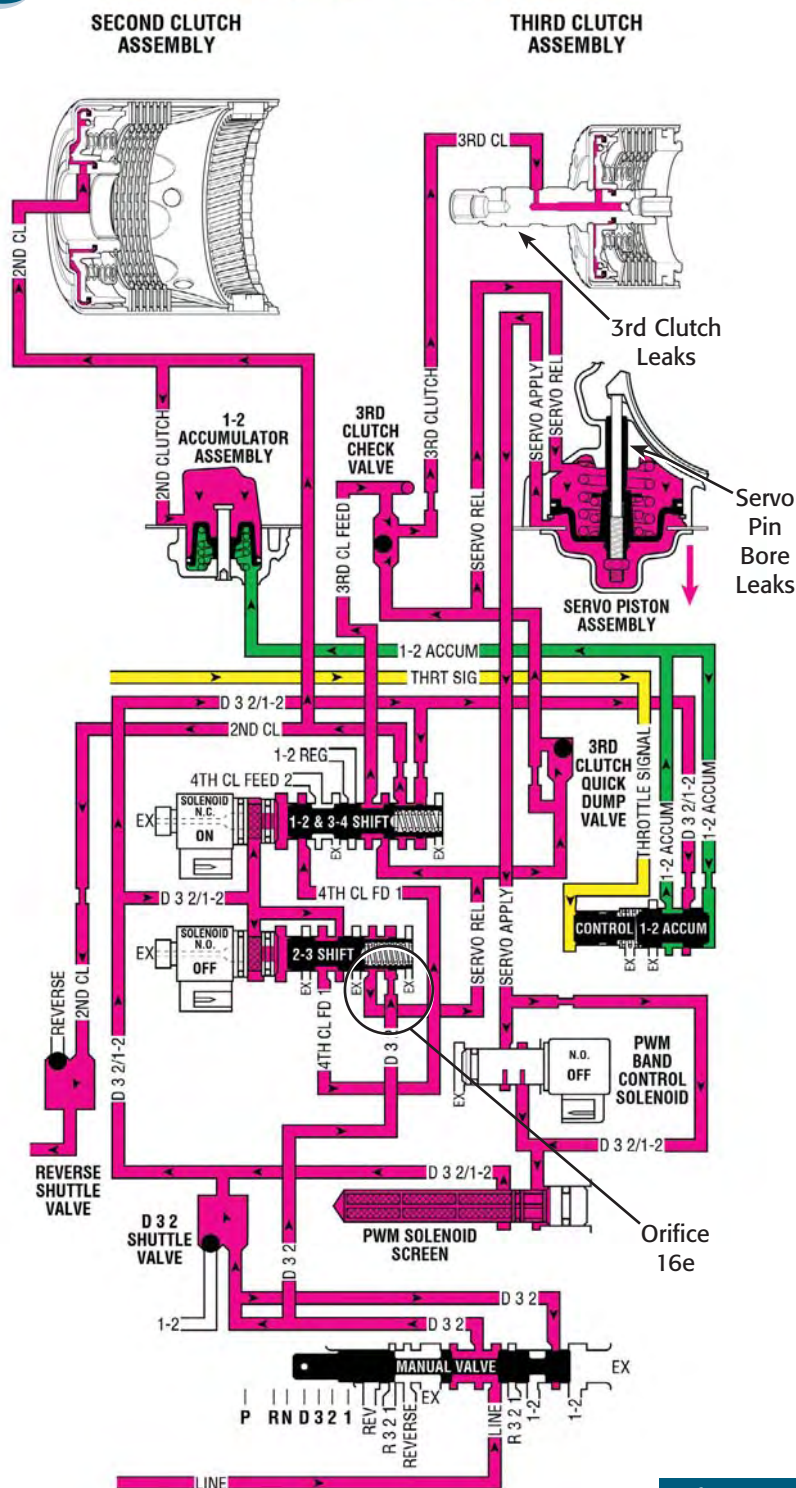
Figure 1

In 3rd gear, 3rd clutch apply pressure is also servo release pressure (figure 1). Since this oil is restricted by orifice 16e, any leaks in the 3rd clutch apply circuit will reduce servo release pressure. If this release pressure is low enough, the servo will stay partially applied, burning the band.

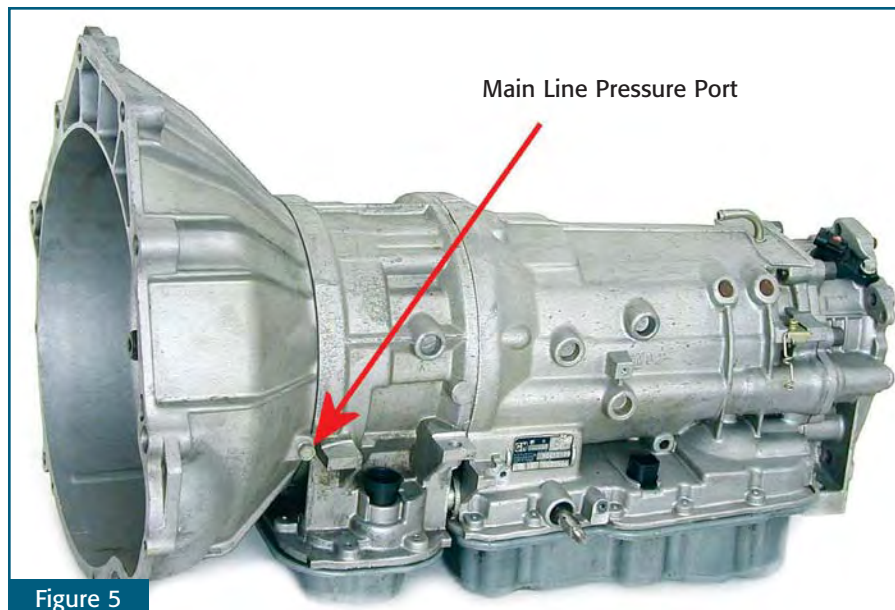
Figure 5

Then, after every rebuild, you should put a gauge on mainline (figure 5) and another on the servo release tap you installed. Get the transmission hot and compare the readings in 3rd and 4th gears. If servo release pressure is 10 PSI or more below line pressure, there's a leak in the release circuit.

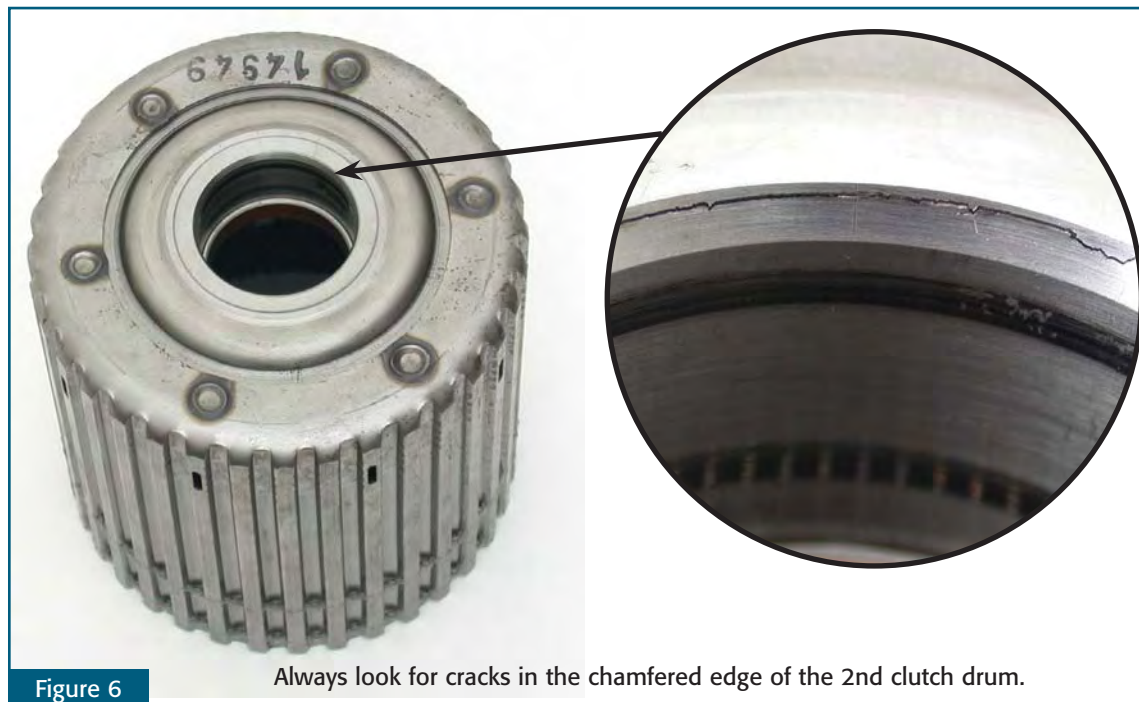
Figure 6

A leak in the 2nd clutch drum will cause a problem with servo release pressure in 4th gear, so always inspect the 2nd clutch drum for leaks. While bad lip seals and sealing rings can cause leaks, the most common problem is a cracked drum

(figure 6). The crack will normally appear along the chamfered edge and can be so small that you may not be able to see it without a magnifying glass.

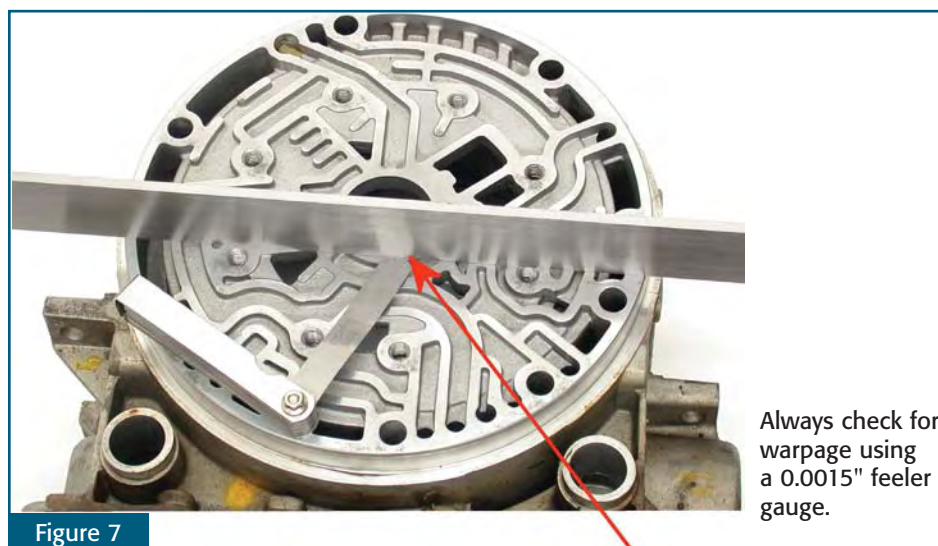
Figure 7

A warped adapter housing or center support can cause a leak in either circuit, so they can cause a servo release problem in 3rd gear, 4th gear or both. Always check the adapter housing and the center support with a straightedge and a 0.0015" feeler gauge (figures 7 and 8). If the feeler

gauge slides freely between the center support and the straight-edge, the support is warped and will create leaks in the 2nd or 3rd clutch circuits.

The bolt holes in the center support are a common high spot, so always check them before replacing the support. If the bolt holes are high, flat file them down and recheck the support.

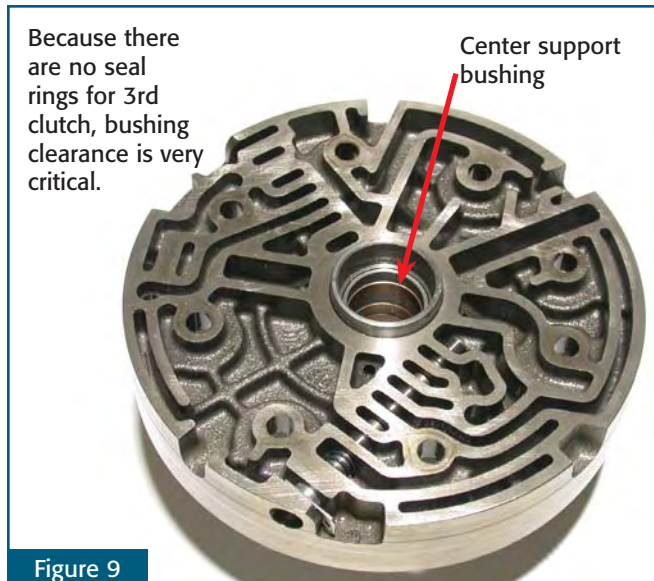
Figure 9

The center support bushing seals 3rd clutch apply oil to the 3rd clutch drum shaft (figure 9). Because there are no sealing rings for the 3rd clutch, bushing clearance is critical. More than 0.002" bushing clearance will cause a leak in 3rd clutch apply pressure.

To check the bushing clearance, apply a thin piece of Scotch tape on the side of the shaft. If the shaft goes into the bushing without scraping the tape off, the bushing is worn. This will cause a servo release problem in 3rd and 4th gears.

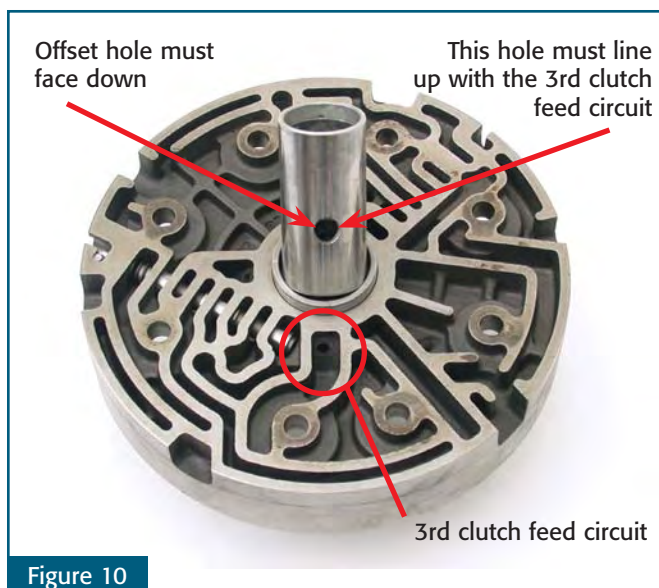
Figure 10

2. The 3rd clutch feed hole in the bushing must line up with the 3rd clutch feed circuit in the center support (figure 10). Improper alignment will cause a bindup in 2nd gear because lube oil will apply the 3rd clutch.

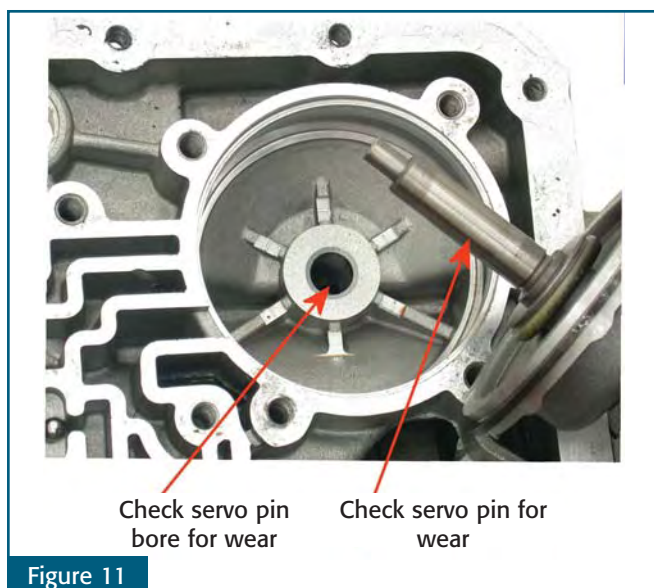
Figure 11

pressure problem in 3rd and 4th gear. You can check the clearance by putting a thin piece of Scotch tape on the side of the pin. If the pin goes into the bore without scraping the tape off, the pin bore is worn.

Pin clearance greater than 0.002" will cause a leak in the servo release circuit and should always be fixed. As far as we know only one company offers a pin bore repair kit for this transmission: Northland Transmissions (715)458-2617.

Servo pin bore wear is another common cause of band burn up (figure 11). A leak in this area will cause a servo release

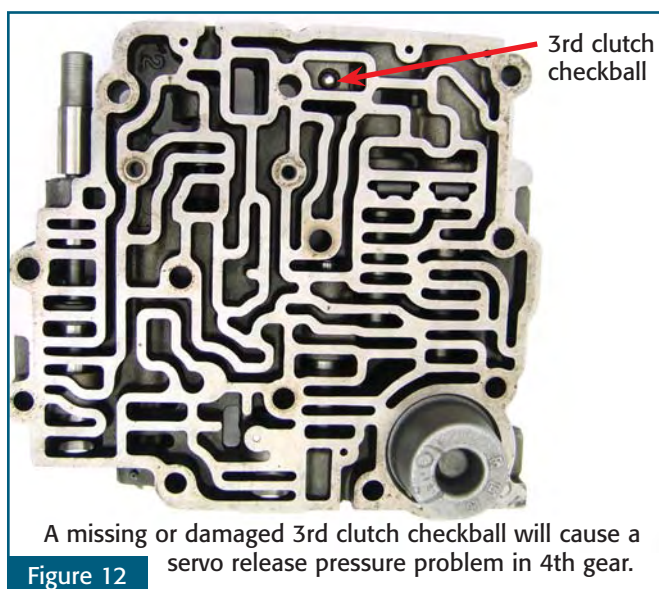
Figure 12

The 3rd clutch checkball must be installed in the valve body (figure 12). If the 3rd clutch checkball is missing or has a bad seat, 3rd clutch apply pressure will exhaust in 4th gear (figure 13). A problem in this area will cause a servo release pressure problem in 4th gear only.
