by Mike Van Dyke and
Chris Ondersma

Ford F250 with *Late* and *Harsh* Upshifts

Getting past the distractions to diagnose a Ford PSOM problem.

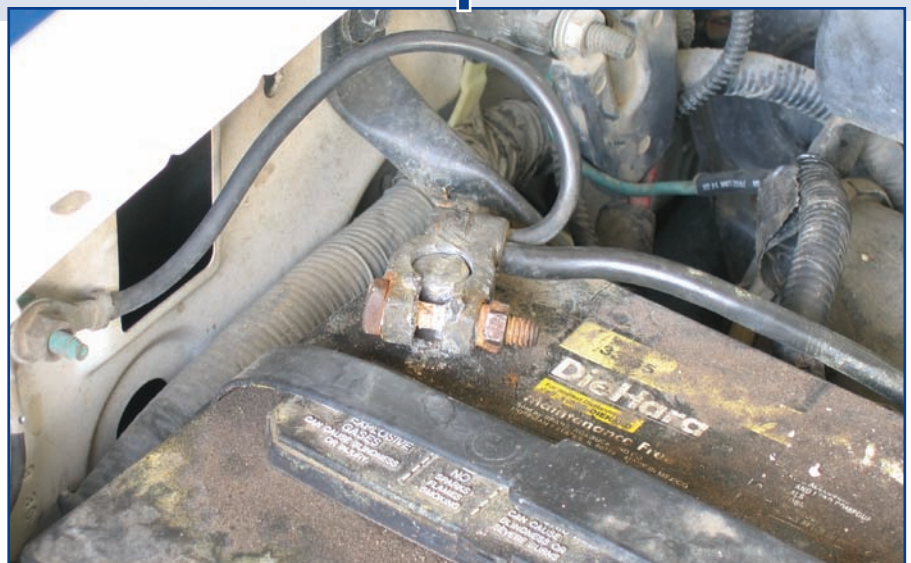
Figure 1: A loose negative battery cable explained the slow cranking, but wasn't the source of our problem.

Before we went too much further, we needed to cover the basics: clean and check the grounds, and check the battery and charging system. We found a loose negative battery cable (figure

1), which explained the slow cranking. The battery was also discharged, having only 12.2 volts at the terminals even with a surface charge just after shutting the engine off. After going over all of the grounds and giving the battery and terminals the attention they needed, we verified the charging voltage and alternator output were good. But our shifting problems persisted.

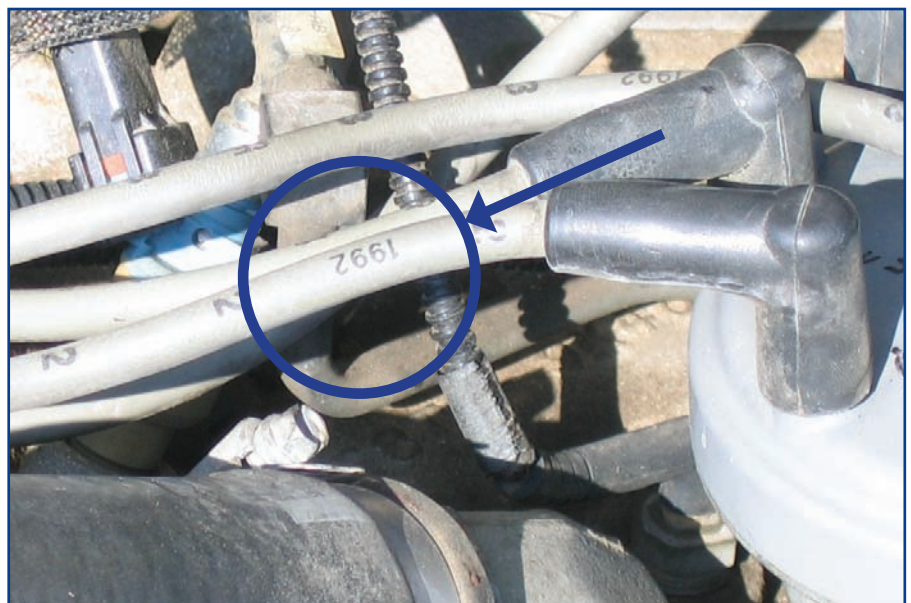
Figure 2: Original spark plug wires with 1992 year code were highly suspicious.

looking components: an original looking TPS and MAP sensor, and OEM Motorcraft spark plug wires with the 1992 year code (figure 2) printed on them!

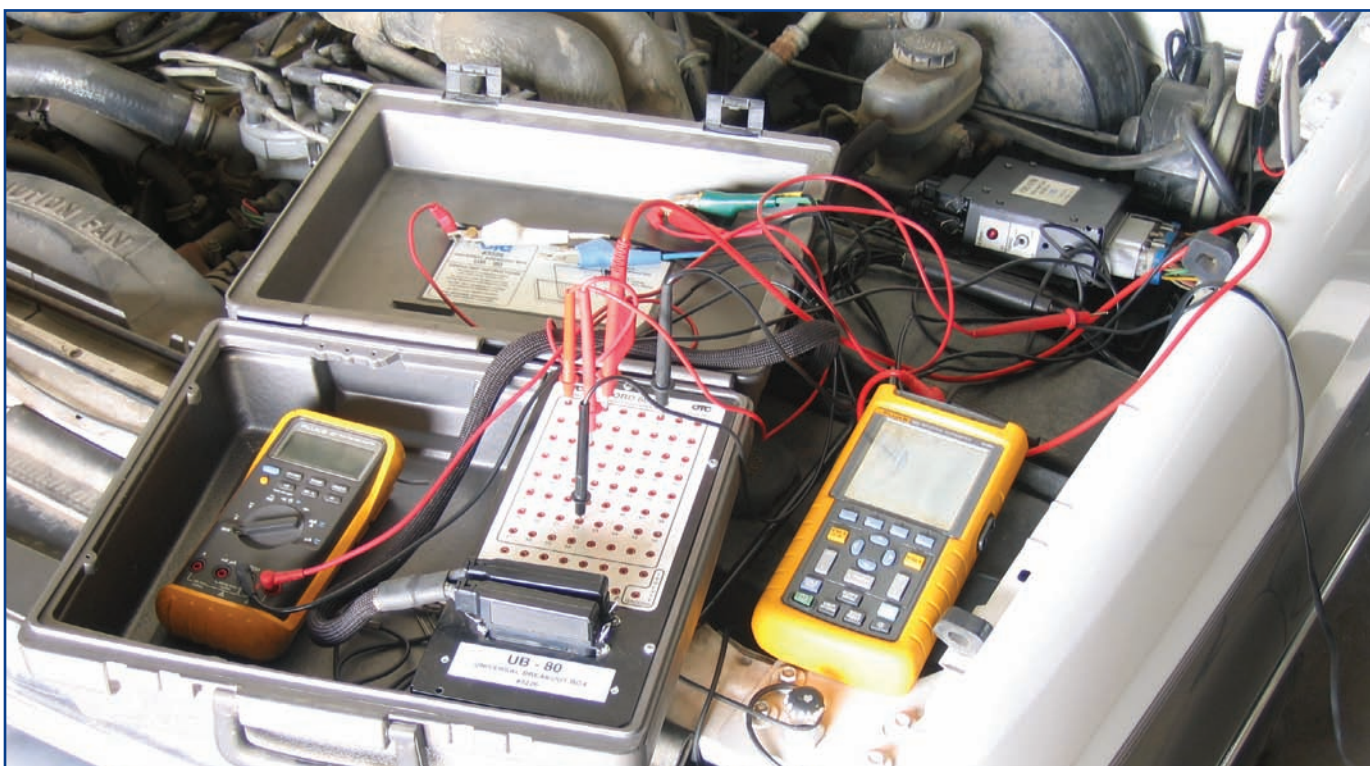
With no available scan data, the next step was to unplug the PCM and connect a breakout box (figure 3). This way we could easily access all of the signals going to and from the PCM. The PCM power feeds checked okay, and the PCM grounds all checked good with a voltage drop test. We connected an oscilloscope to the TPS circuit and performed a static sweep; there was a little signal dropout right off idle.

Figure 3: With no scan data available, you have to get down and dirty with a breakout box, oscilloscope and DMM.

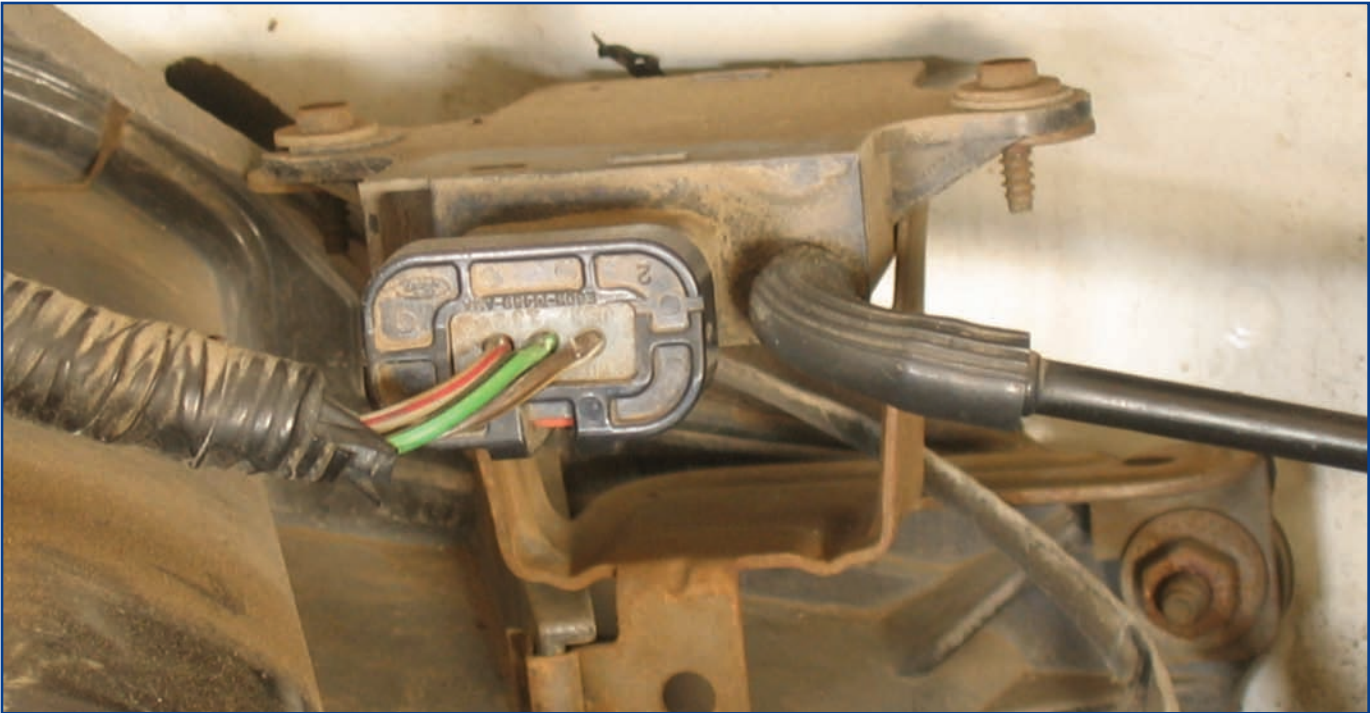
Figure 4: We eliminated our original-looking MAP sensor from the suspect list by simply unplugging it.

We plugged the TPS back in, cleared the DTCs, and moved on to the next suspect: the MAP sensor (figure 4). The MAP sensor signal checked out okay on the scope, but we still unplugged it to take the signal out of the picture. As you probably already guessed, the problem was still there. The MLPS signal voltage was giving a correct Drive range voltage signal as well.

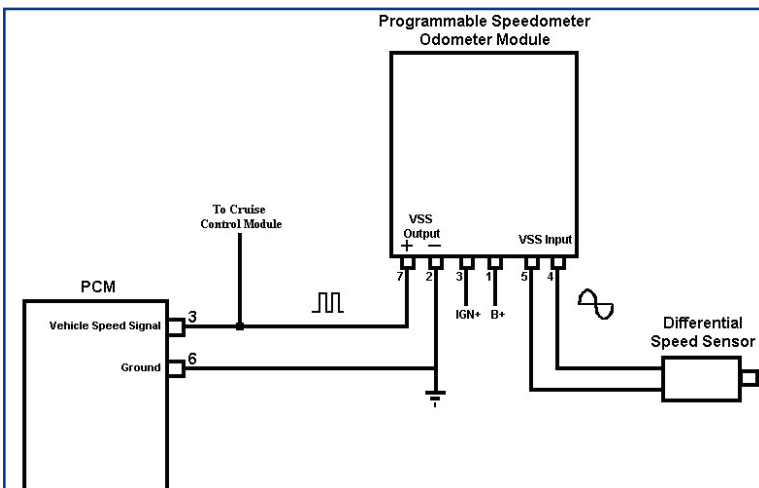
Figure 5: The PSOM (Programmable Speedometer Odometer Module) receives an AC signal from the differential speed sensor and sends out a square wave vehicle speed signal to the PCM.

Look at the wiring diagram in figure 5: The PSOM receives the AC signal from the differential speed sensor and sends out a square wave vehicle speed signal to the PCM. Because the speedometer maintained a good, steady reading, we knew the PSOM was getting a good signal from the differential speed sensor.

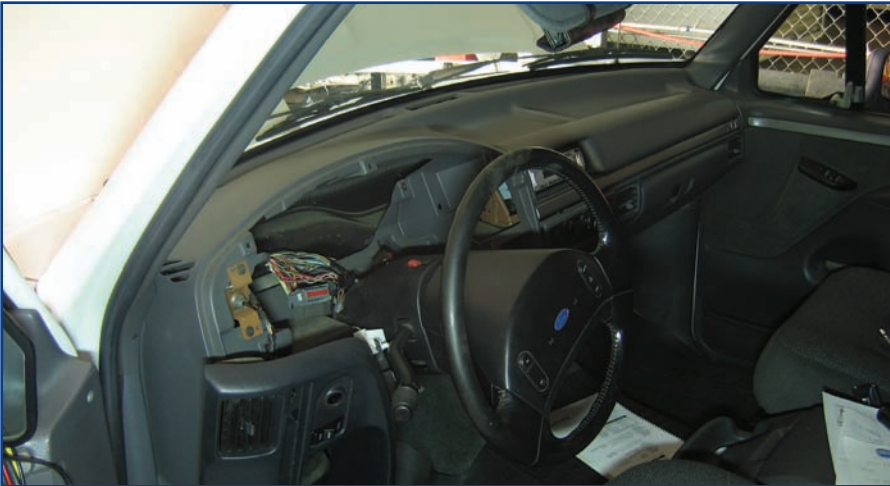
Figure 6: Once we narrowed down the problem, we removed the instrument cluster for further testing.

In order to access the PSOM connector we removed the instrument cluster (figure 6) to check the signal right from the back of the PSOM (which is part the speedometer assembly), and test the circuit between the PSOM and the PCM. There was no short to ground, and the circuit checked out okay, with

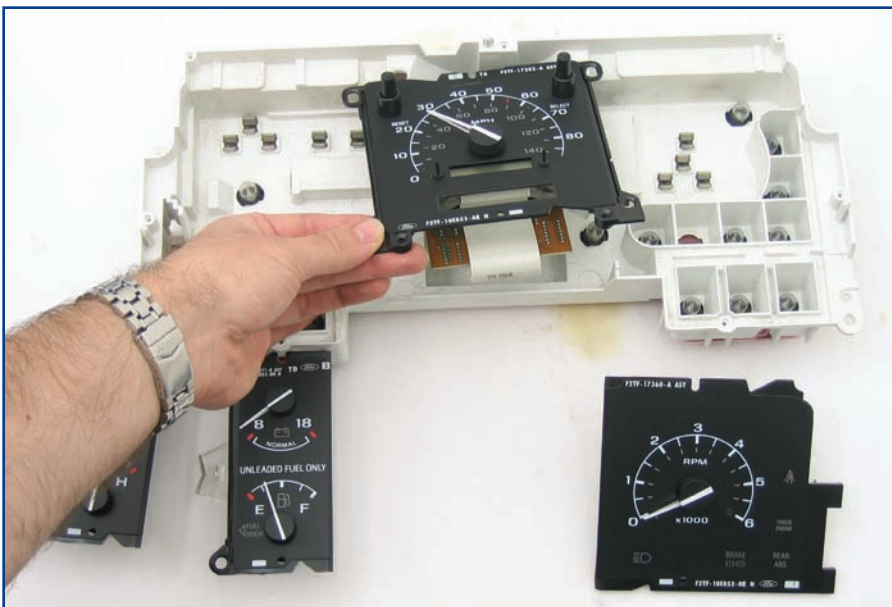
Figure 7: Plugging the speedometer module into the dash by itself offers more room for live circuit testing.

to remove the speedometer assembly from the instrument cluster (figure 7). You can accomplish this fairly quickly: Remove the lens from the instrument cluster, then carefully remove the gauges one by one, starting from the ends of the cluster. The PSOM/speedometer module has to be removed last.

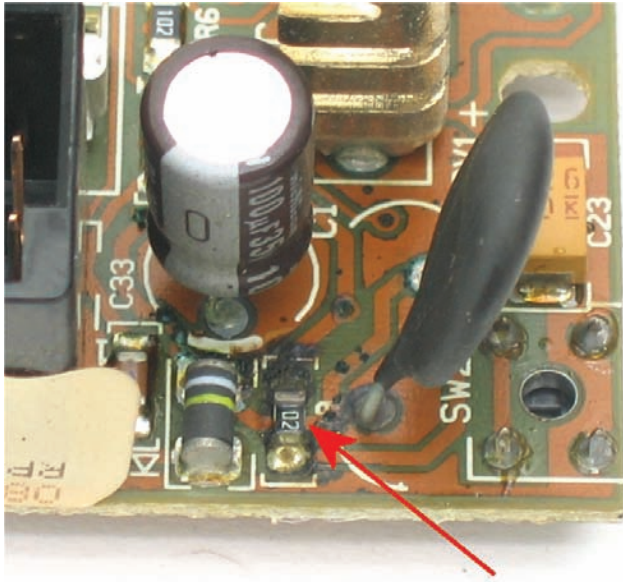
Figure 8: A leaking electrolytic capacitor on the PSOM circuit board also provided a visual indication of failure.

With the PSOM/speedometer removed from the instrument cluster, we could also see signs of damage on the circuit board caused by a leaking capacitor (figure 8). This gave us more evidence to suggest a problem with the PSOM.

Once we verified the PSOM had everything it needed to work, but still wasn't providing the necessary signal to the PCM, we ordered and installed a replacement instrument cluster from the salvage yard. Just as we expected, we now had a good vehicle speed signal waveform between PCM terminals 3 and 6, and the transmission now shifted smoothly and on time.

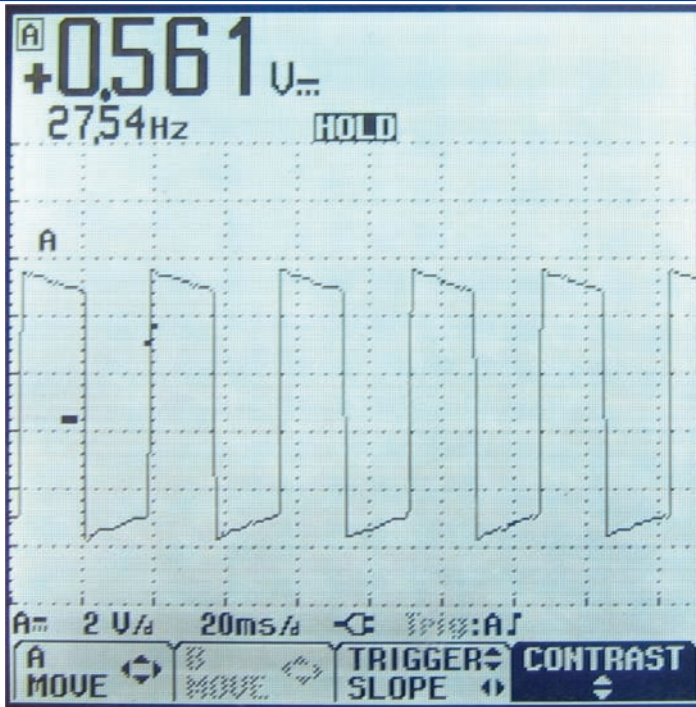
Look at figure 9: Notice the correct vehicle speed signal to the PCM is an AC square wave that rises to about 5 volts positive and drops to about 3 volts negative. The sloping tops and bottoms on the waveform are normal, and don't indicate a problem in the circuit.

Figure 9: The correct PSOM vehicle speed signal to the PCM is an AC square wave that rises to 5 volts positive and drops back to 3 volts negative, with a frequency of about 120 Hz at 60 mph.
