A Last Lix for the Allison LCT 1000

by David Skora

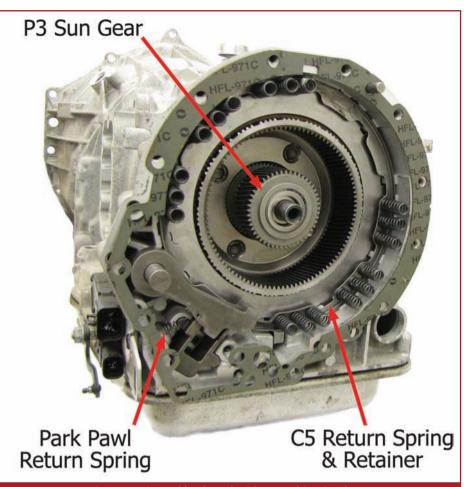
Figure 2: View of back end with everything in place.

Before going any further, examine the back end of the unit. If it looks like figure 2, it may be your lucky day. If it looks more like figure 3, the intermediate shaft, P3 sun gear, or P2 ring gear have shifted farther back. You will need to check for mislocated thrust bearings or damage (figure 4).

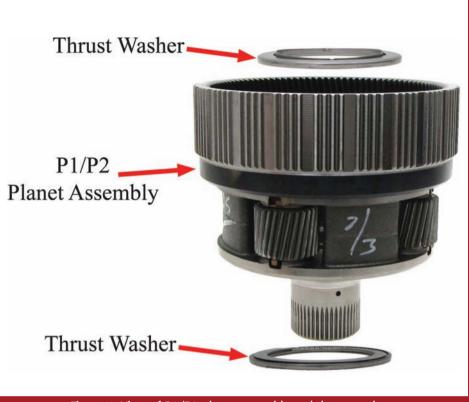
Figure 4: View of P1/P2 planet assembly and thrust washers.

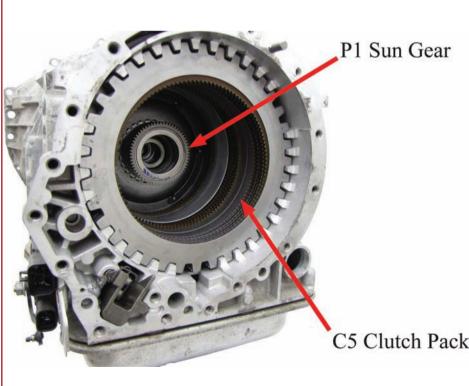
NOTE — Figure 5 shows the rear of the LCT with as much of the geartrain as can be removed from the rear of the case.

Figure 5: View of LCT 1000 with rear geartrain removed.

Depending on the damage, you should also remove the P3 planet carrier, bearings, output shaft, and C5 clutches and inspect them for damage or debris.

Once these are out of the way, inspect the P3 sun gear and ring gear, main shaft, related bearings, case, park pawl, etc., for damage or further problems. Use your judgment to decide if any other internal parts have been damaged.

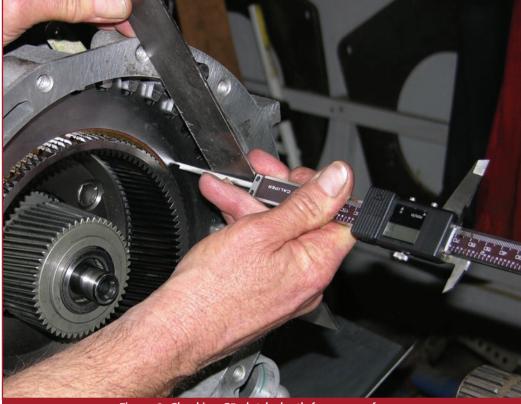
Figure 6: Checking C5 clutch depth from rear of case.

If you've changed the C5 apply piston, make sure the height above the extension housing is the same as the original. If so, you'll have the same clearance as before. If you've had to change any of the C5 clutch stack or the apply piston height is different, you should measure the distance from the clutch reaction plate to a straightedge across the

rear flange of the case (figure 6).

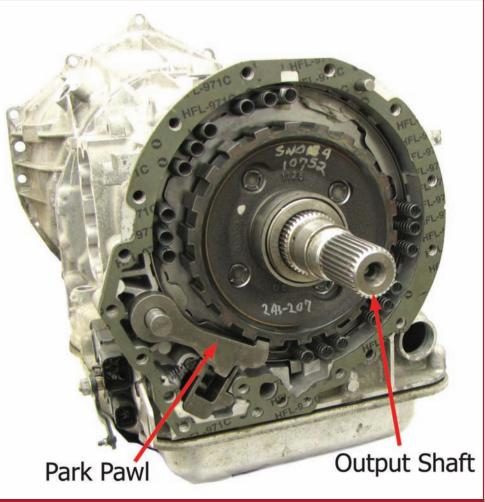
Figure 7: Rear of LCT 1000 ready for extension housing.

The back of your LCT 1000 should look like this (figure 7). There isn't much more to say, except tighten the output flange nut with pin drive wrench J 43769 to 40-50 ft-lbs.
