The RE5R05A: PROSA: A Deeper Look

by Mike Souza members.atra.com www.atra.com

The RE5R05A, also referred to as the JR507E, was first introduced in the US in 2002 in the Infiniti Q45.

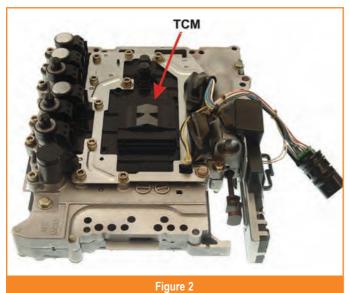
In mid-2004, the Transmission Control Module (TCM) was moved into the transmission. If you take in a 2004 RE5R05A with antifreeze contamination and you don't change the TCM

(figure 2), the vehicle may return in a couple days or weeks with ghost codes for solenoids that have nothing wrong with them.

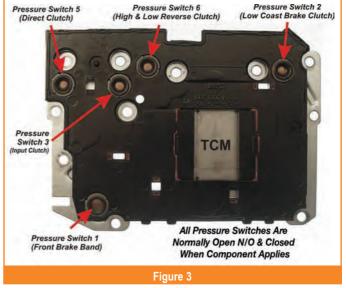
In addition to TCM contamination, the pressure switches on the TCM (figure 3) can also set ghost codes.

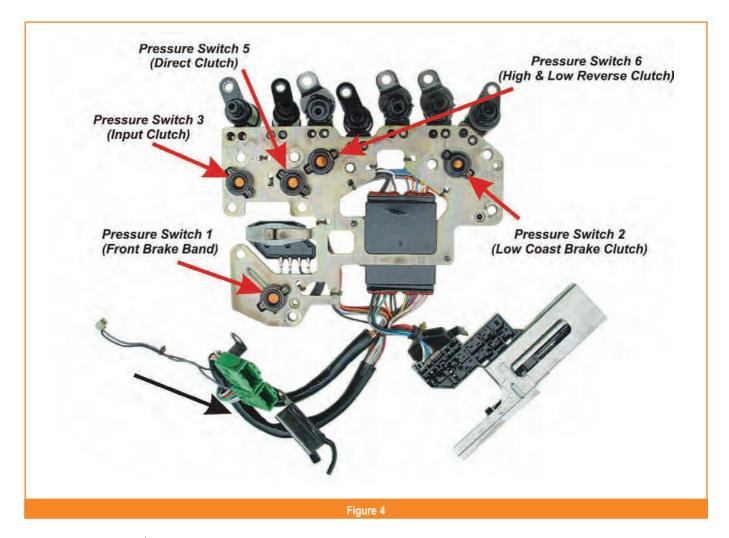
P0731 ratio error in 1st has been caused by a false signal from pressure switch 2 (low coast brake). The pressure switches on the earlier system are part of the internal harness (figure 4).
