Sticking Thermal Element Can Cause Thermal Failure

4R / 5R55E / 5R55W / S/N Cooler Bypass System

by Mike Souza
members.atra.com
www.atra.com

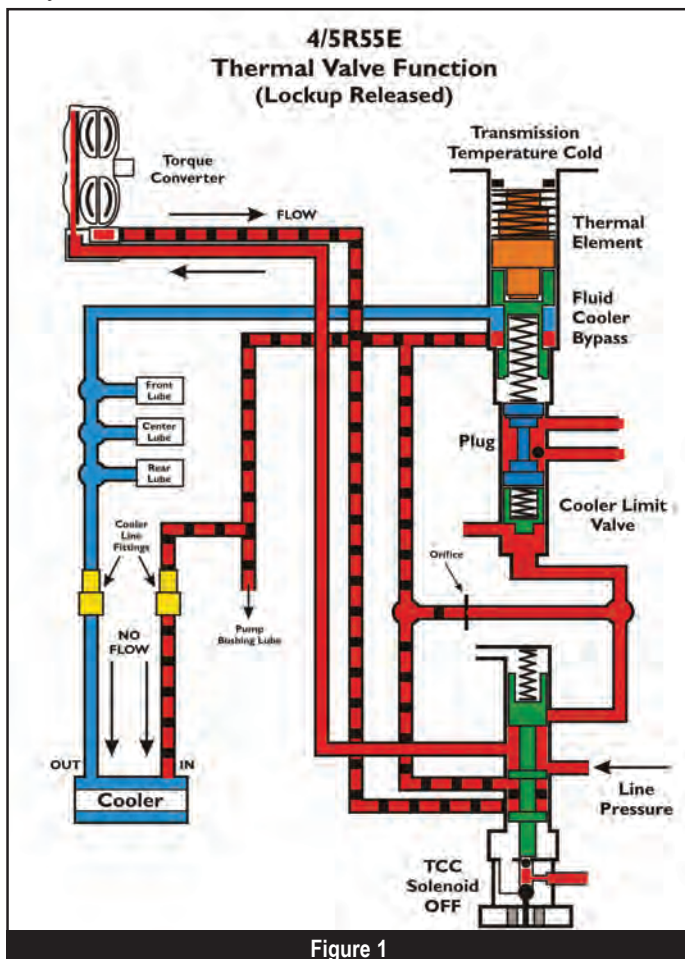
Figure 1 shows the thermal valve at rest (4/5R55E; orange) in the cold temperature position. In this position, the valve directs oil through the fluid cooler bypass sleeve (green), which allows the oil to flow to the cooler

through both cooler lines at the same time. Since there's no return, there's no cooler flow. This helps the transmission reach normal temperature faster in colder climates.

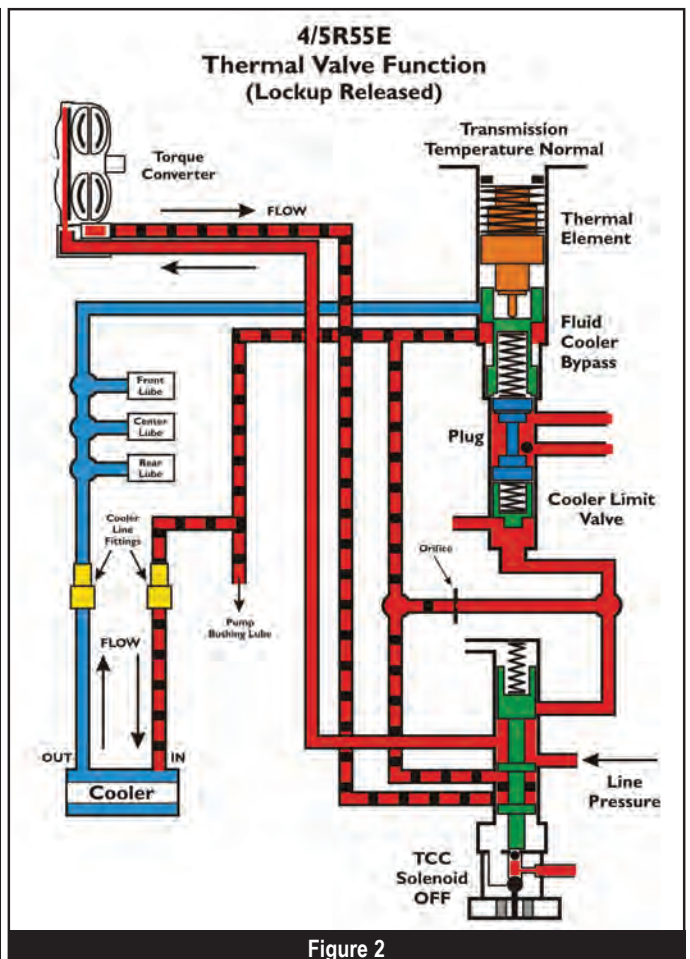
Figure 2 shows the transmission at normal temperature: The thermal element moves the fluid cooler bypass sleeve (extended pin), blocking off the oil being applied to the upper cooler line fitting. In this position, oil flows to the cooler through the lower cooler line and returns through the upper cooler line. Figure 2 shows the lockup converter flow in the released position at normal temperature.

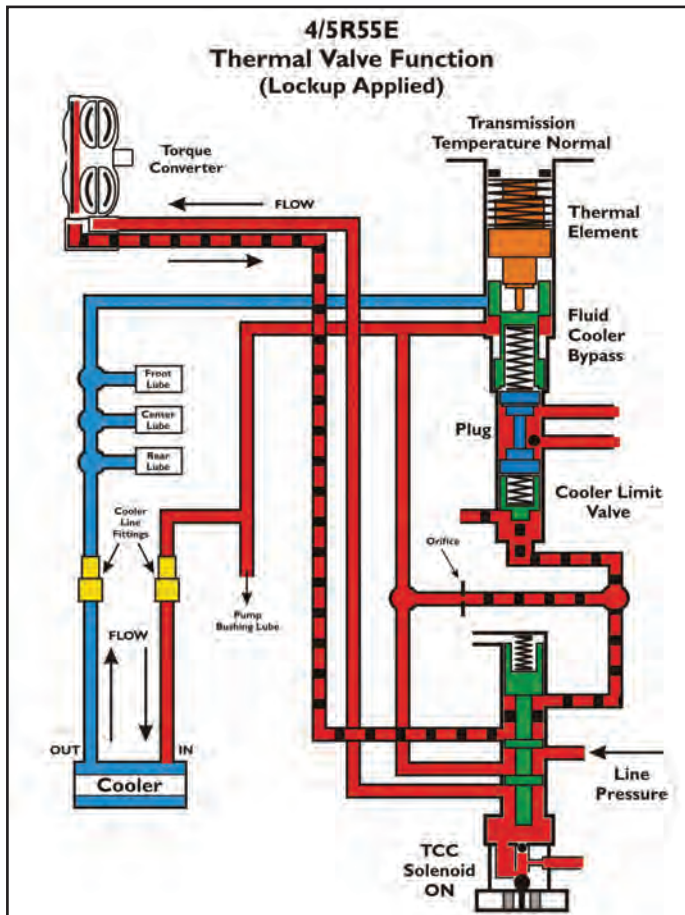
Figure 3 again shows oil flow to the cooler at normal temperature, but with the lockup converter flow in the applied position. If the sleeve gets stuck — completely or part way — it can restrict cooler flow in the converter clutch release pressure circuit. This can set DTC P0741.

Placing the cooler bypass sleeve spring on the opposite side of the sleeve locks the sleeve in the normal temperature position, preventing a cooler flow problem.

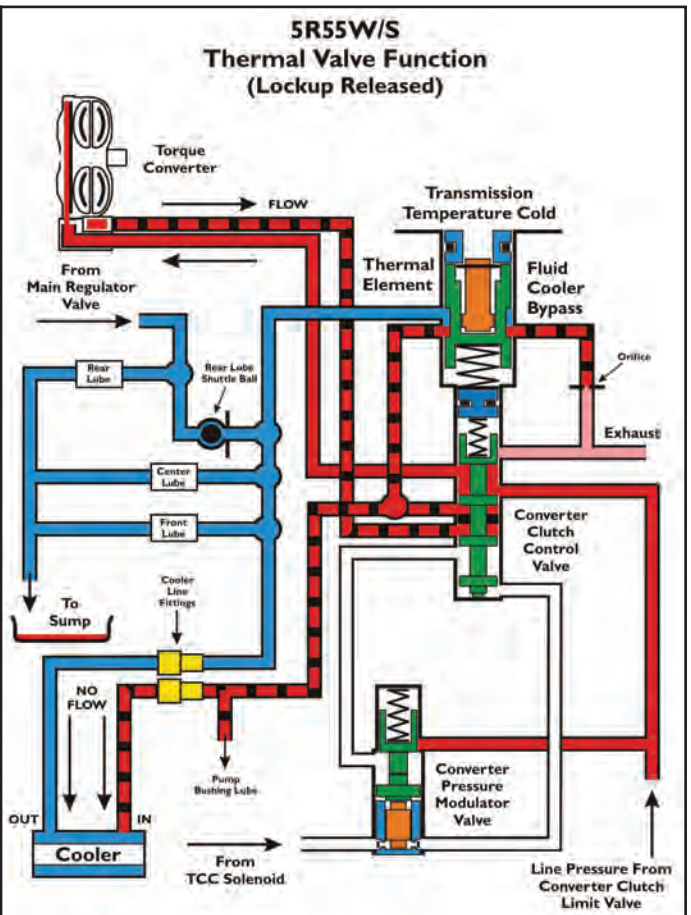
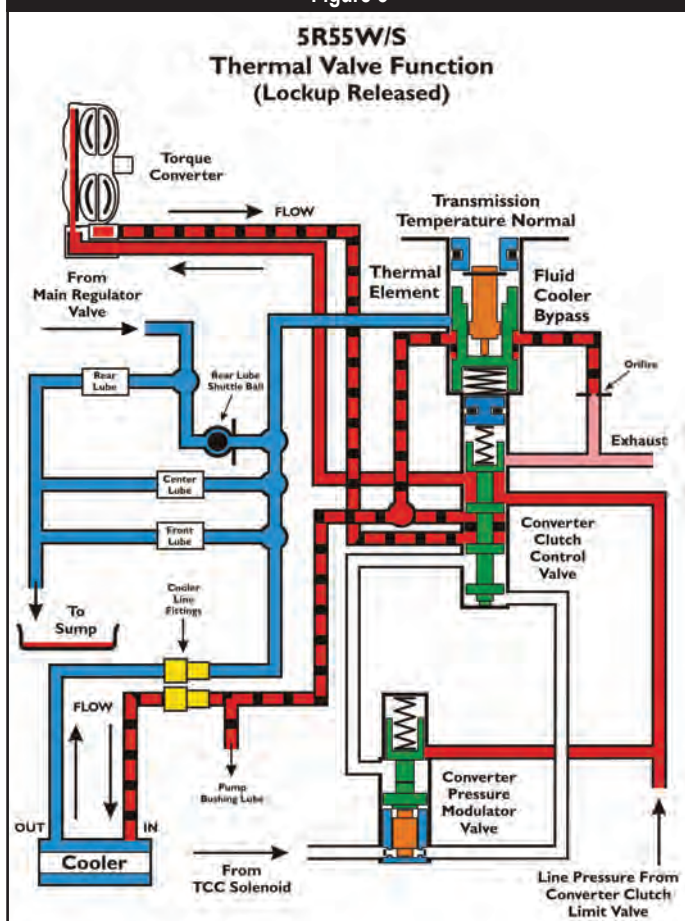
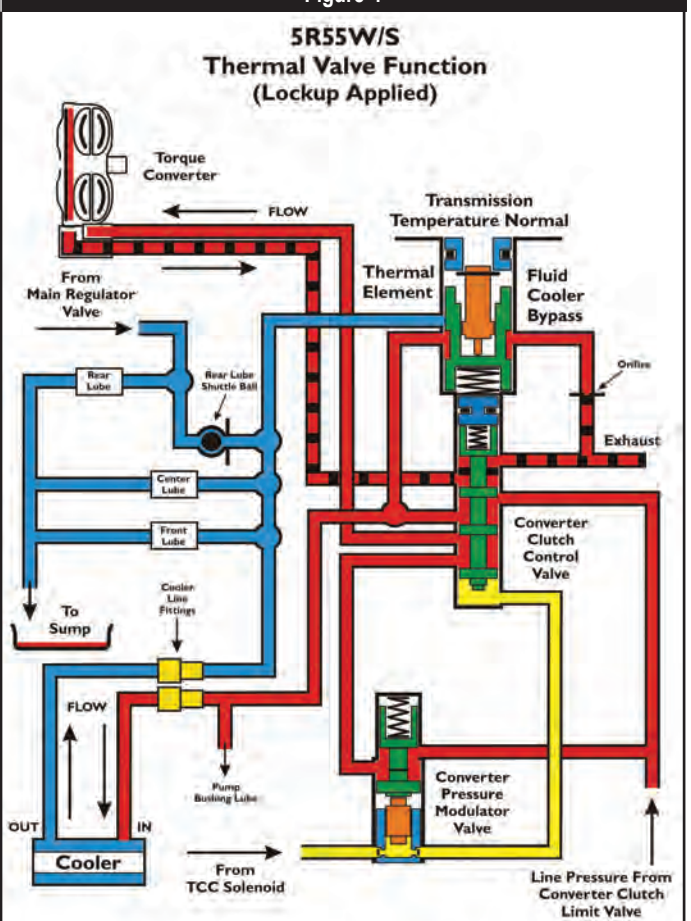
The diagrams for the 5R55W/S (figures 4, 5, and 6) and the 5R55N transmission (figures 7, 8, and 9) show cooler flow working the same way. The only difference is the thermal element, fluid cooler bypass sleeve, and converter clutch control valve lineup aren't in the same bore.

But blocking the fluid cooler bypass sleeve in the normal temperature position, such as by relocating the spring to the opposite side of the sleeve, will still keep the cooler flowing properly and prevent overheating problems.
