Slipping and Sliding with the 6L80/6L90

by Steve Garrett
members.atra.com
www.atra.com

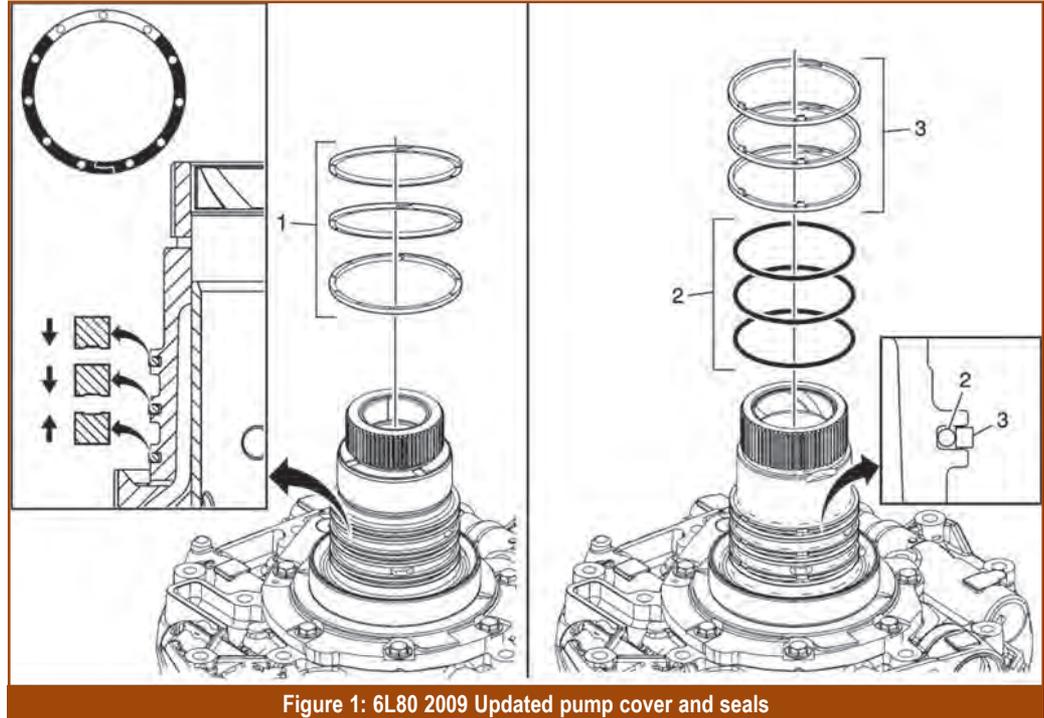
Figure 1: 6L80 2009 Updated pump cover and seals

Beginning with the Start of Production (SOP) for the 2009 model year, a major change occurred to the 3-5-reverse system in an attempt to address these conditions. The change revolved around the sealing rings mounted onto the back of the pump (pump cover).

The grooves in the pump cover were changed to accommodate a new

design, quad backup ring, and a new design, tabbed sealing ring. The update looks very similar to some of the GM 4-speed, front-wheel-drive, driven sprocket support ring designs.

The updated pump cover has additional machining to allow it to accommodate the updated ring design. The updated rings won't fit on the previous design support. And never attempt to install the old design rings on the new design pump cover support (figure 1).

One common cause for these conditions after a rebuild was that the early design support and rings were directional. The rings have a series of identification marks on them to help you with installation. The first ring is supposed to be installed with the identification marks facing up, away from the pump; rings 2 and 3 should be installed with their identification marks facing down, toward the pump (figure 1). Installing the rings incorrectly will cause sealing ring leaks and the problems discussed earlier.

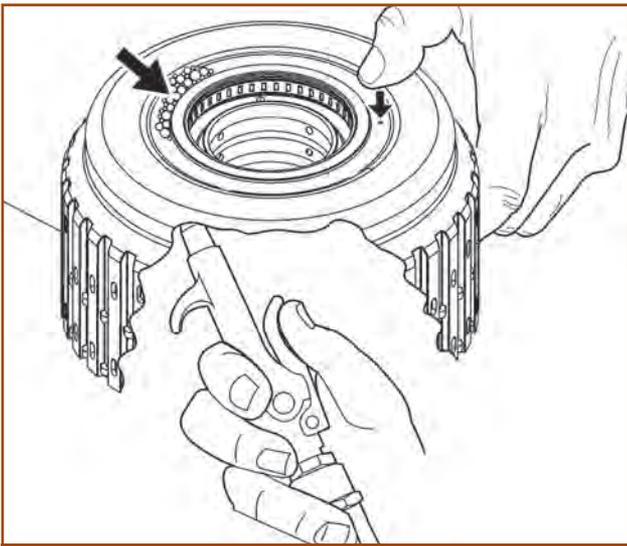
Figure 2: 3-5 reverse leak 6l80

Another condition that's started to pop up involves cracks in the 3-5-reverse drum. If you're faced with any of these complaints, always air check the drum this way:

- Hold your thumb over the bleed hole in the drum.
- Apply shop air to the drum.

- Apply soapy water around the drum weld and inspect it for evidence of a leak.

If the drum is leaking, replace it (figure 2).
