by Mark Puccinelli
members.atra.com

Double Duty Dodge Diesel: The 68RFE P0871 Overdrive Clutch Failure

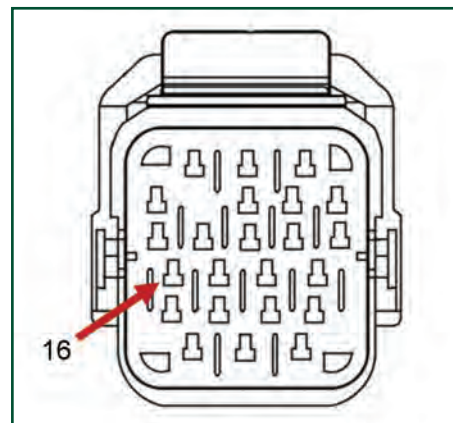
Figure 2

Cut the overdrive pressure switch circuit wire: pin 16 at the transmission connector

Cut the overdrive pressure switch circuit wire: pin 16 at the transmission connector (figure 2). This eliminates

the possibility of a shorted circuit causing the code to set.

Since you've taken the circuit out of the equation by cutting the wire, if the code sets while in 1st through 3rd gears, the TCM has to be at fault. Always recheck the TCM event data on your scan tool to make sure the code didn't set while in 4th gear. If the transmission shifts into 4th with this wire cut the P0871 will set on the 3-4 command; that's normal, because the circuit can't pull down the way it should in 4th gear.

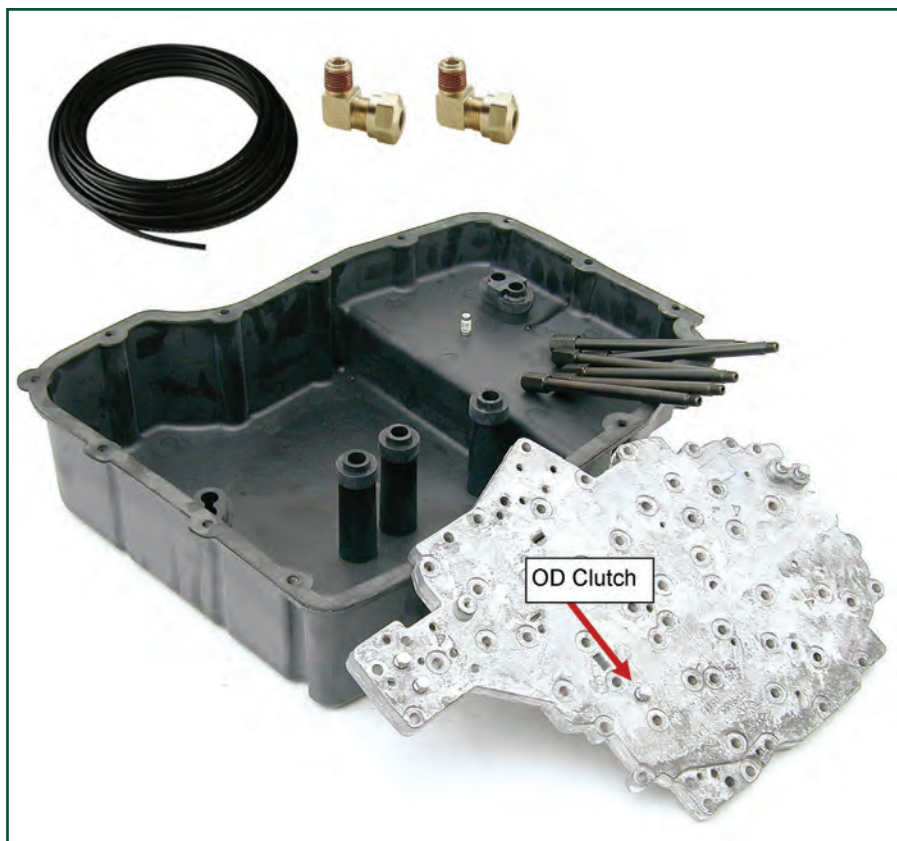
Figure 3

Miller 1456-6, and attach a 100-PSI gauge or transducer to the overdrive clutch port. If you don't have the test pan, make a trip to your local hardware store and pick up some 1/16" pipe thread brass fittings for 1/8" plastic tubing. You can run the gauge tubing or the wiring for a transducer out the filler tube (figure 3).

Road test and monitor the pressure in the overdrive circuit. While the transmission is in 1st through 3rd gears, the overdrive clutch circuit should remain at 0 PSI. If you see pressure on the overdrive clutch circuit while the transmission is in 1st through 3rd gears, the code is being set hydraulically.

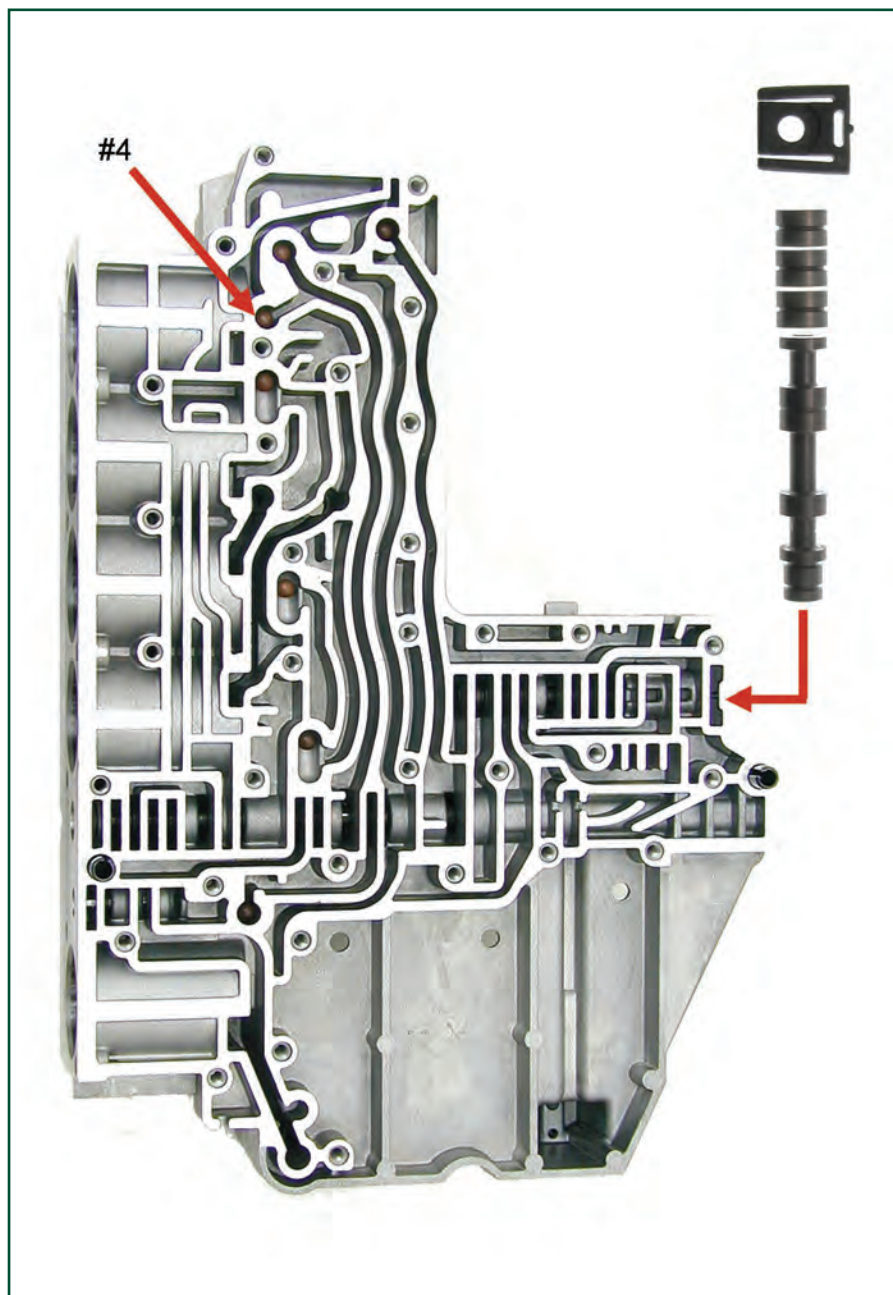
Figure 4

- A worn #4 checkball will feed line pressure in the overdrive circuit.
- Wear in the solenoid switch valve bore can cause P0871 to set by feeding the overdrive circuit and closing the switch. There are aftermarket repair kits available to fix this (figure 4).

If the overdrive pressure switch is closing from a valve body problem, the pressure will also apply the overdrive clutch when it's supposed to be off. This will cause a bindup in 3rd gear and cause the clutch to drag and burn out.

While there are other possible valve body problems that can set code P0871, they haven't been resolved yet. If the code still sets after repairing the switch valve bore, the only other solution available is to replace the valve

body with a new one. Dodge sells a replacement valve body with the solenoid pack for \$479.
