# AW55-50N/ AF33-23/RE5F22A: No 3rd after Servicing

by Mike Brown  
[members.atra.com](http://members.atra.com)

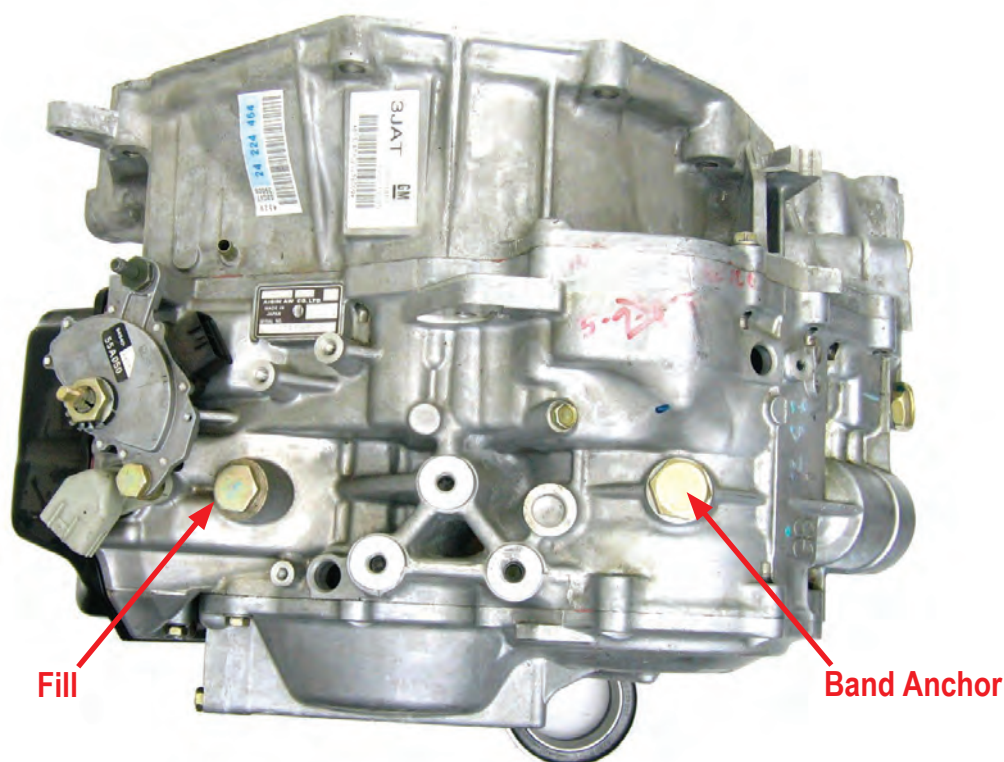
Figure 1

one problem can occur as a result of a simply fluid change. Here's where the do-it-yourself (or even the transmission professional) can find themselves in big trouble. That's because the fill plug and band anchor look almost alike (figure 1). Loosening the anchor by mistake releases the band (resulting in no 3<sup>rd</sup> gear).

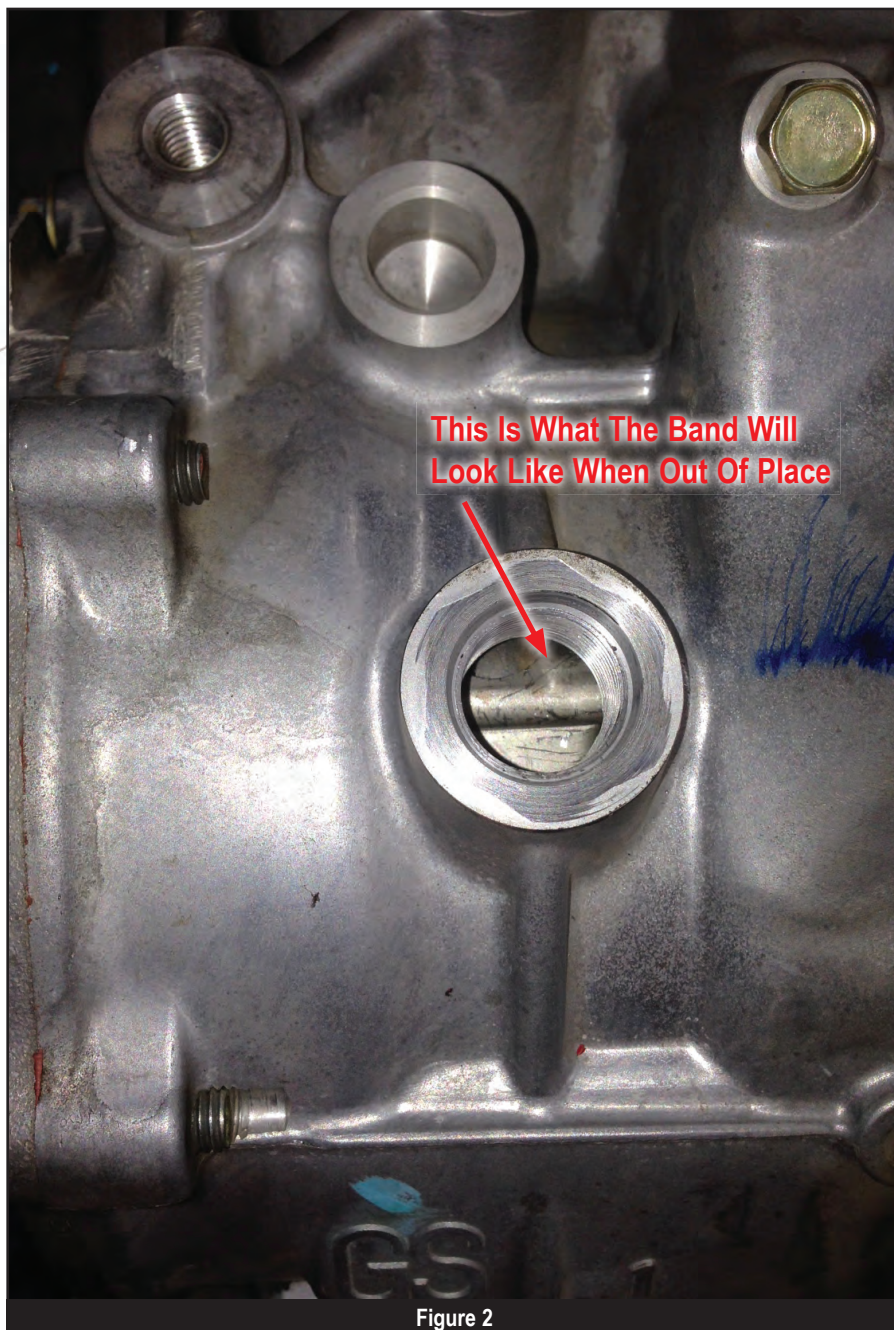
Figure 2

Figure two shows the band out of

position once you remove the anchor. You can move the anchor back in place (figure 3) but as soon as you release it, the band moves out of place again.
