**2000**

**TECHNICAL SEMINAR**

# ***Automatic Transmission Rebuilders Association***

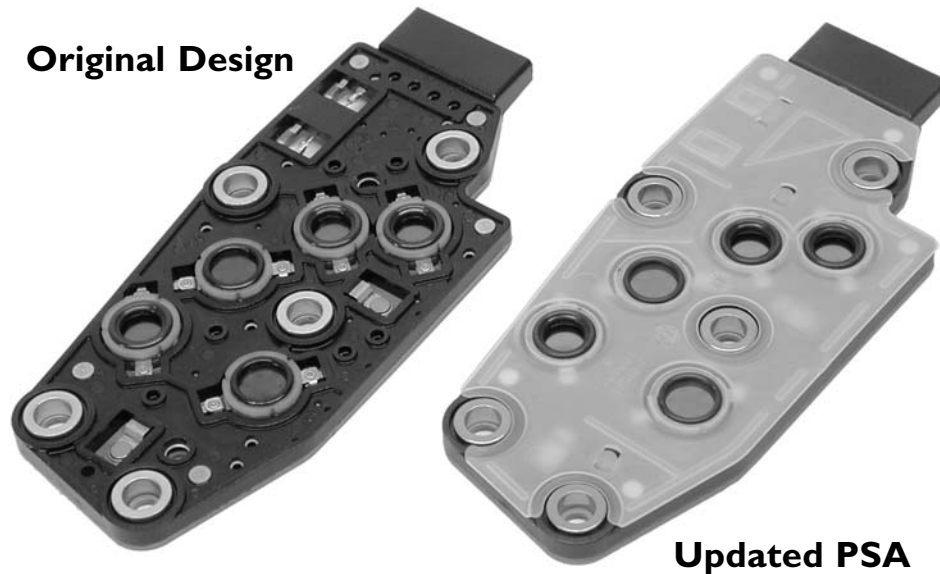
## New-Design Pressure Switch Assembly; Code P1810

A diagnostic trouble code P1810 refers to a problem with the pressure switch assembly. This can be caused by debris shorting out the switch contacts. GM has introduced a new-design switch assembly that has a plastic shield, to protect the switch contacts from exposure to debris.

The GM part number for the new switch assembly is 24215111.

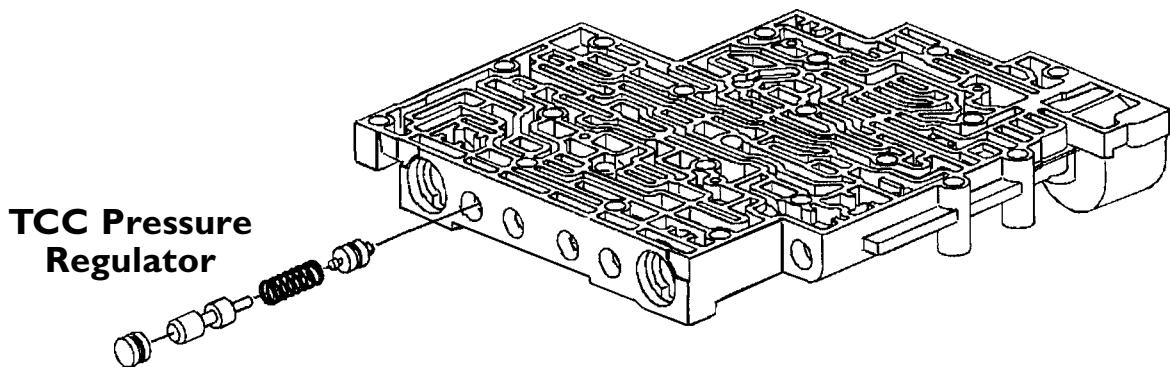
If the slip isn't consistent with every TCC apply, check the TCC pressure regulator valve in the valve body for side-loading.

This is a very common problem and very often the valve body bore is worn, allowing the valve to cock in the bore. This reduces the amount of TCC apply pressure, resulting in excessive TCC slip. If a possible side loading occurs, replace the valve body or install a TCC pressure regulator valve kit readily available from many aftermarket companies. GM no longer produces new valve bodies as service parts: All valve bodies are now serviced as remanufactured valve bodies only.

If no damage is present and you are confident a TCC pressure regulator valve side loading isn't present, replace the TCC PWM solenoid.

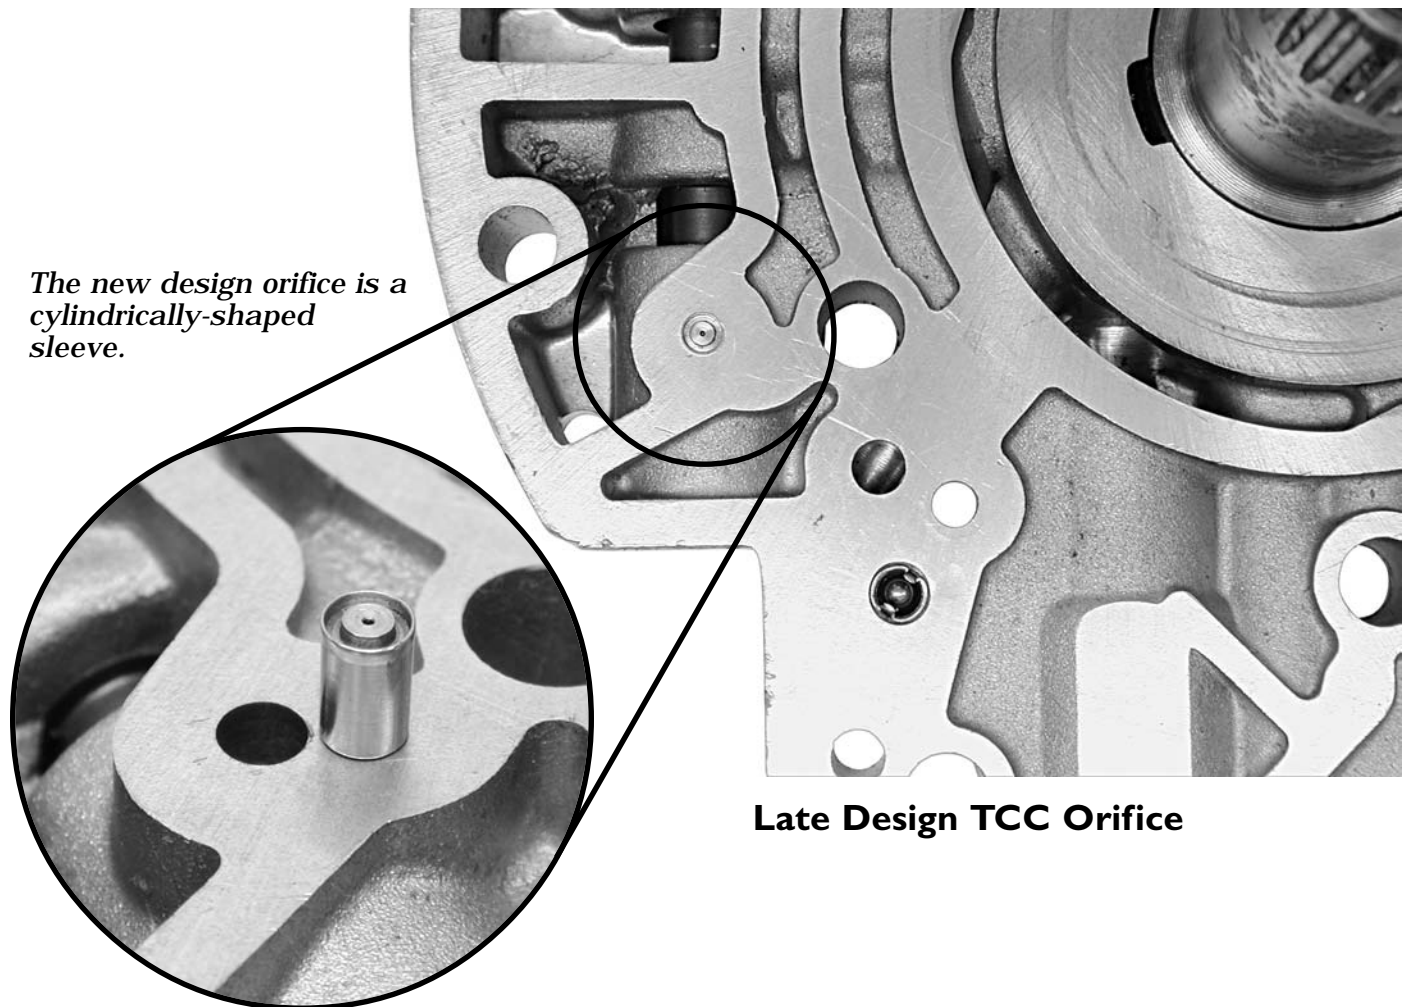
**Late Design TCC Orifice**

*The new design orifice is a cylindrically-shaped sleeve.*

Under severe overheating conditions, the plastic insert can melt, clogging the orifice. Currently, the orifice isn't serviced separately, which gives you two choices:

1. You can replace the stator support with an earlier PWM support.
2. You can replace the orifice with an orificed cup plug. The cup plug used in earlier supports is too small for the bore, but you can use a larger plug. To do this you first need to enlarge the existing hole.

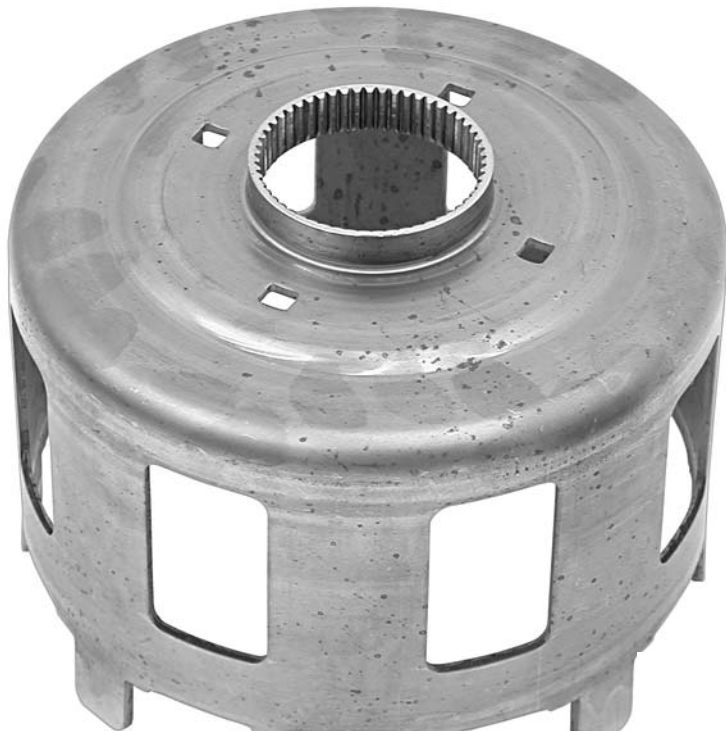
**Here's how the sun shell should look**

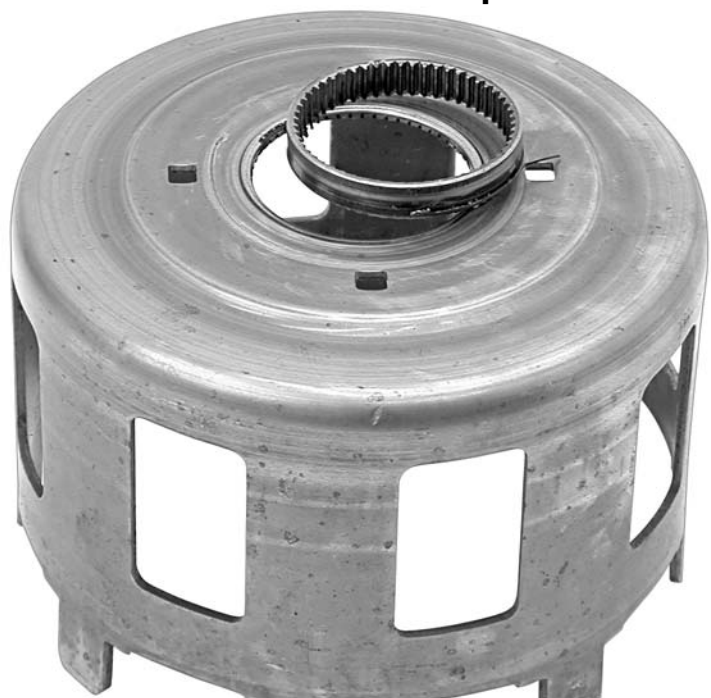
Many 1997-99 4L60Es may lose reverse, 2<sup>nd</sup> and 4<sup>th</sup> gears. This is caused by a change in the manufacturing process for the sun gear reaction shell. During production, the radius of the area attaching the splines on the shell to the shell housing was reduced. This leads to a fatigue failure of the shell.

**This is how the sun shell looks when it strips out**

GM increased the radius of this area for added strength. To repair this condition, replace the shell. The part number for the updated shell is the same as the old shell. What's more, GM didn't purge the faulty parts from inventory, so you may not get the updated part when you order it.

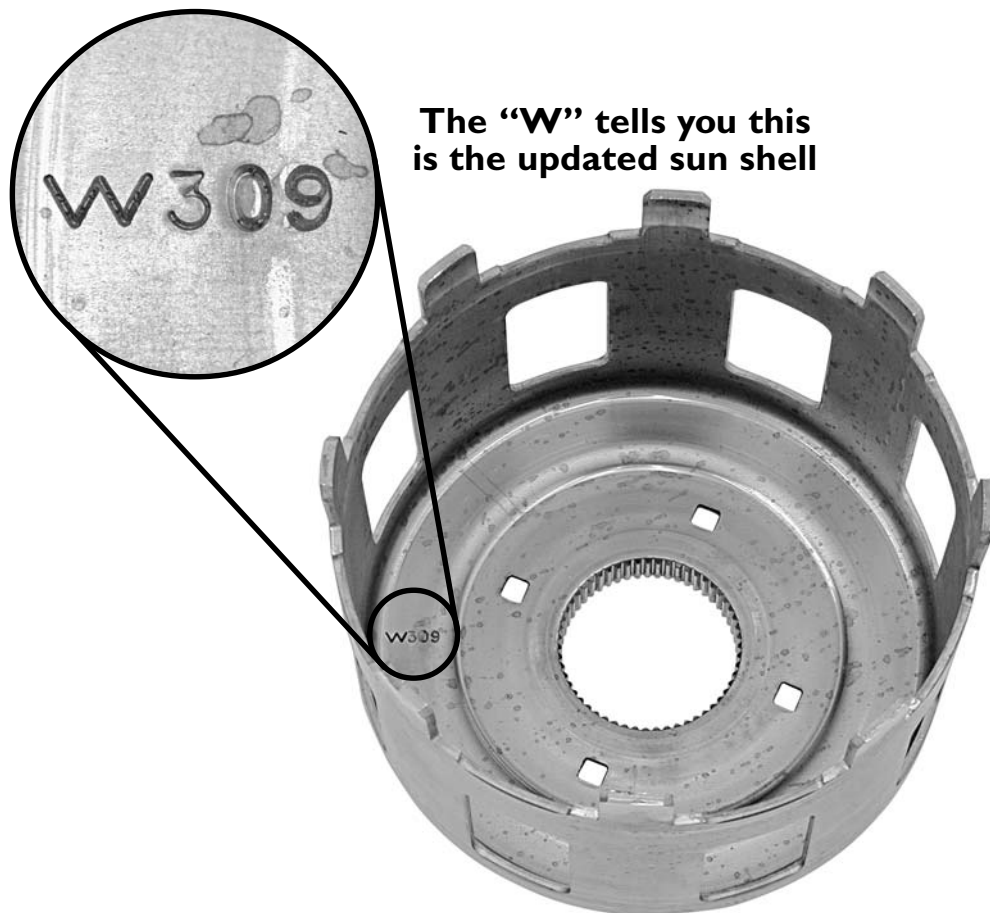
The "W" tells you this is the updated sun shell

The GM part number for the sun gear shell is 8683439.

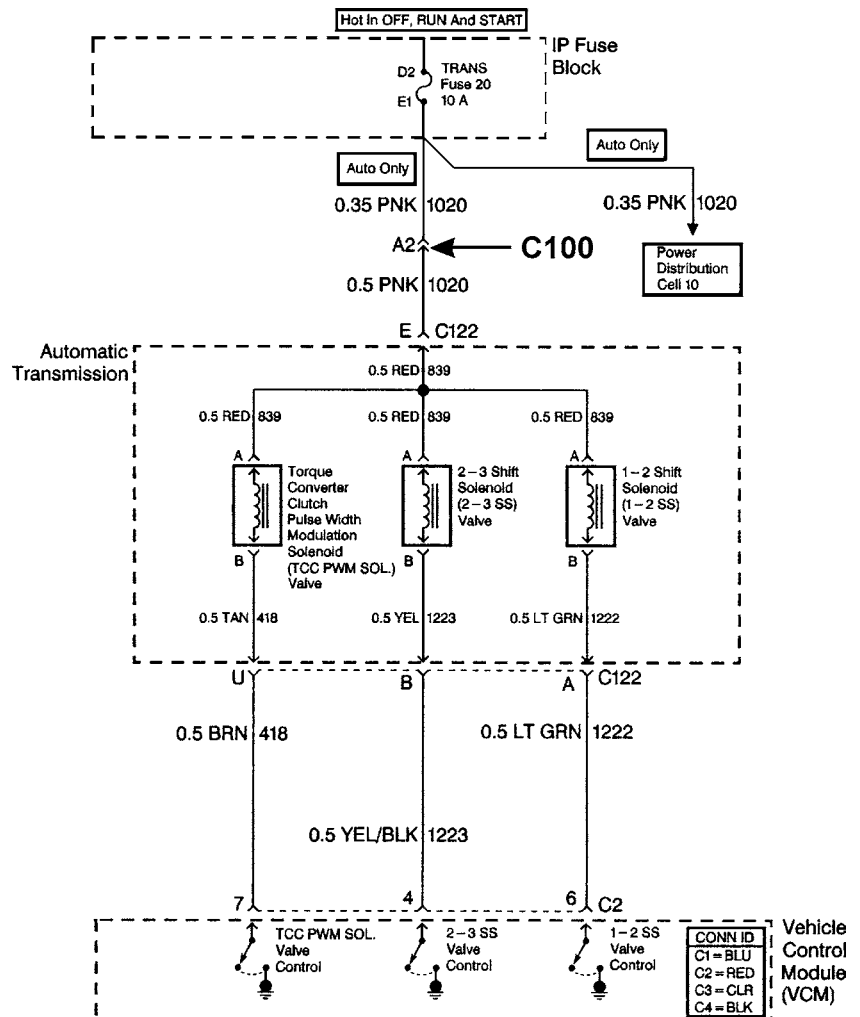
This problem is caused by a poor crimp on one of the terminals for circuit 1020.

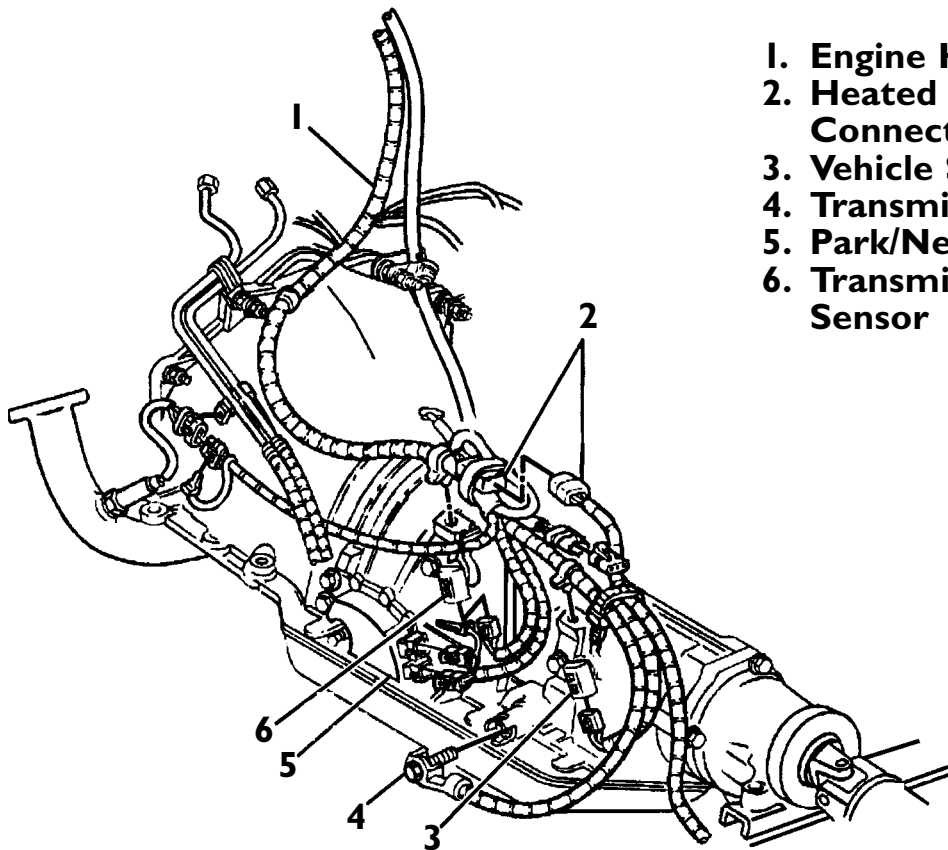
The typical cause for this code is the wiring is incorrectly routed. The harness is designed to be routed over the top of the transmission bell housing. In many cases the harness is incorrectly positioned, allowing it to wedge between the fuel lines and the body. This results in severe damage to the wiring harness, as the pinch weld on the body wears through the conduit and wiring insulation.

If code P0756 is set, inspect the harness, and repair as necessary. If there's no damage to the harness, other possible causes include:

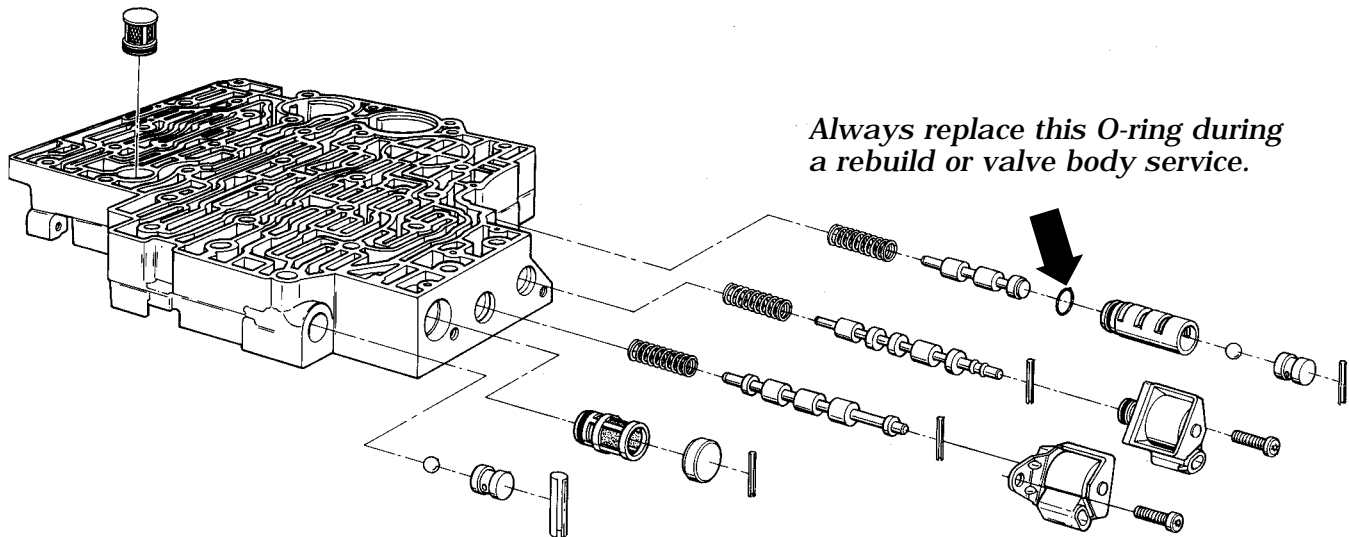
A second gear start complaint (that often goes away when you step on the gas) is often caused by poor shift solenoid A pressure. This can be caused by a leaking shift solenoid or poor feed to the shift solenoid.

One of the often overlooked areas for this leak is the O-ring on the #11 checkball capsule bushing. This bushing is located at the end of the 3-4 shift valve bore, and serves as a seal for solenoid A pressure. Always replace this O-ring during a rebuild or valve body service.

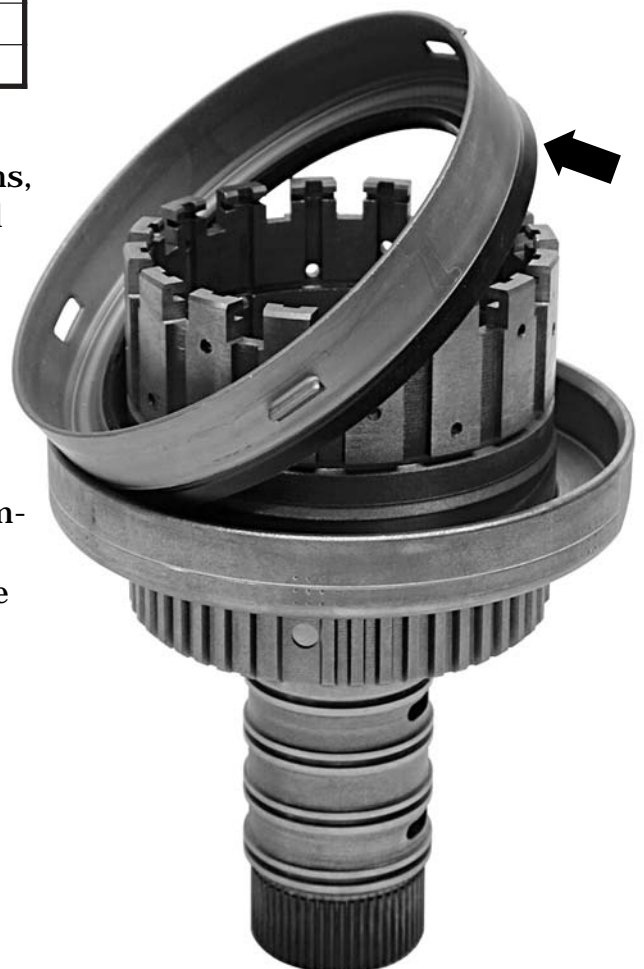
If line pressure readings are within specifications, inspect the direct clutch piston for possible seal delamination. If chunks of the seal are missing or if cracks are developing in the seal rubber, the seal is delaminating. The seal used in the direct clutch is a molded design; that is, the piston and seal are a one-piece assembly.

An upgraded molded piston has been released. You can identify the new piston by the part number molded into the rubber of the seal. Updated pistons have number 24205044 molded into the seal.

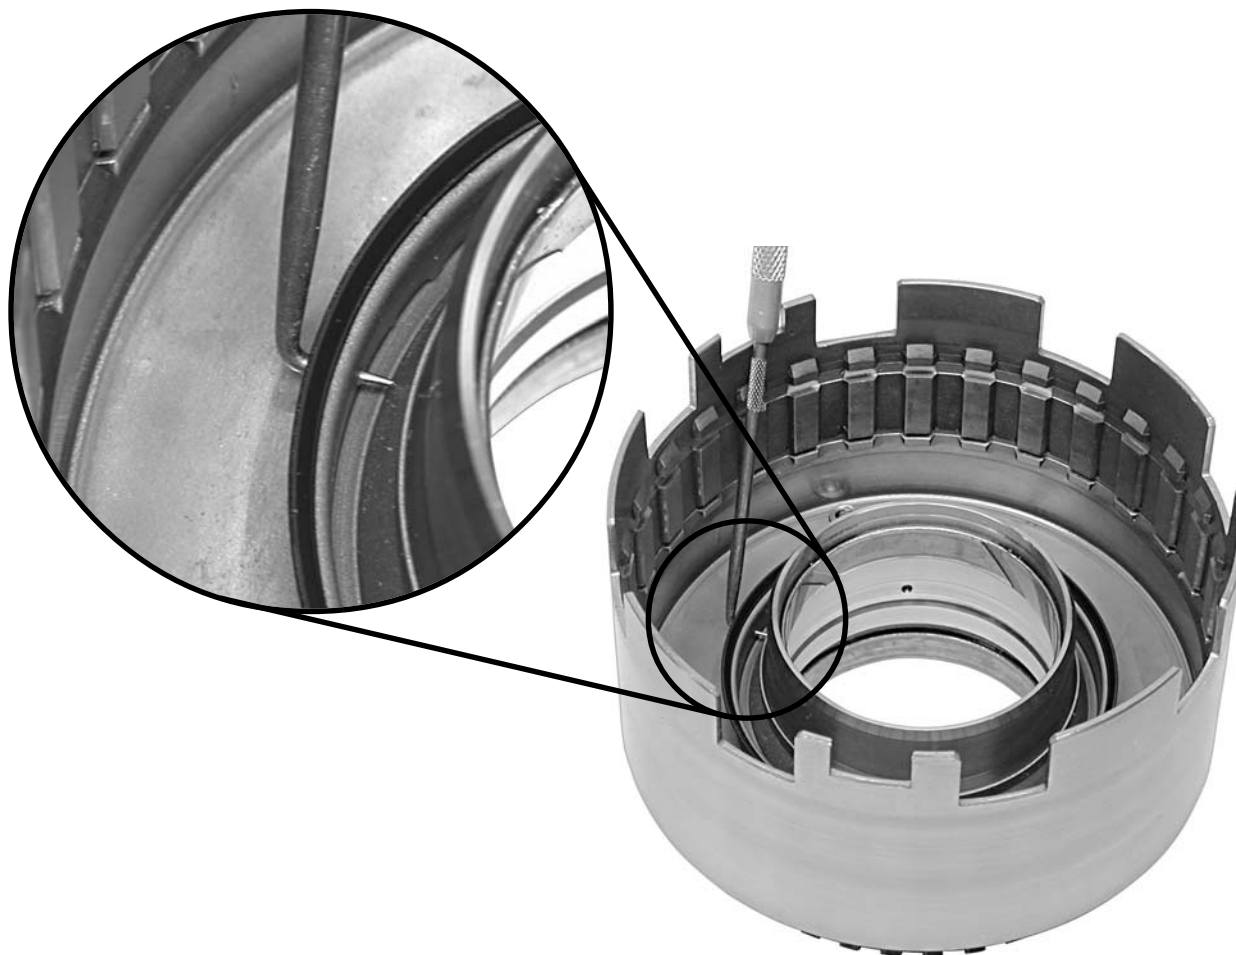
Check line pressure and the Pressure Control Solenoid (PCS) commanded status before disassembling the unit. If line pressure the PCS commanded and actual amperage readings are correct, check the orifice in the reverse input clutch center retainer and seal assembly. Make sure it isn't plugged, incorrectly sized, or missing. The orifice should be about 0.055" in diameter.

A problem at this orifice will prevent the reverse clutch from applying all the way, which can lead to slipping and cause the clutches to fail. The slip is caused by a reduced clutch clamping load as the outer diameter of the piston isn't being supplied with enough pressure. The GM part number for the retainer and seal assembly is 24205041.

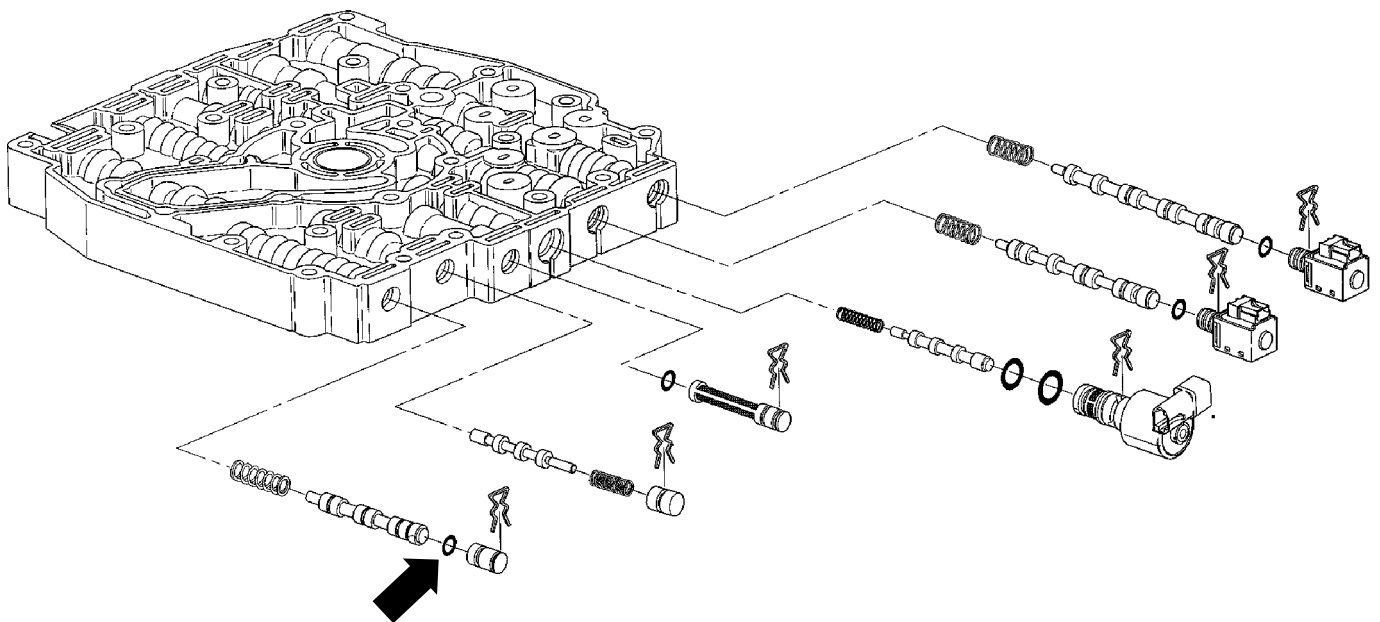
*A leak at this O-ring can cause 2<sup>nd</sup> gear starts.*

One of the often overlooked areas for this leak is the O-ring on the 3-4 shift valve plug. Always replace this O-ring during a rebuild or valve body service.

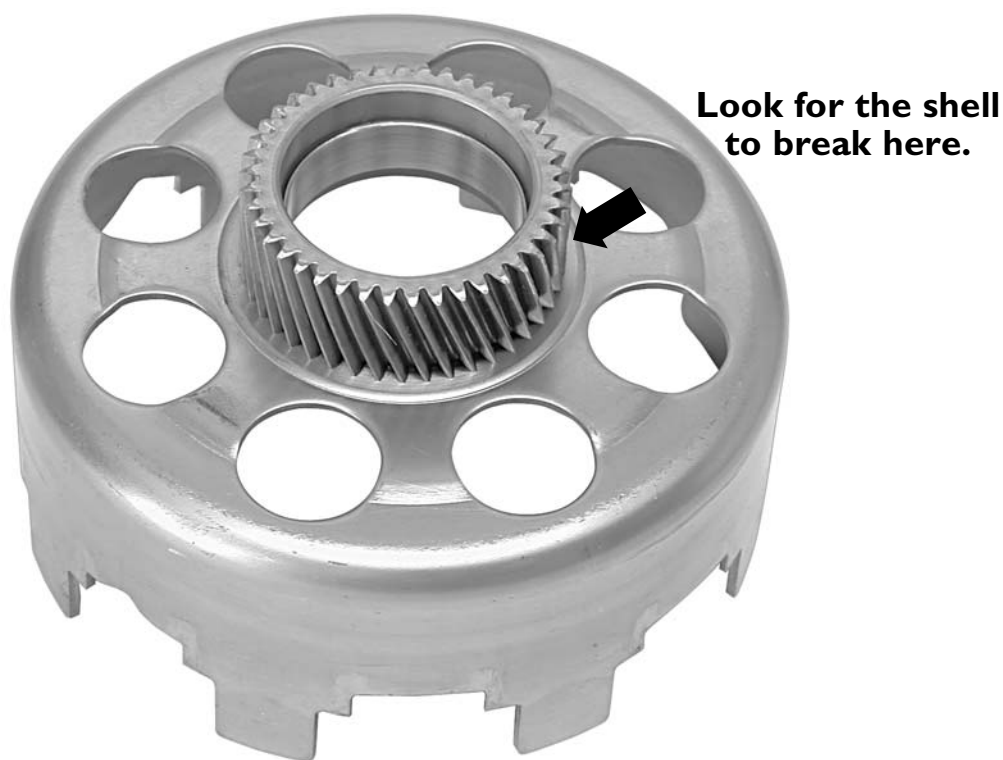
A common problem on 97-and-later 4T40E/4T45E applications is a lack of 2<sup>nd</sup>, 3<sup>rd</sup>, 4<sup>th</sup> and reverse gears. This is caused by a broken weld on the reaction sun gear and shell assembly. Typically the friction weld attaching the sun gear to the shell breaks, allowing the sun gear to turn free of the shell. To repair, replace the shell with an updated version. The GM part number for the revised shell is 24204471.

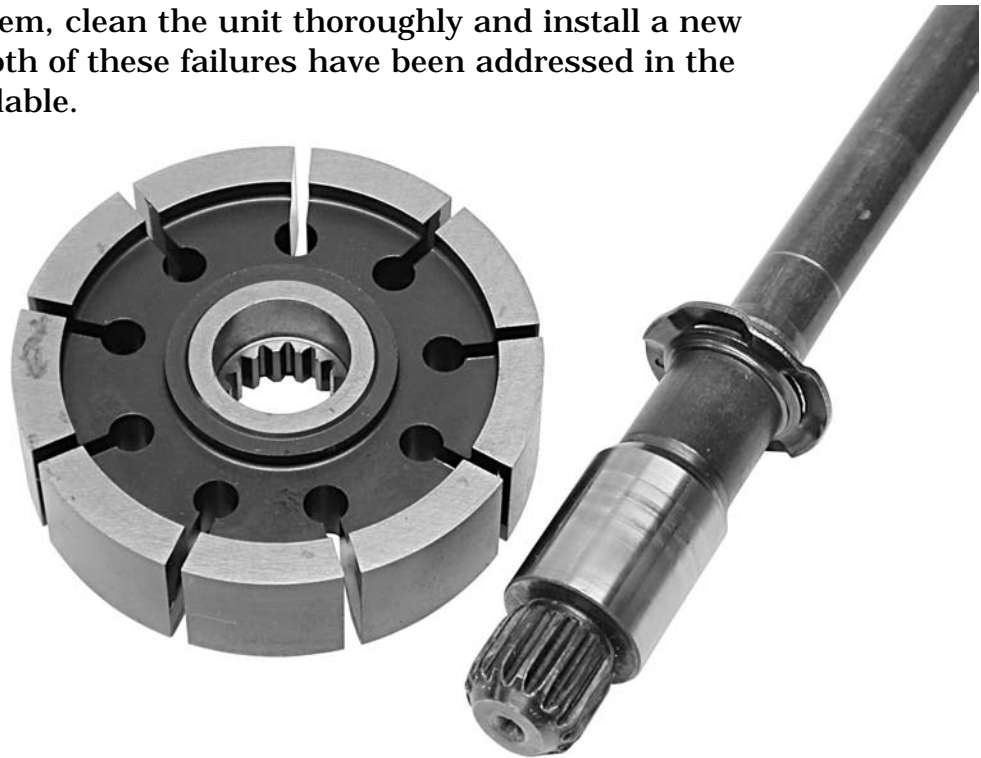
This problem is usually caused by a shattered or broken pump rotor, caused by one of these conditions:

- an improper heat-treating process during manufacturing.
- the spacer on the pump drive shaft came apart and got into the pump rotor.

To repair this problem, clean the unit thoroughly and install a new pump assembly. Both of these failures have been addressed in the service pumps available.

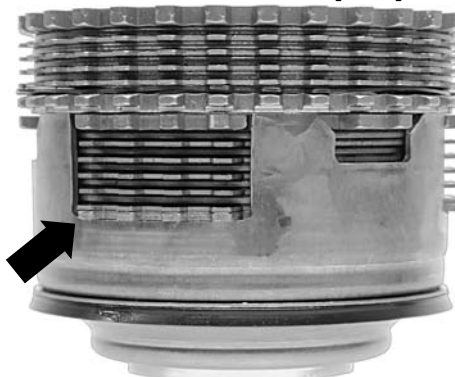
**Clutch Stacked Improperly**

One of the more common causes is a mismatch between the type of input clutch piston and 3<sup>rd</sup> clutch piston used. If you use 10-plate 3<sup>rd</sup> clutch components with an input clutch piston designed for 8-clutch 3<sup>rd</sup> clutch components, the input clutch piston will interfere with the 3<sup>rd</sup> clutches, causing the 3<sup>rd</sup> clutch to apply anytime the input clutch is applied.
