TECHNICAL SEMINAR

# *Automatic Transmission Rebuilders Association*

# *Program Contents*

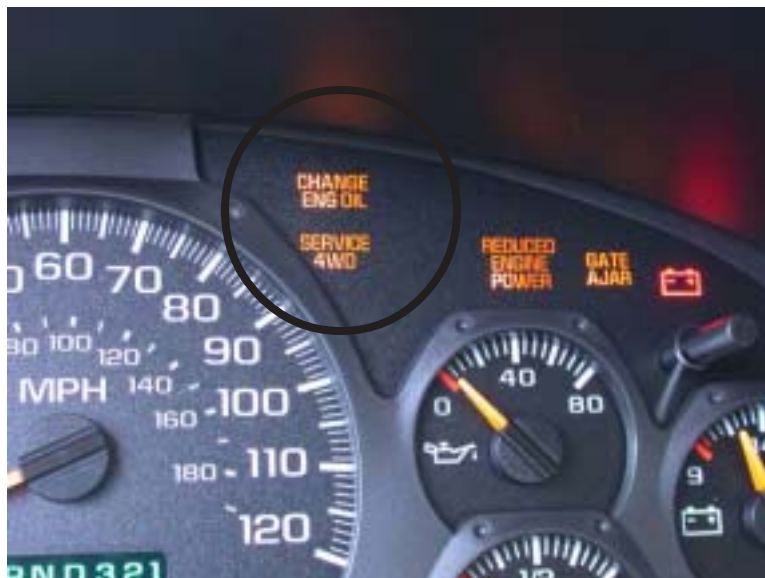
Once the DTC is set, the transfer case will not shift into 4WD. This condition may effect 1999-2003 Full size GM trucks and sport utility vehicles such as Silverado, Tahoe, Escalade, Yukon, Yukon XL, Avalanche and Suburban applications with the NV 246 transfer case (RPO NP8) and/or the 2002/2003 Trail Blazer/Envoy with the NV236 transfer case. In addition complaints of incorrect reading in the transfer case switch assembly is illuminated.

If B2725 is set the TCCM will:

- Â Inhibit 4WD
- Â Illuminate the 4WD light

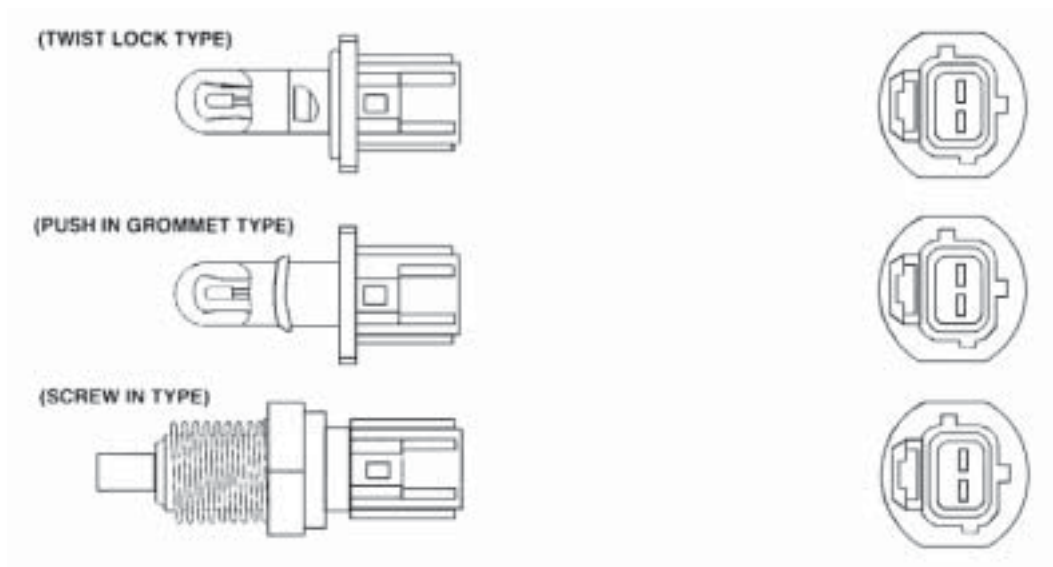
The most common causes of this concern are:

- Â Broken wiring, generally the wire is damaged at the sensor connector
- Â Terminal pin tension, terminal crimp damaged
- Â A faulty IAT sensor

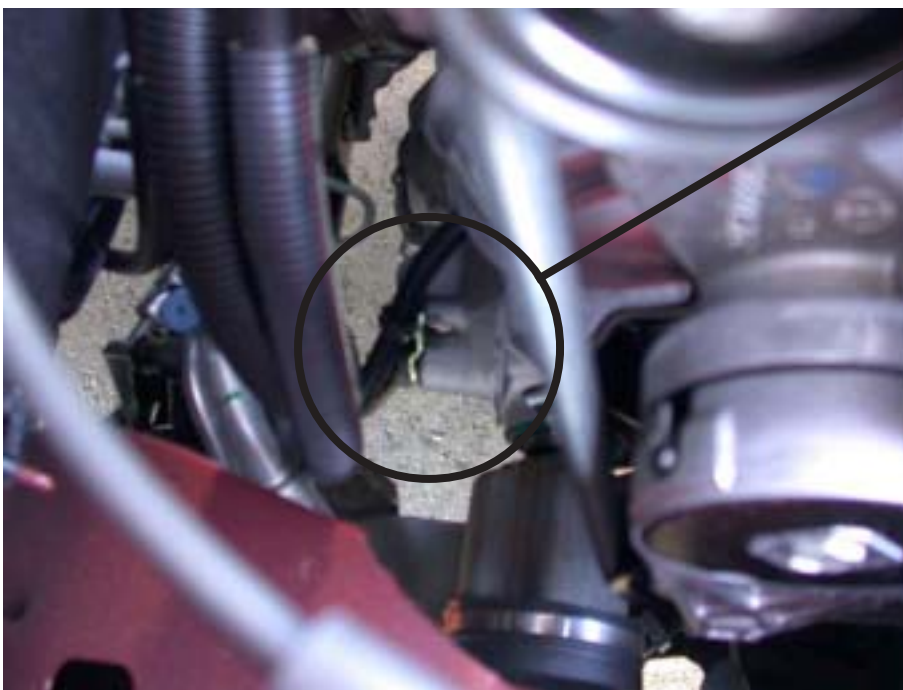
A common cause for this is the VSS harness being too long in the area of the right hand (passenger side) axle shaft area. The extra harness length allows the harness (circuit 400 and 401) to contact the axle shaft leading to harness chaffing and the intermittent complaint.

**VSS harness  
the right hand  
(passenger side)  
axle shaft area.**

Reposition the conduit for the wiring leg to allow clearance at the top of the engine rather than at the axle area. Secure the harness in the mounting clip.

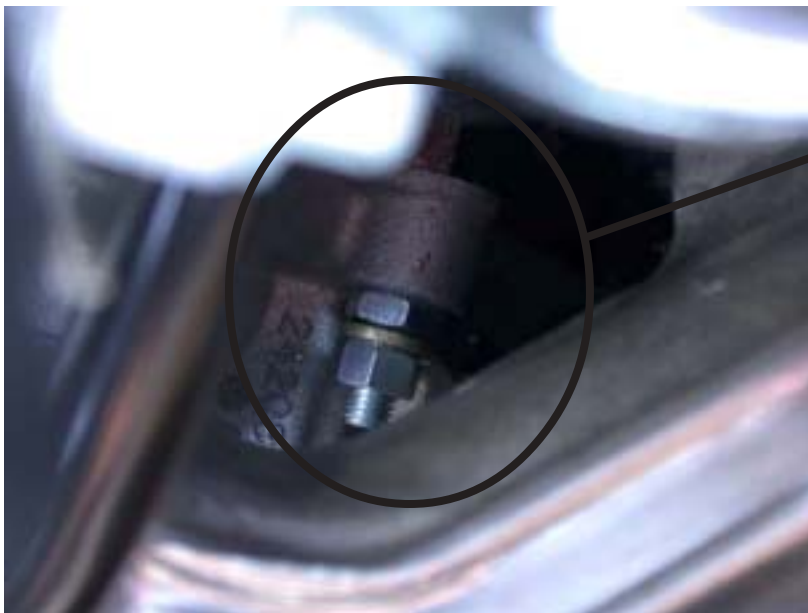
A common cause for these concerns are Ground G-103 being loose or corroded. Remove the ground from the bell housing. Clean and reinstall the ground. You may want to install a star washer to assure proper ground continuity. The ground strap is located on the right upper bell housing bolt on the drivers side.

**Located on  
the upper right  
hand side of the  
bell housing.**

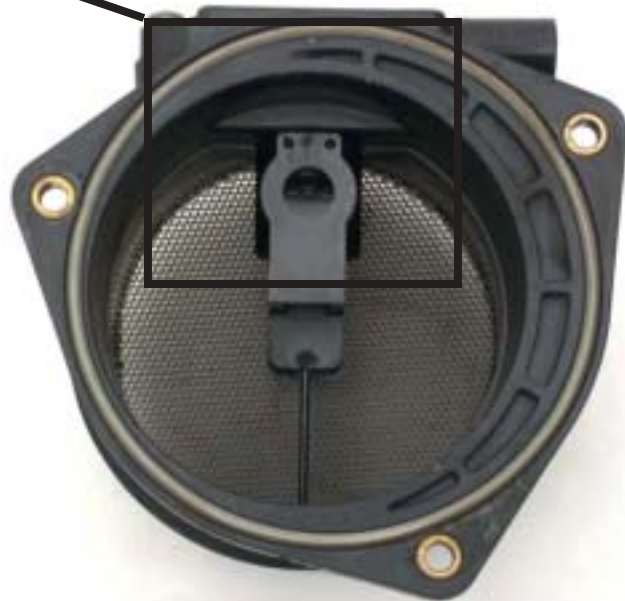
Skewed MAF sensors are quite common with these applications. Generally, fuel trim values will be around +20% when the surge is present. If this occurs, clean or replace the MAF sensor and clear any DTCs that may be set.

**Look for contamination  
in the inlet air hole**

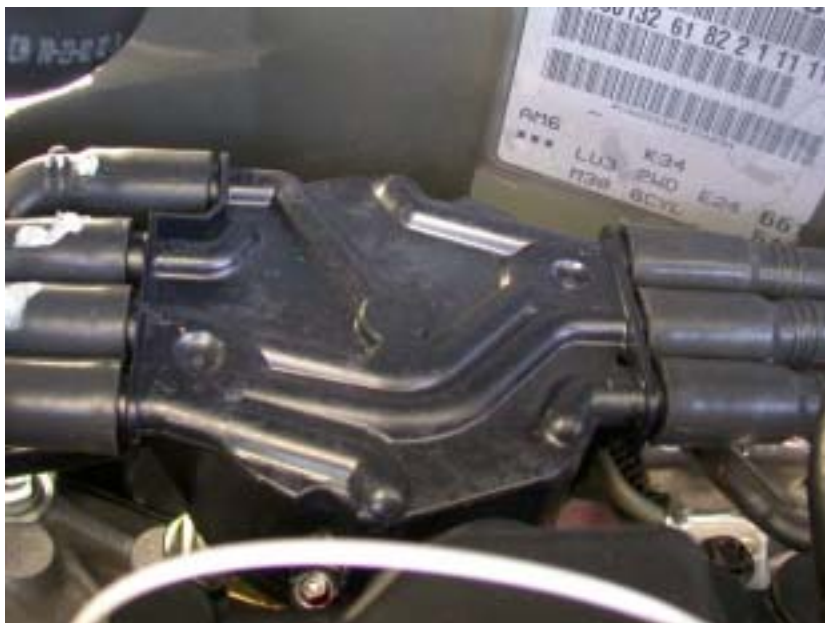
The problem is often caused by moisture leaking from the A/C line onto the distributor. On several of the applications, the A/C line is routed directly over the distributor. This moisture leads to corrosion, and crossfire within the cap.

⌘ White corrosion/residue on the cap wall, or on higher mileage units brown residue

**Locate the AC hose above the Distributor and install a foam conduit over the hose which will allow the water to drain off the sides.**

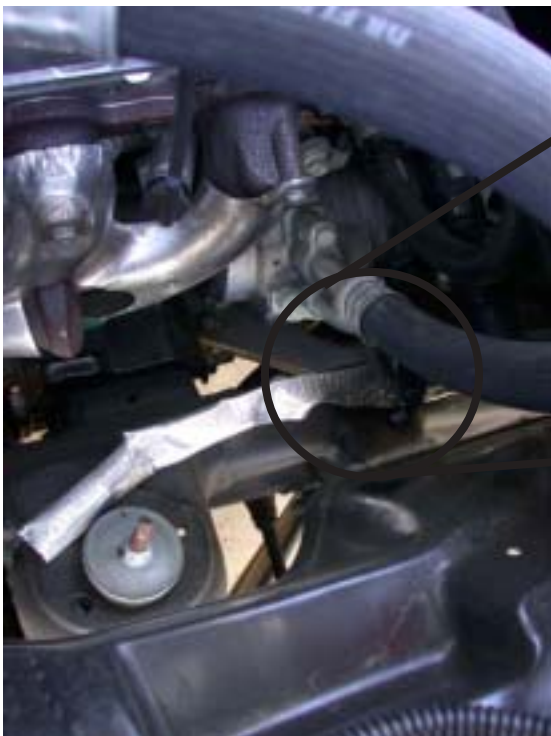
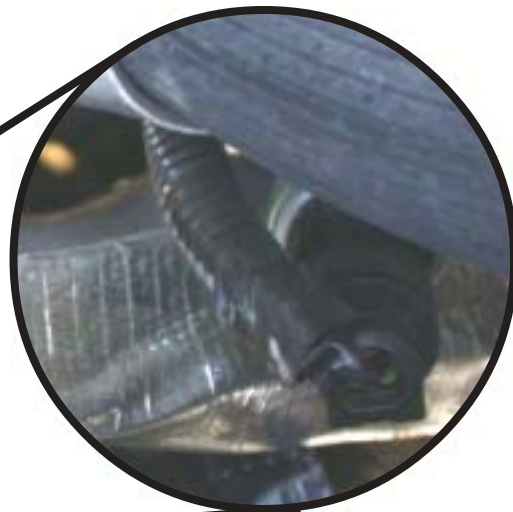
The wiring harness for the front axle circuit may be chafed near the A/C compressor.

**Secure the harness so it can no longer contact the A/C compressor.**

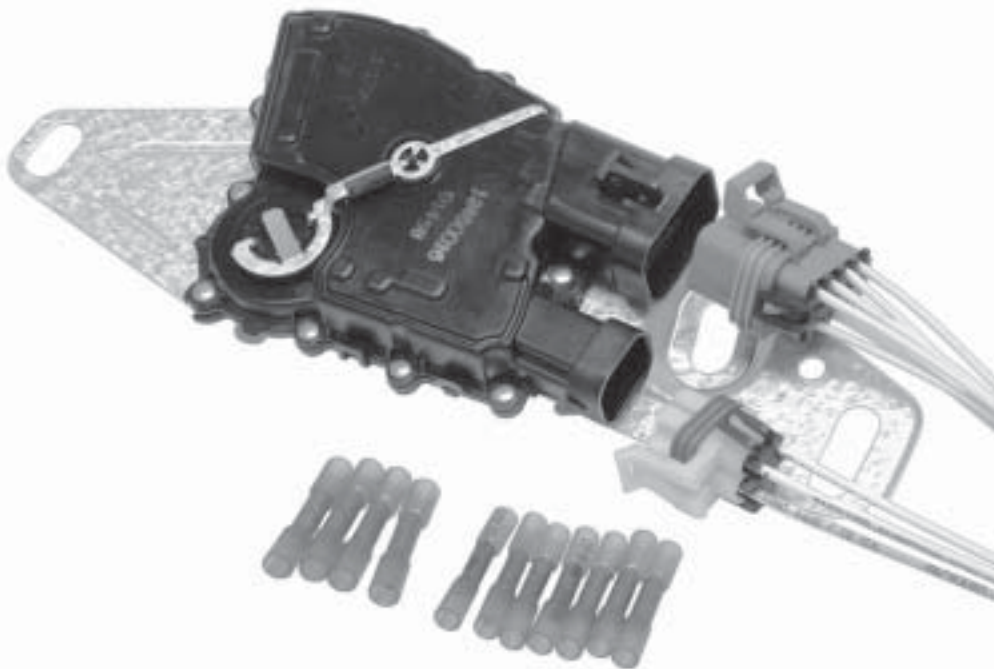
**NOTE: Always check the connections for melting and wire damage**

Before part repairs are done check the web site <http://calid.gm.com/vci/> for updated calibration to repair the false P0706.
