# **4T40E / 4T45E**

## ***Multiple Codes, Slips, Failsafe***

***DTCs P0753, P0758, P1860, C1223, C1224 or C1275***

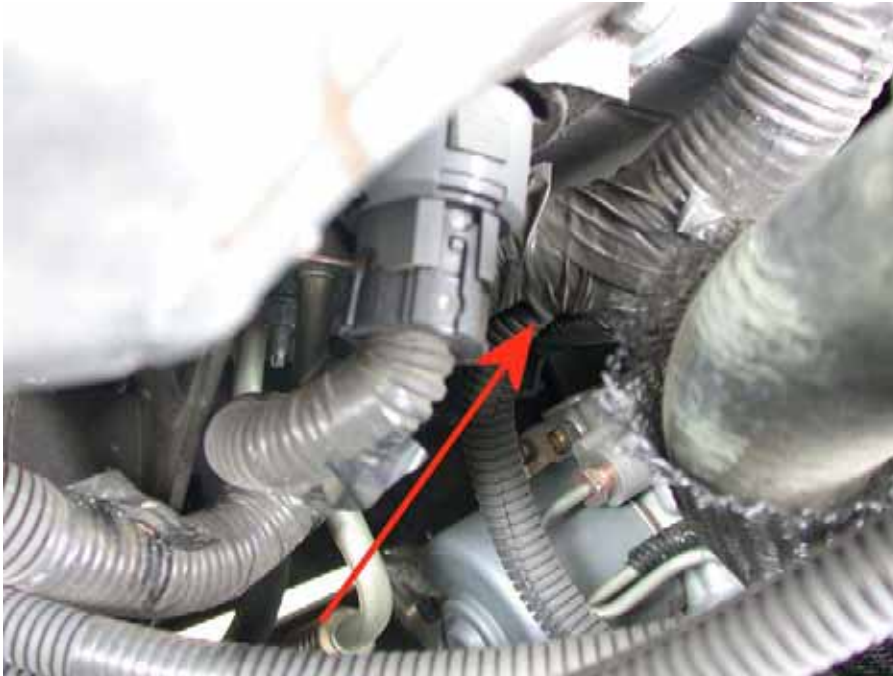
Possible water intrusion at the transmission to the front end vehicle harness. This harness is located near the transmission breakout and is protected by plastic split tube type conduit and electrical tape. In some cases, the split may be facing upward which will increase the tendency of the conduit to hold water. Eventually, the #107 splice to the transmission may become corroded and become non-conductive.

Locate the conduit for the transmission breakout directly above the transmission oil cooler lines. Remove the electrical tape wrap from the plastic conduit and peel the conduit open. With the conduit open, examine the splices inside for signs of corrosion. Splice #107 (part of circuit 439, PINK) is located approximately 13 in forward of the transmission breakout point. Examine the splice for signs of corrosion. If corrosion is found, repair the splice. Use only a GM Crimp and Seal splice. Strip back the wire until clean, non-corroded wire is available.

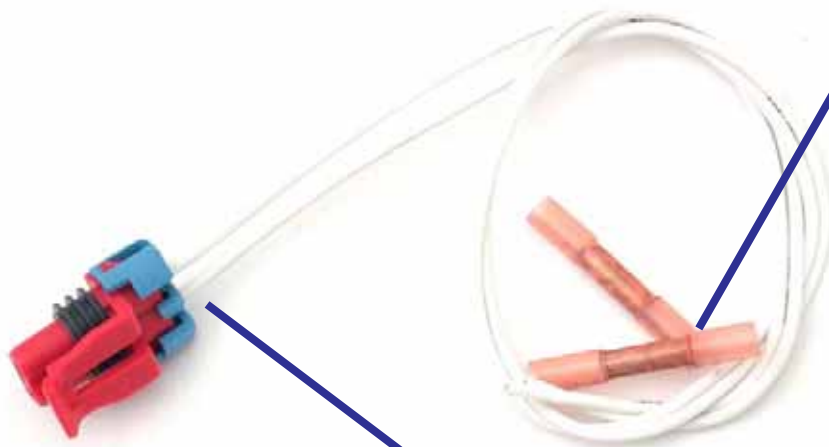
Cause #2 The Evaporative Emissions Canister Vent Solenoid retainer may have come loose, allowing the associated wire harness to contact the axle. Abrasion of the wire against the axle may rub through the insulation creating a short to ground.

1. The Evaporative Emissions Vent Solenoid is retained by a molded in, plastic extension. The retainer has molded in ridges that create an interference fit to the underbody. Under some instances, the retainer may have not been fully seated when installed.
2. Remove the jumper harness from the Evaporative Emissions Vent Solenoid and repair the harness as necessary.

**Connector, GM Crimp n' Seal Butt End Part# 12089189**

**Connector, Body Harness Extension Part# 12101858**

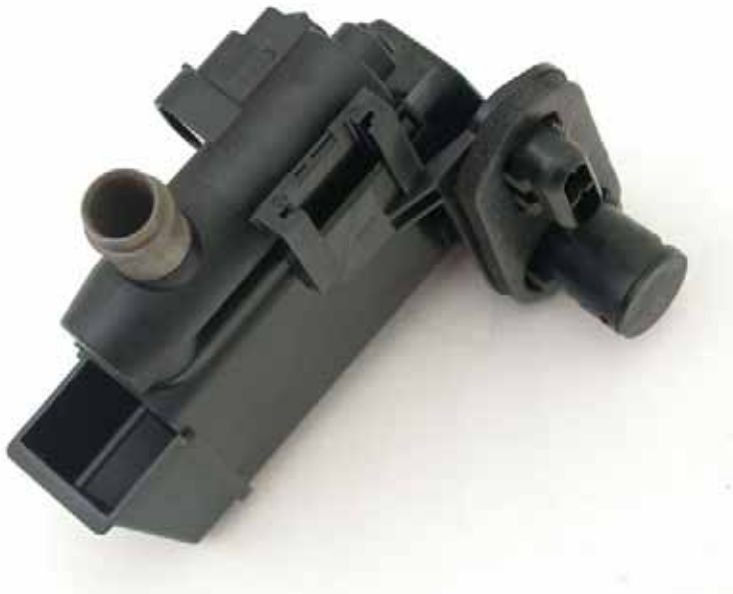
The fastener style used to retain the Evap vent solenoid does not click when properly installed. This is normal, try to seat the fastener as deeply as possible without using excessive or damaging force.

Inspect the retainer for damage. Additionally, examine the solenoid body for any signs of damage. If the retainer and solenoid body appear in good condition, verify that the fastener holds properly by pulling on the solenoid body to check that it is retained. If the fastener will not retain properly or there are signs of damage, replace the Evap Vent Solenoid.

Discard and replace the jumper harness with P/N 12101858, lower the vehicle and clear all DTCs.

**Part Number**  
**22622022**

**Description**  
**Valve, Evap Canister Vent**
