# A4AF3, A4BF2

## Harsh 2–3 or 2–3 Slide-Bump

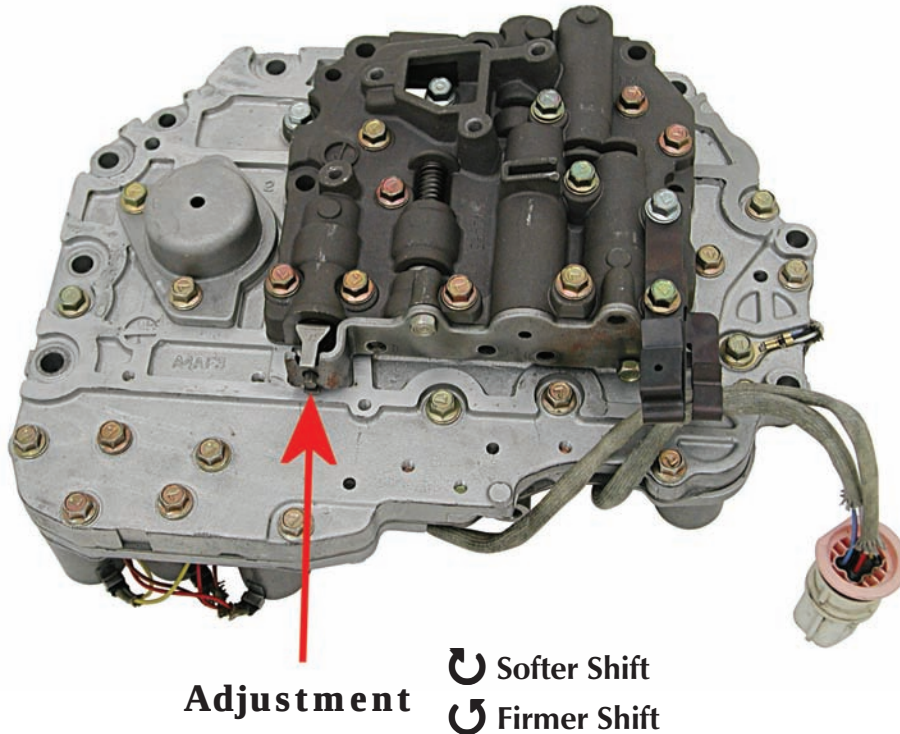
Most harsh 2–3 shift complaints on KM series transaxles are caused by the friction material or *low* shifting pressure. The harsh shift or bump that you feel is caused when the end clutch applies. Normally the end clutch applies *after* the front clutch completes the 2–3 shift. If the 2–3 shift isn't completed when the end clutch applies, you'll get a bump. As the front clutch engagement gets worse, the harsh shift or bump gets worse.

To fix this, try increasing reducing pressure. Start with about 1½ turns counter-clockwise. In most cases this'll fix the problem. If not, try increasing it a bit more. Keep in mind, increasing reducing pressure will make the 1–2, 3–4, and converter clutch applies more aggressive.

If these other shifts aren't too aggressive you can increase reducing pressure until the 2–3 complaint is gone. Otherwise, you'll need to replace the friction material in the front clutch.
