# A4AF3, A4BF2

## *Failed End Clutch Hub Bearing*

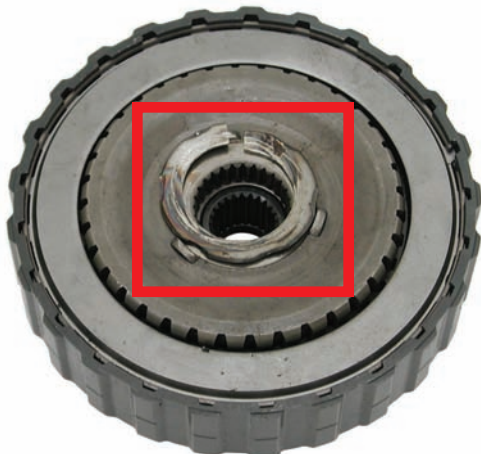
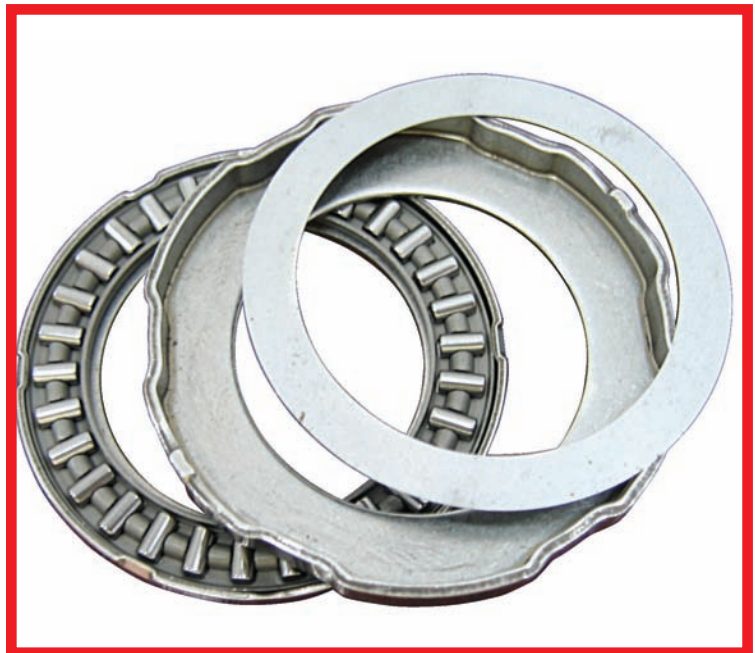
This may be the most common mechanical failure on this transaxle. There are three main causes for this:

1. The end clutch hub bushing wears out, allowing side movement of the hub and an uneven load on the bearing.
2. Too much clearance between the end clutch hub and bearing, allowing the bearing to move out of place.
3. High line pressure, placing a greater load on the bearing.

**This bearing damage indicates a worn hub shaft bushing.**

**Always replace the  
hub shaft bushing  
with a babbitt-style  
bushing.**

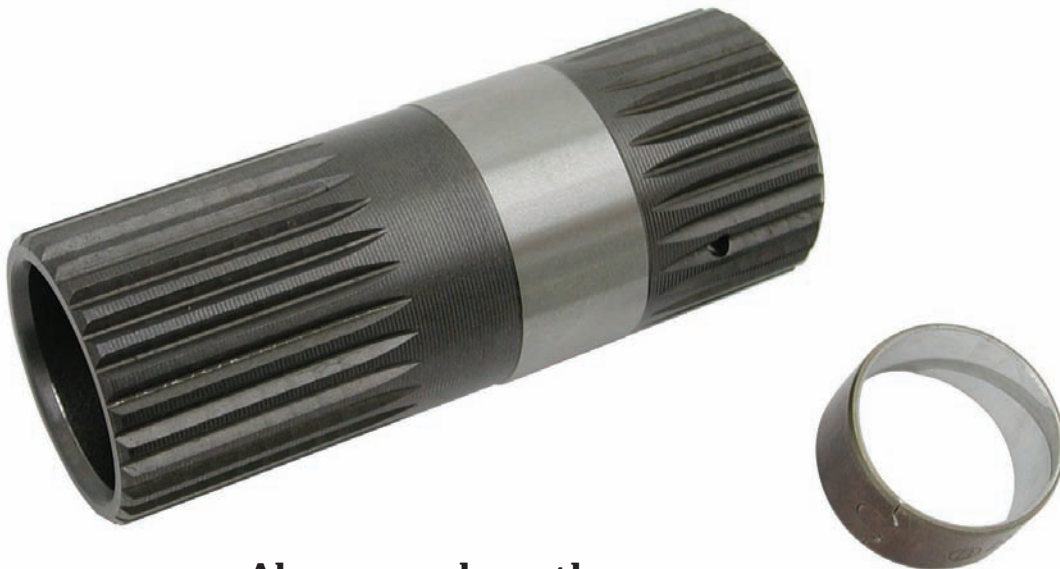
Since there's only one sealing ring on the end clutch drum, line pressure pushes the end clutch drum toward the bearing anytime it's pressurized. Unfortunately, Hyundai increased the sealing ring size for this unit, and consequently, increased to load caused by this affect by 40%. Maximum line pressure should not exceed 130 psi. However, it is not uncommon to see pressure at the end clutch as high as 150 psi. 150 psi results in a load of 639 lbs of force on the bearing, compared to 554 lbs of force at 130 psi (a difference of 85 lbs of force). If your line pressure is higher than 130 psi adjust it down at the pressure regulator adjustment on the valve body. A good target is between 125 and 130 psi.

Try to keep the clearance between the end clutch hub and bearing below 0.020". Aftermarket shims are available for this. To check the clearance simply use an H-gauge.
