4L60/65/70E

Hard/Erratic Shifts, DTC P0716 and/or P0717

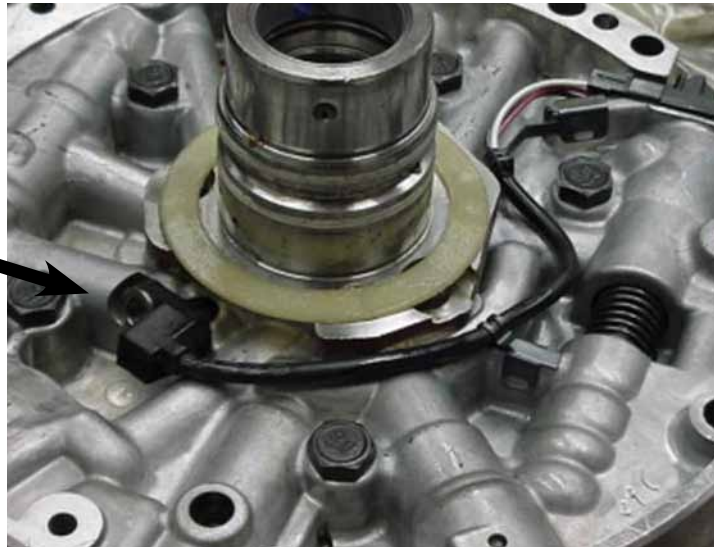
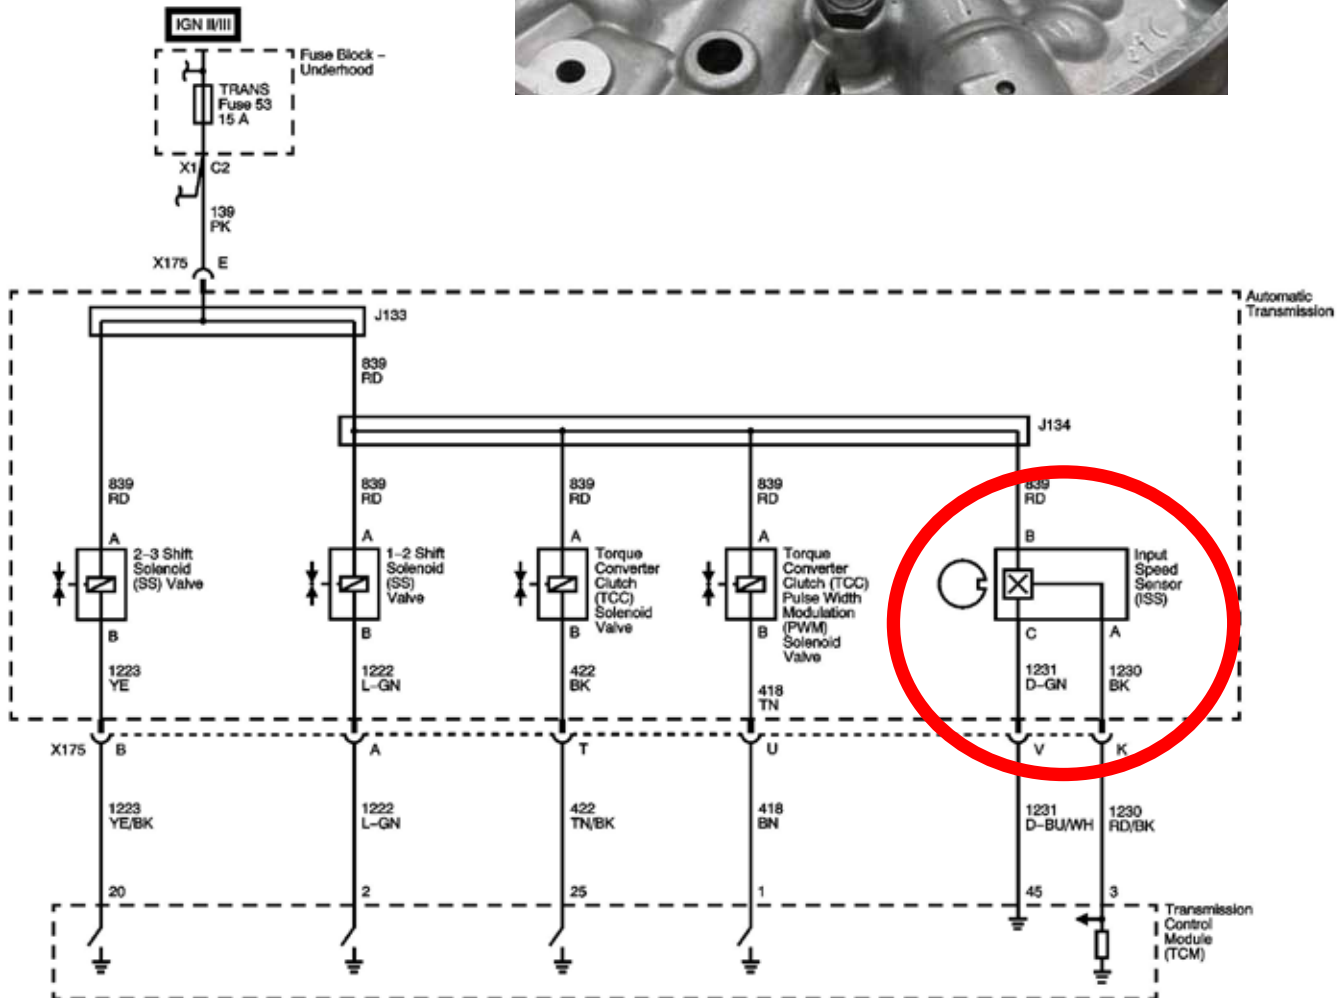
Input Speed Sensor wiring

One common cause for P0716/P0717 DTC has been the input speed sensor wiring. The sensor wiring has been known to short to ground on the pump assembly. Part of the ISS wiring is not shielded in conduit. Casting flash can lead to the sensor shorting to ground on the pump. If either the sensor signal circuit or the sensor voltage feed circuit short to ground, the sensor will not function. If you find the sensor wiring damaged you will need to replace the sensor and dress the sharp edges on the pump that caused the damaged.
