General Motors

6T70/6T75 DTC's P0752, P0872, P0877, P0989

GM L body (RPO MH2, MH4, MH6, MY9) (Terrain, Equinox, Vue) R/V body (Traverse, Enclave, Acadia) Z body (Malibu, G6, Aura) applications equipped with a 6T70 or 6T75 transaxle may experience DTC's that relate to the fluid pressure switches located in the TEHCM (TCM).

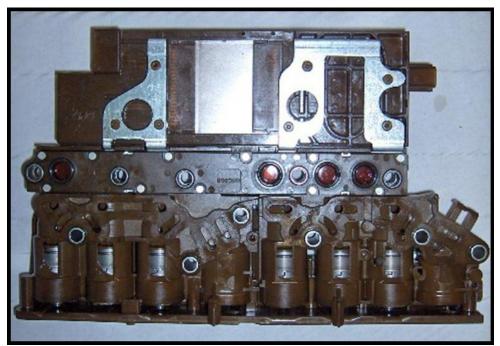
The DTC's can include any or all of the following, P0752, P0872, P0877 or P0989.

P0752 will set if:

- The transmission has achieved 1st locked, 1st free-wheel, or 2nd, the 4-5-6/R1 pressure switch is pressurized, 3rd gear is commanded, and gear box slip is 400 RPM or greater for 2.0 seconds, 5 times.
- The ignition voltage is 8.6 volts or greater.
- The engine speed is 400 RPM or greater for 5.0 seconds.
- The high side driver is enabled.
- The throttle position signal is valid.
- The output shaft speed is greater than 0 RPM, or the throttle position is greater than 0.5%.
- The TFT is -7° C (19°F) or greater.
- DTC P0101, P0102, P0103, P0106, P0107, P0108, P0171, P0172, P0174, P0175, P0201, P0202, P0203, P0204, P0205, P0206, P0207, P0208, P0300, P0301, P0302, P0303, P0304, P0305, P0306, P0307, P0308, P0401, P042E, P0716, P0717, P0722, P0723, or P182E are not set.

To repair any or all of these concerns, remove the TEHCM from the vehicle and inspect the suspect pressure switch for debris. Inspect the pressure switch for a delamination problem. Units with 50,000 miles or more, have displayed issues with the pressure switch membranes coming apart leading to the DTC's. If the pressure switch is delaminating you will need to replace the TEHCM (TCM with valve body).
