# 6L80/6L90

## Slips in Reverse, 3rd, 5th P0776 Possibly Set

6L80 (RPO MYC) and 6L90 (RPO MYD) transmissions equipped in the GM C/K full size trucks and SUV's, Cadillac D body (STS-V) and the Cadillac/Chevrolet Y body (XLR, Corvette) may experience any or all of the following complaints.

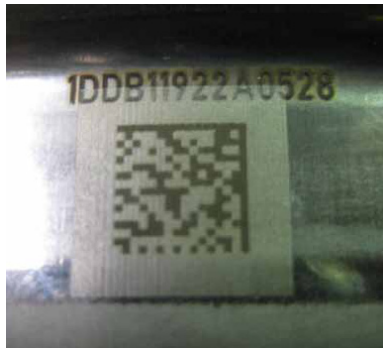
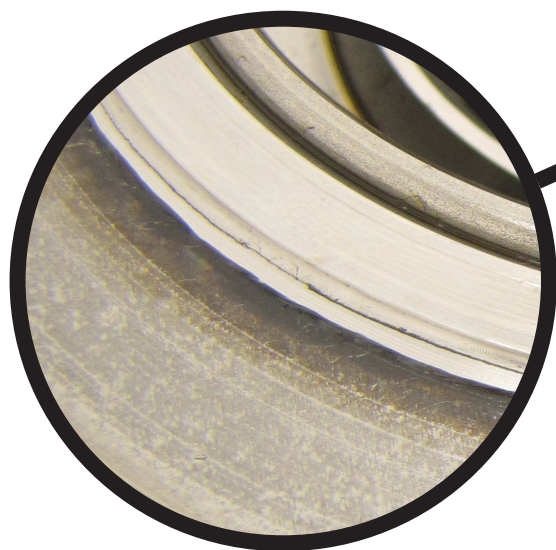
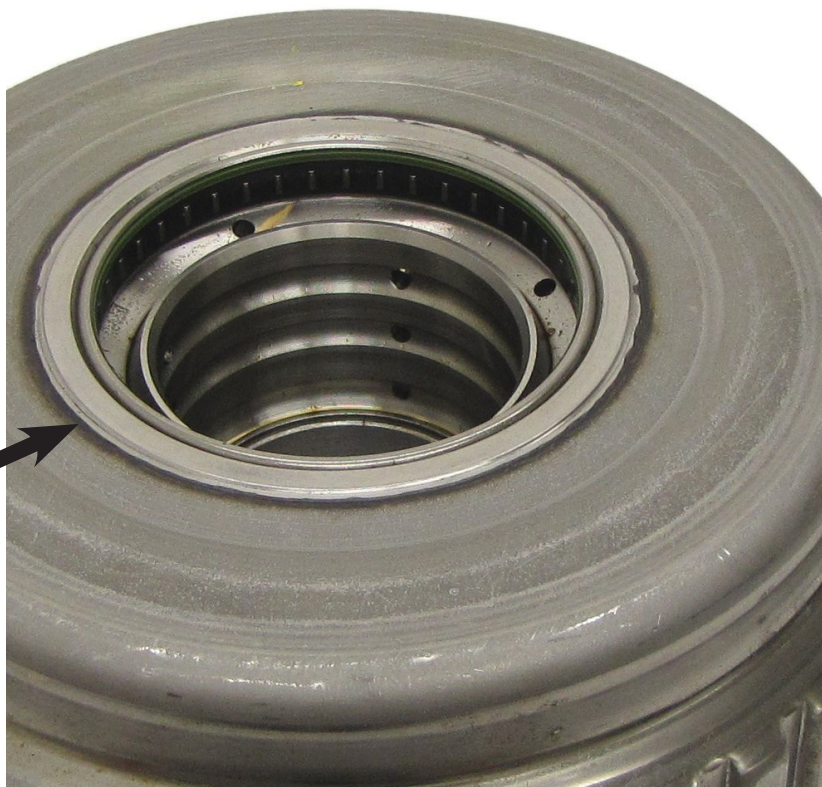
Cracks have been found in the 1-2-3-4/3-5 reverse housing that can cause any combination of the complaints listed above. The cracks effect the 3-5-reverse area of the clutch drum and they can change severity with temperature and input torque changes.

Always inspect the drum for cracks both visually and with a soapy water/air test. In addition, the suspect drums can now be identified by looking for a DOT MATRIX stamping on the housing that indicates that you have the updated housing. If you do not find the stamping, you must inspect the housing for cracks as that housing was manufactured prior to the supplier change.

**NOTE:** When replacing the 1-2-3-4/3-5-reverse housing make sure that the bearing that supports the housing is installed in the new replacement housing. Some early replacement housings from GM did not contain the bearing. The current housing includes the bearing so this should no longer be an issue. If the bearing is not present shift feel problems will occur.
