2013 TECHNICAL SEMINAR

**2013 TECHNICAL
SEMINAR**

The
Automatic Transmission
Rebuilders Association

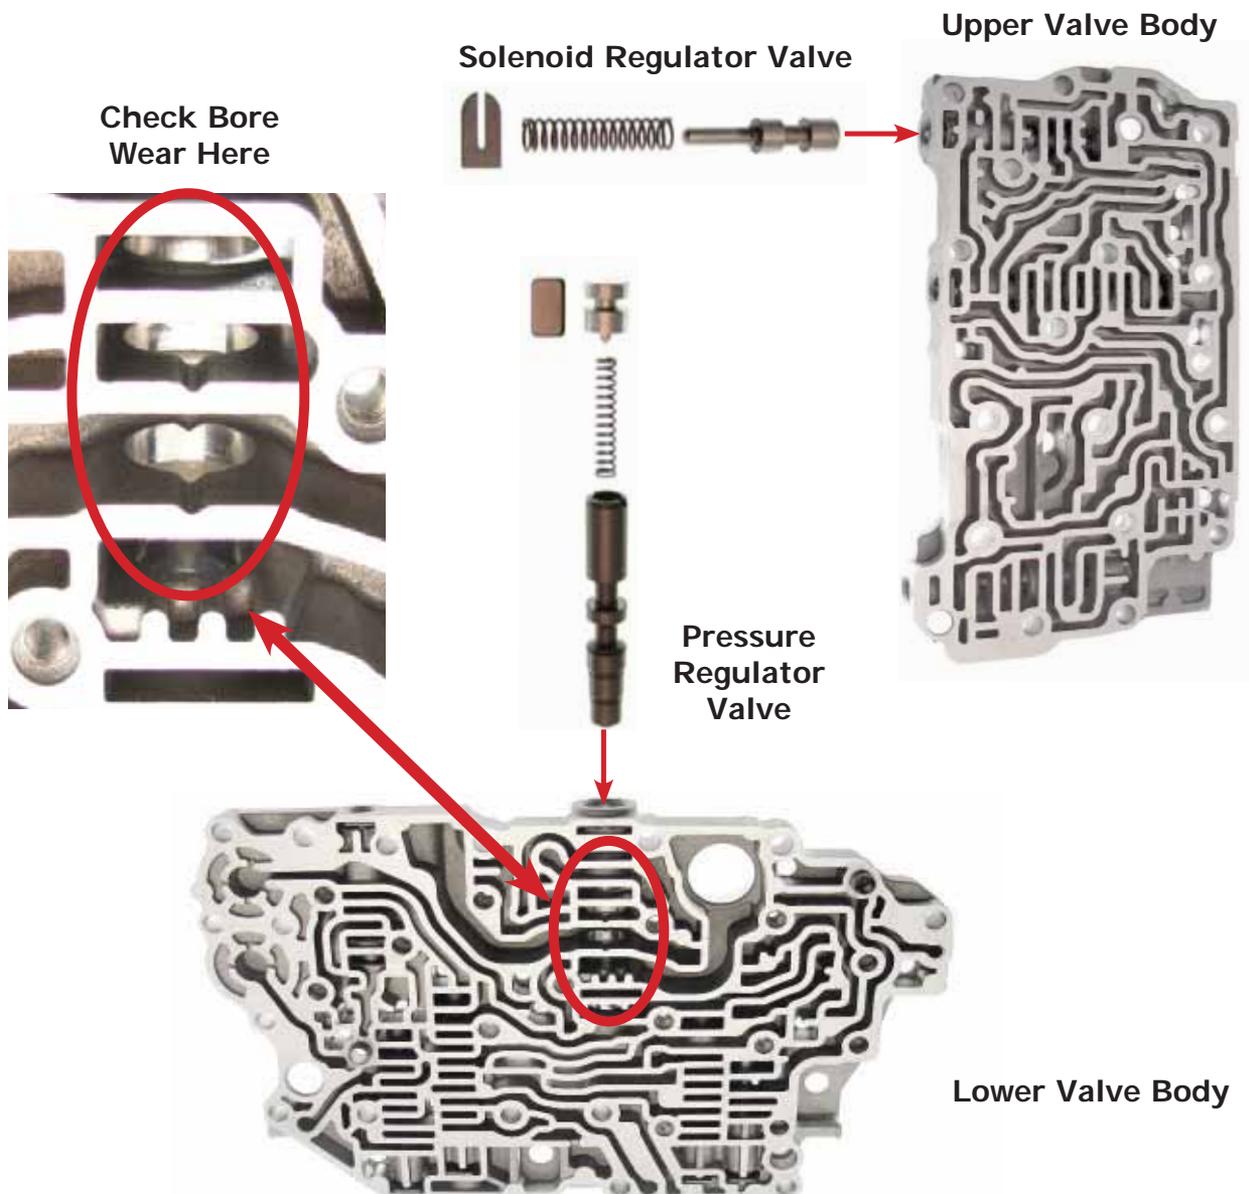
Remove the valves shown. Carefully inspect and test the valve bores. When you look closely, you can see the ridge that is formed from excessive bore wear. If the transmission is on the bench it's advisable to sleeve the servo pin bore. Be sure to check the FNR5 for similar wear problems.

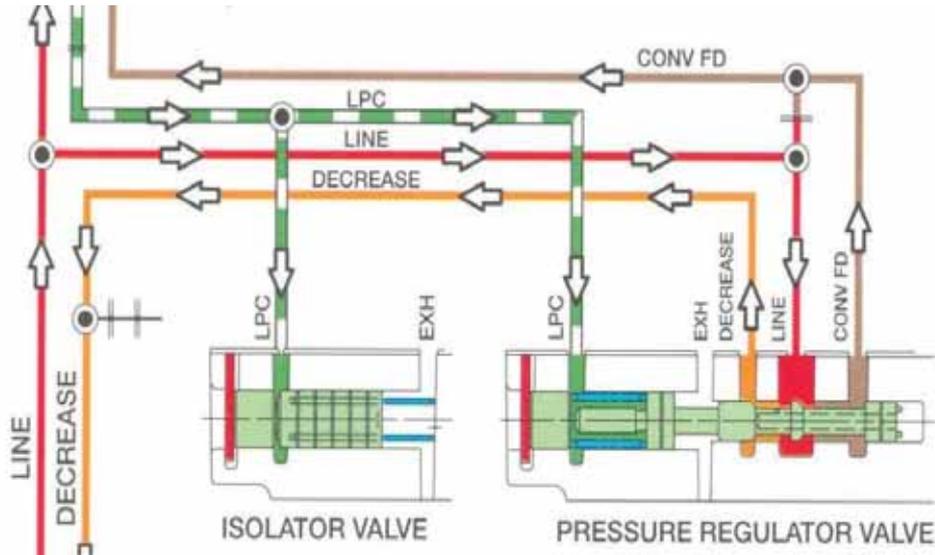
The isolator valve is really an accumulator for the line pressure control (LPC) circuit. The isolator valve smooths out the pulses from the LPC solenoid.

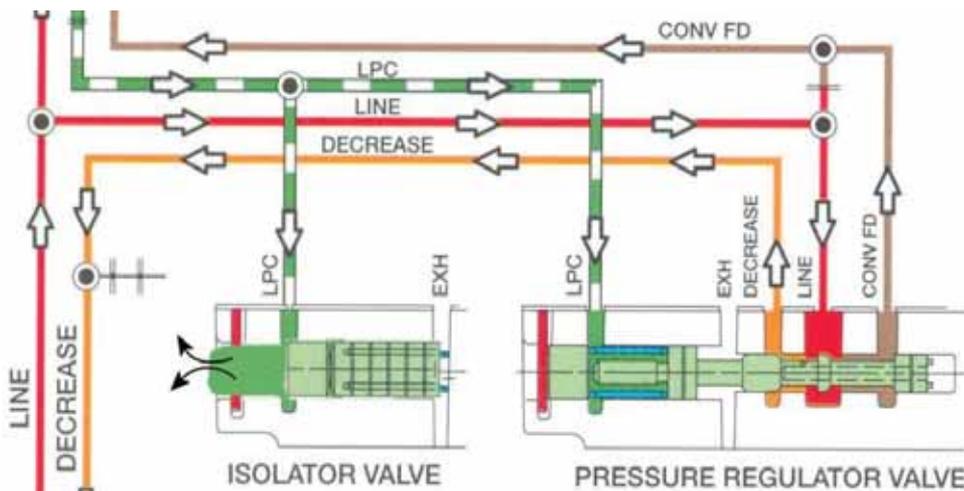
When the isolator valve spring breaks the end plug has room to move towards the middle of the valve body. This allows LPC oil to exhaust back into the sump and cause low line pressure.

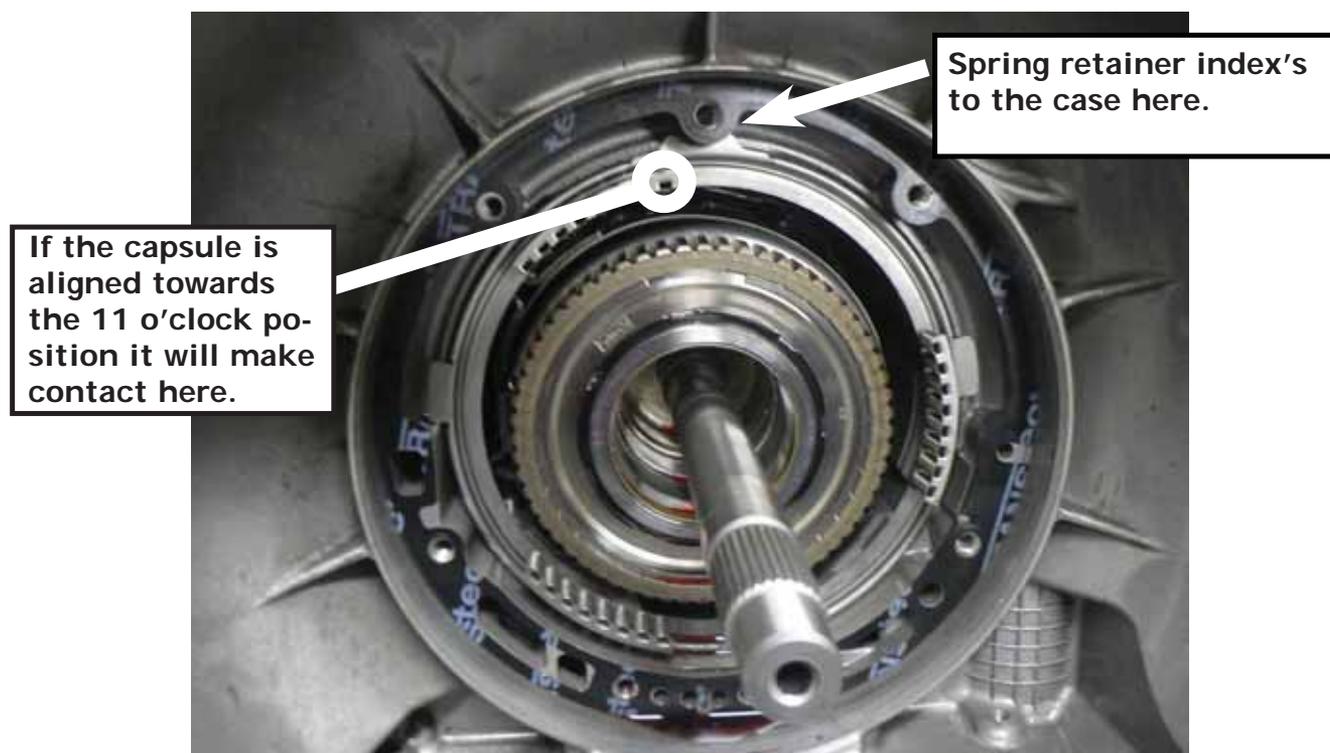
A slip into 2nd gear at medium to heavy throttle or no 2nd gear apply at all after rebuild may be caused by intermediate air bleed capsule misalignment.

The air bleed capsule in the intermediate piston must be properly aligned in relation to the spring retainer. If the bleed capsule is not at the 12 o'clock position it may come in contact with the spring retainer. This will push the capsule out of the piston and cause 2nd gear problems.

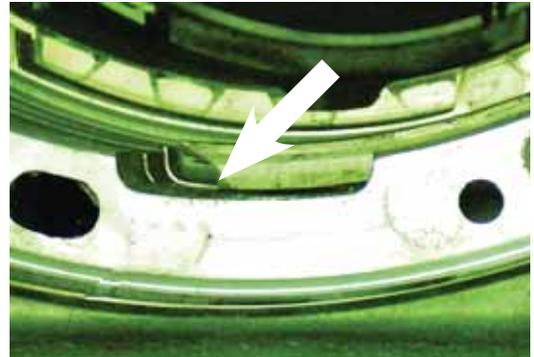
**Incorrect Snap Ring Location
This Area Must Be Kept Open**

When you install the plate in the case, the extended tab is supposed to face the valve body, or the 6 o'clock position with the flat side up. If you don't place the snap ring opening in the proper location during a rebuild (incorrect installation shown below), the O/D clutches will mechanically lock when you bolt the pump to the case. If you make this mistake, you'll have no choice but to remove the transmission from the vehicle and correct it.

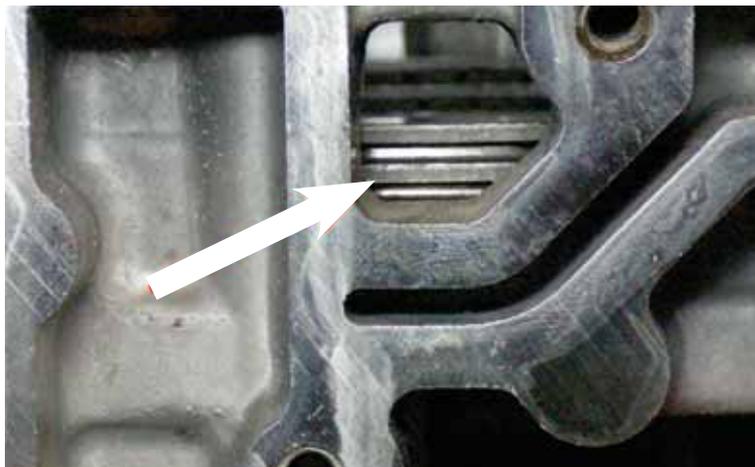
You can see the clutches through a small opening in the main case. You can check the clutches for free play through this opening with a scribe or thin screwdriver. You should feel noticeable movement in the clutches and steels to verify that they aren't clamped down.

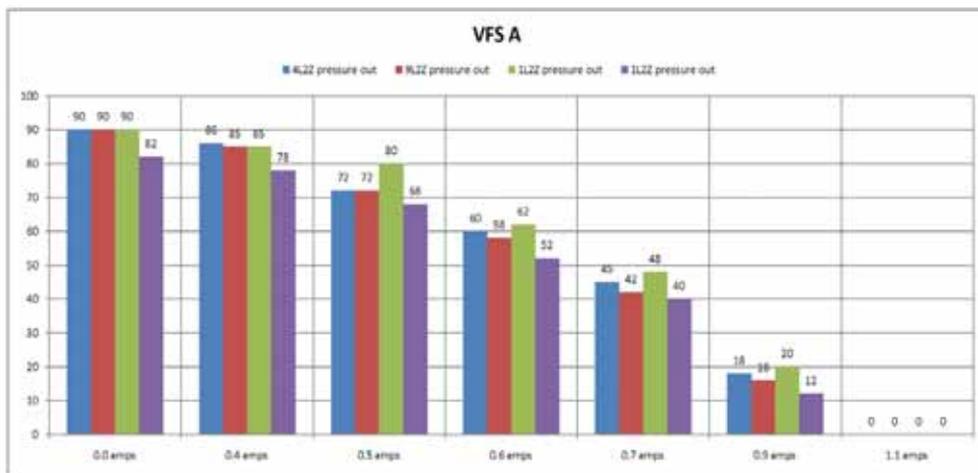
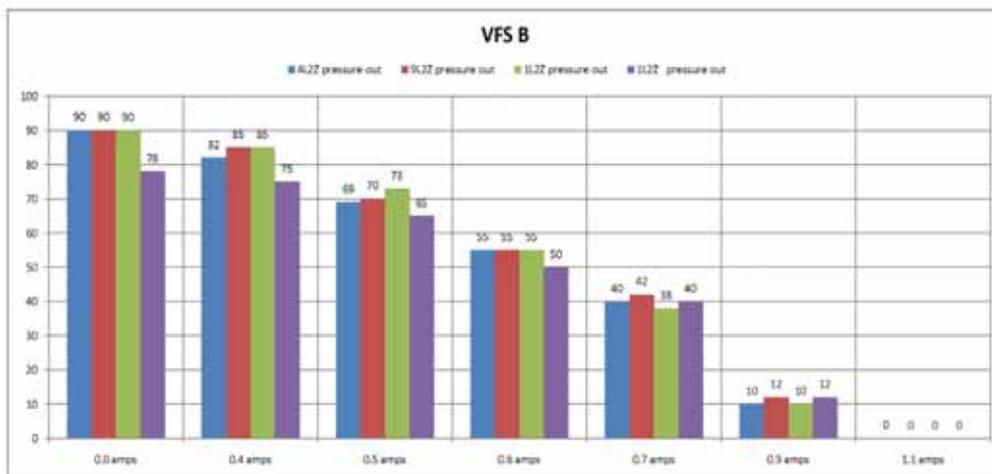
After many tests and countless hours reading hydraulic schematics, measuring valves, and applying the math. We discovered; there's a slight difference, but a difference nonetheless in solenoid output. When we tested the PCA solenoids from the different solenoid packs, we found that at 0.6 amps, there was a 4 psi difference.

That doesn't sound like much but it becomes a big deal when it comes to overall pressure in the system. The 4 psi difference equates to about 30 psi of mainline pressure, enough to cause the problems we've been encountering. In nearly every case, replacing the solenoid pack corrects the problem.

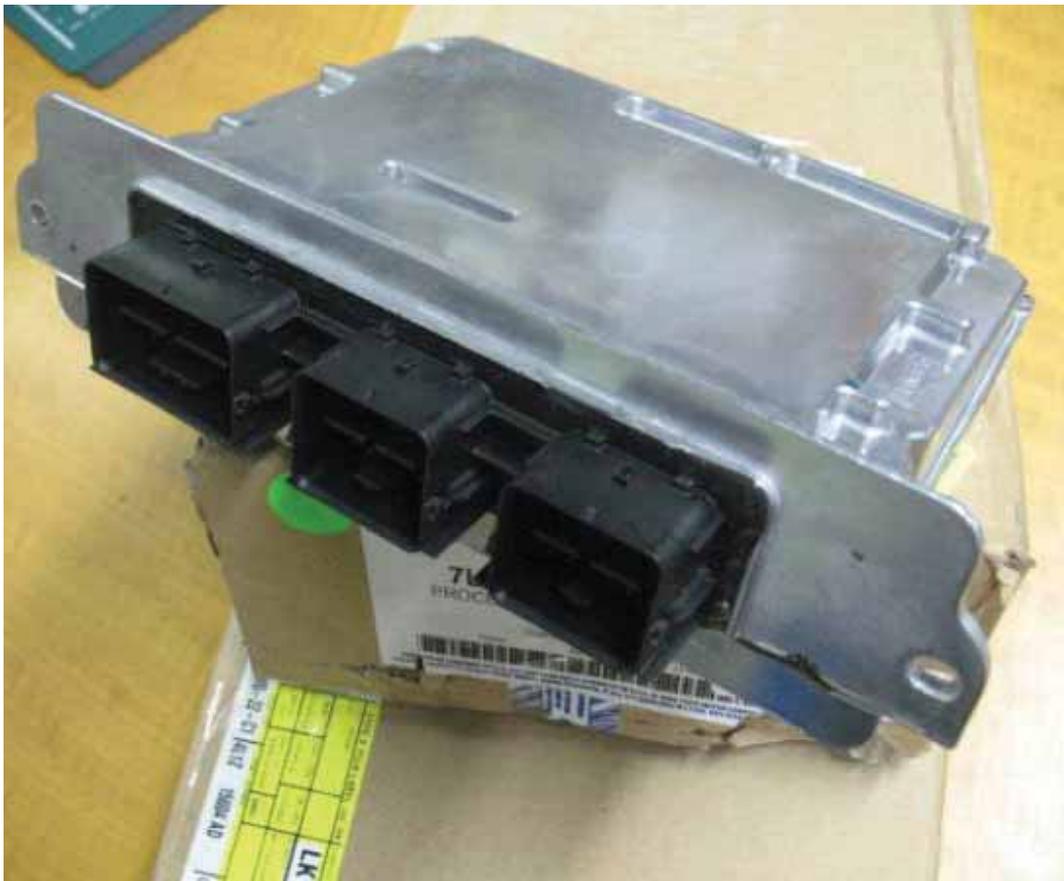
Complaints of a harsh shifts, engagements and/or erratic shuttle shifts found on 2003-04 Lincoln LS and Aviators only. There may or may not be codes set, such as P1744.

The ECM's have been reflashed on several of these vehicles but it doesn't fix the problem. The module connections were inspected closely for corrosion and no problems were found. The valve bodies were also changed without any luck.

When line pressure was checked on the driver's side tap it was extremely high. In some cases the module was tapped with a large screw driver and pressure dropped and shifts were normal. At times the pressure may only drop and rise back up. In these cases only a new module corrected the problem.

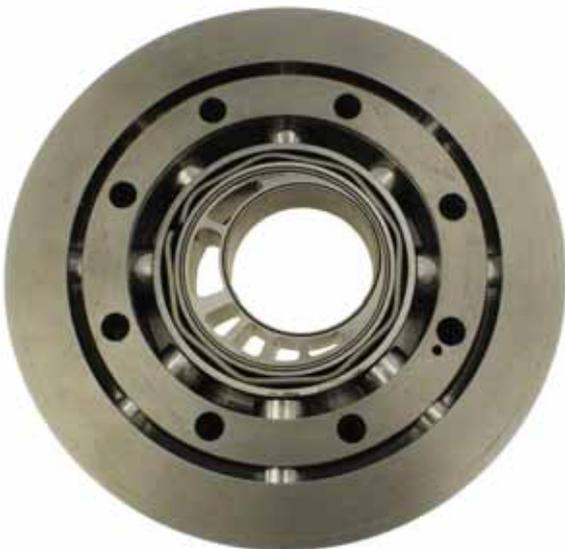
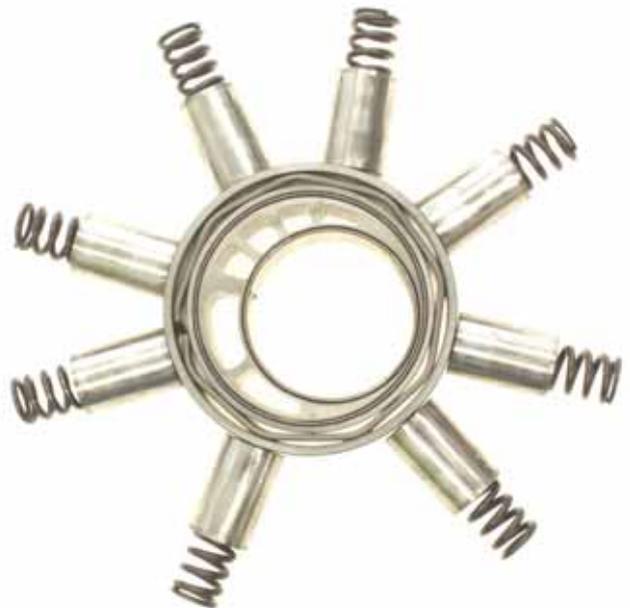
In this case it sure sounded like a broken flexplate or flywheel. We removed the transmission and inspected the flexplate: There was no damage. So what could be causing the noise?

The CFT 30 has springs in the pump rotor area, so we decided to remove the pump and inspect them. We found a broken spring in the pump rotor. You have two options for repairing this: replace the pump assembly or replace the spring. The spring dimension free length is 1.715", the diameter is 0.553" and the coil diameter is 0.083". The working height is 1.312" at a weight of 40lbs.
