# Problems with the MP Transfer Case

by Steve Garrett members.atra.com www.atra.com

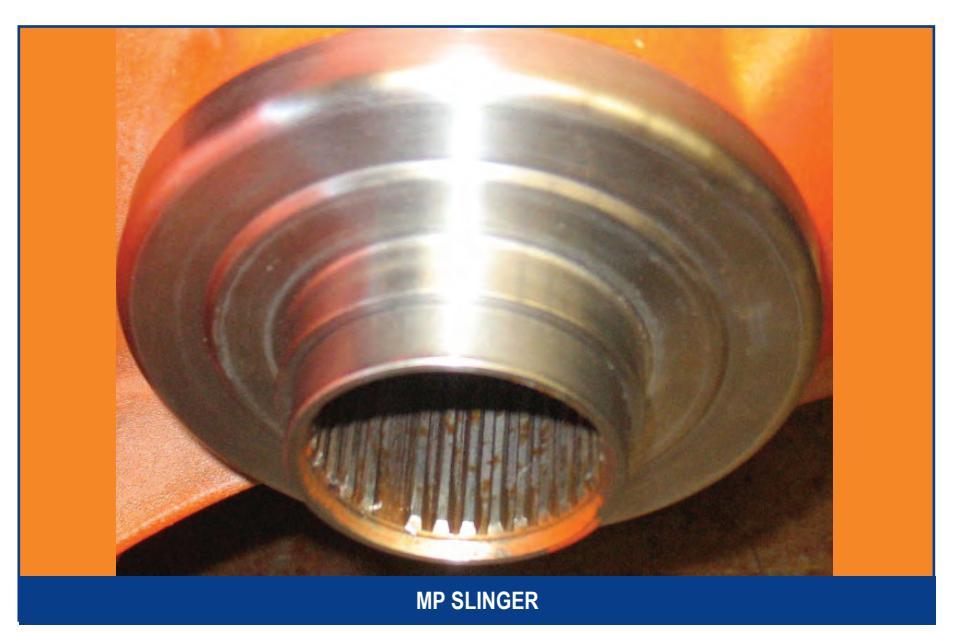
#### Transfer Case Chain Stretched

On applications that are used off road or on roads with standing water,

some customers may comment that they hear a popping noise, especially on turns, in 4WD or Auto mode.

Upon inspection you may find that the transfer case has taken on water. Water contamination will cause the chain to rust, leading to accelerated wear of the chain links and other transfer case components.

If water has gotten into the transfer case, chances are the front output seal probably allowed the water in. The early seal design was unable to shed the large volume of water that struck the front propeller shaft area from the front tires and road surface.

To address this, GM and Magna developed a new design front seal and added a shield to the front output shaft. The new seal will retrofit all MP transfer case applications and will be available early 2011.

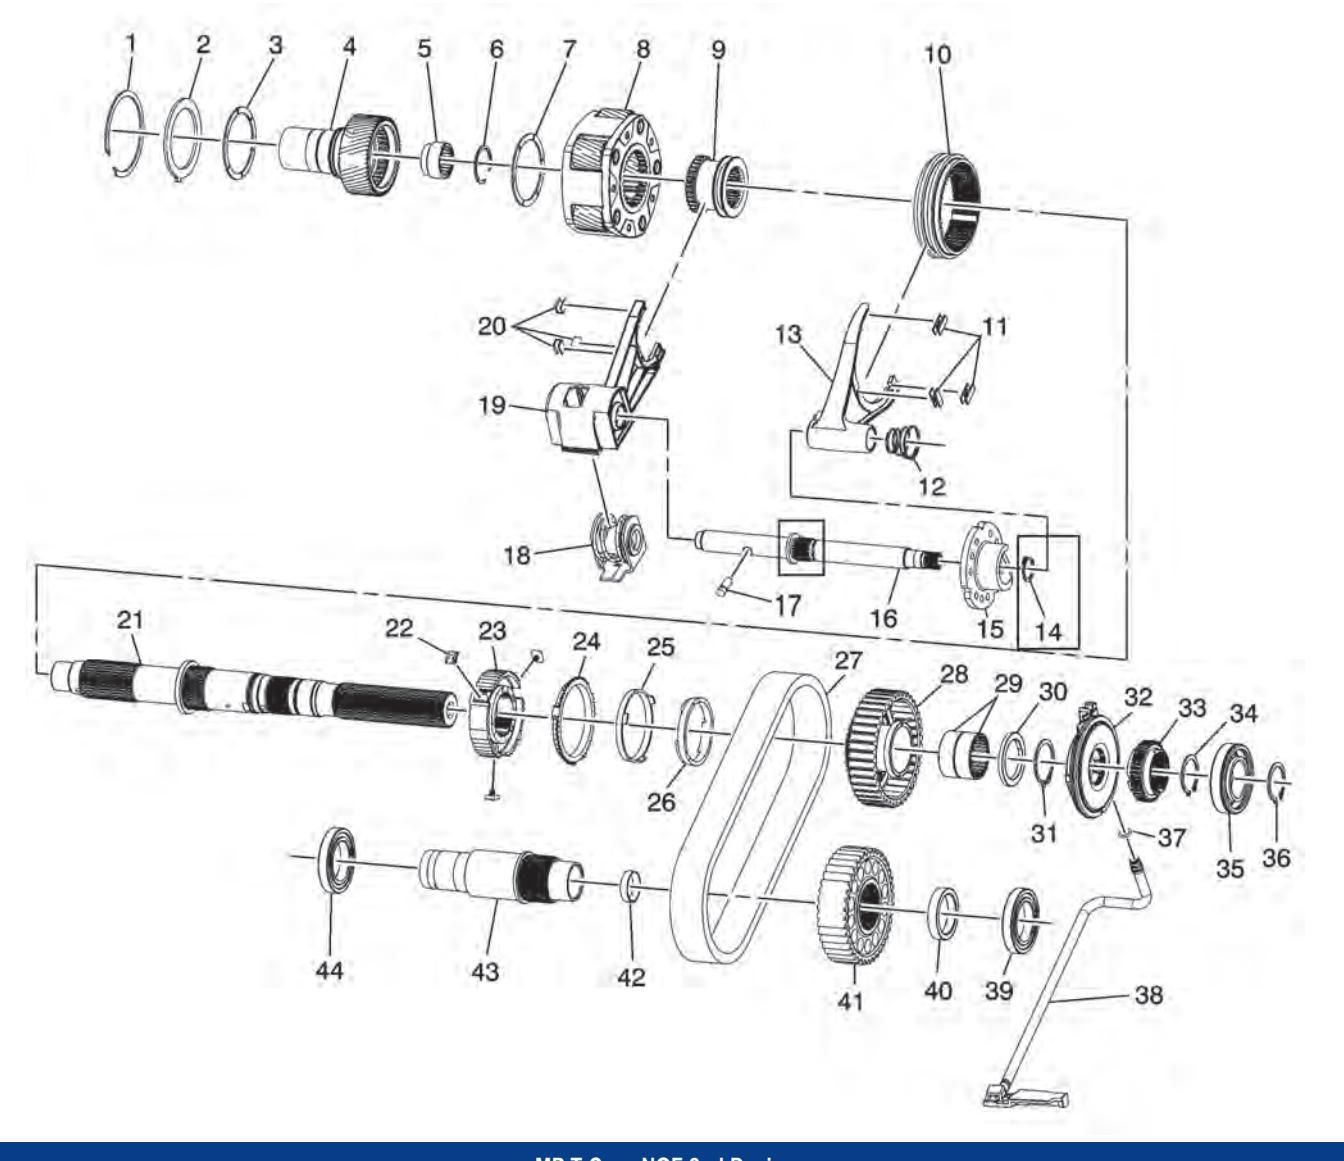
#### MP T Case NQF 2nd Design

The new seal is similar to a Stemco or Scott seal that you may have seen on some HD truck wheel bearings. Because of the internal seal design it is critical that you install the seal to the correct depth in the front case half.

The new seal is similar to a Stemco or Scott seal that you may have seen on some HD truck wheel bearings. Because of the internal seal design it is critical that you install the seal to the correct depth in the front case half. It should be flush with the case half.

If you install the seal too deep, it'll fail prematurely due to the pressure placed on the internal lips of the seal. If you don't install it deep enough the seal could fail to keep water out.

A shield has been added to act as a deflector for the seal. To mount the shield, a small amount of material was machined from the front output shaft in the shield area. If you want to add a shield to your application you either need to replace the front output shaft with the updated design or have your shaft machined.

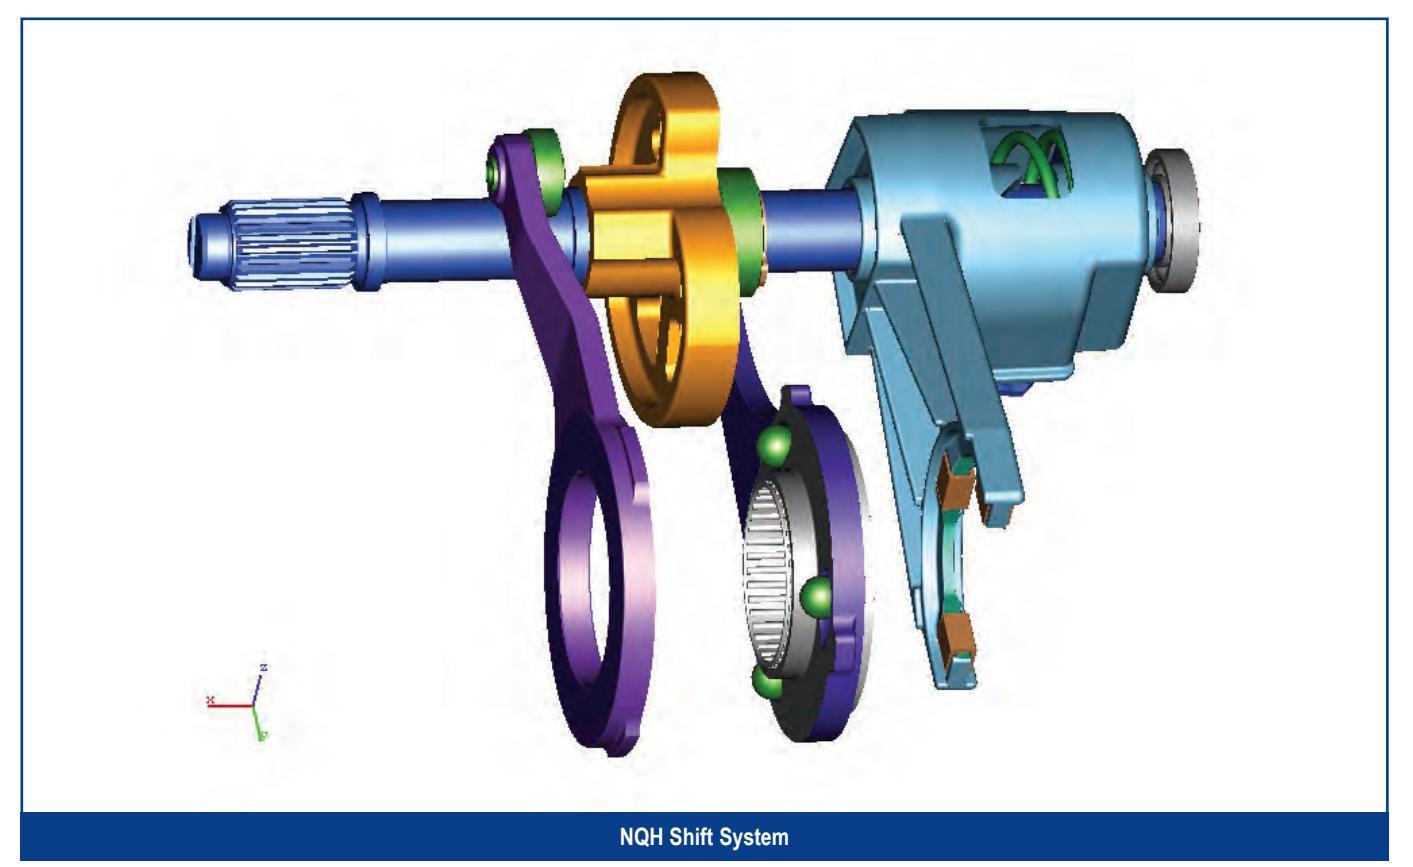
NQF (electric shift model) applications may experience shift problems on early design units (2007-2009). If the condition is present, the transfer case may fail to complete the shift or it may fail to shift again once the shift has been completed.

NQF (electric shift model) applications may experience shift problems on early design units (2007-2009). If the condition is present, the transfer case may fail to complete the shift or it may fail to shift again once the shift has been completed. In addition, you may find a DTC C0387 or C0569 in TCCM memory.

NQF Models — The snap ring (#15 in parts book) on the shift shaft may have popped out of its snap ring grove. This is due to the end thrust on the snap ring during the shift.

To repair the condition, an updated shift shaft has been developed. The updated shaft has a flange built into it to prevent the end thrust from reaching the snap ring. To repair the condition, you'll need to install the updated shaft and hardware. As noted in the picture, the position of the components will change with the  $2^{nd}$  design shaft and hardware.

The updated parts are:

- Shaft 19210805
- Cam 19210806
