# 4R70W/4R70/75E

## Interchange Information

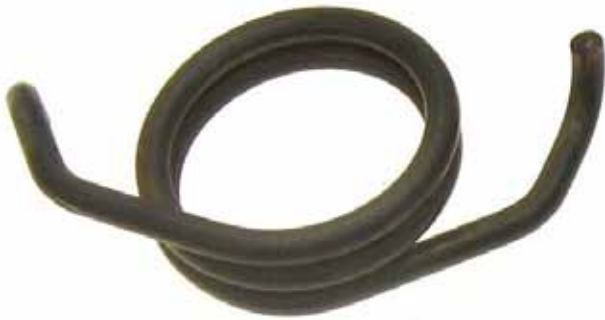
### Discard

Ford has come up with a better designed anti rattle spring. The updated spring is a “V” shaped strip of spring steel that won’t eat into the case or center support. This spring will retrofit back all the way to the AOD transmission and is a great case saver for severely worn cases. The part number for the updated spring is 2L3Z-7F277-AA.

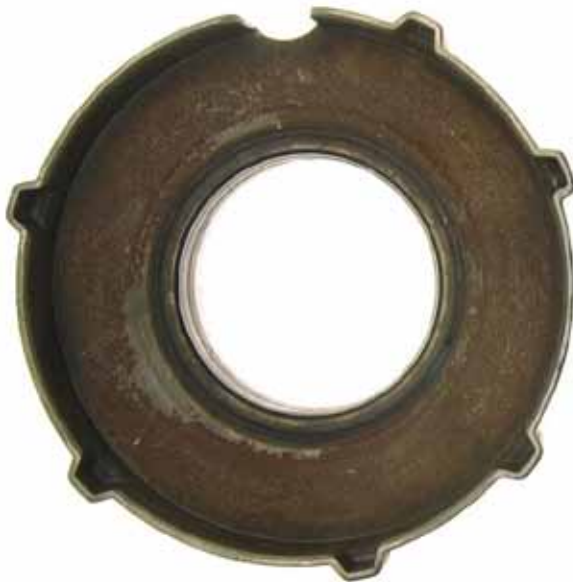
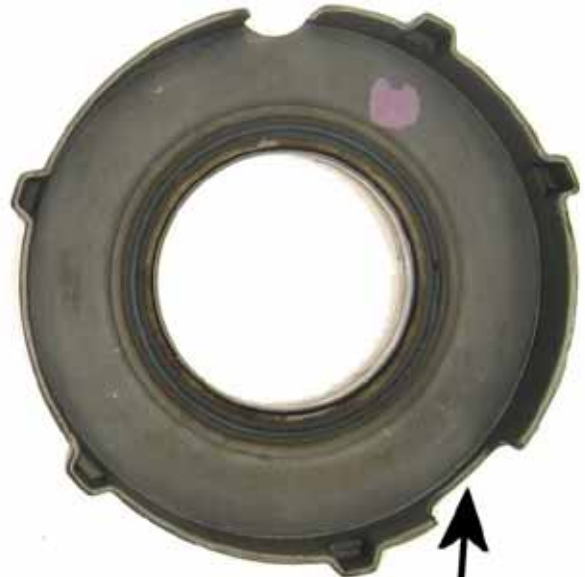
To make room for the turbine speed sensor, the 4R70E/75E center support has an extra notch cut out. If you install a 4R70W support in a 4R70E/75E case, the turbine speed sensor will not install all the way into the case.

NOTCH FOR  
TURBINE SPEED SENSOR

If you are in a pinch, grinding a notch into the support to make room for the sensor will not pose a problem.

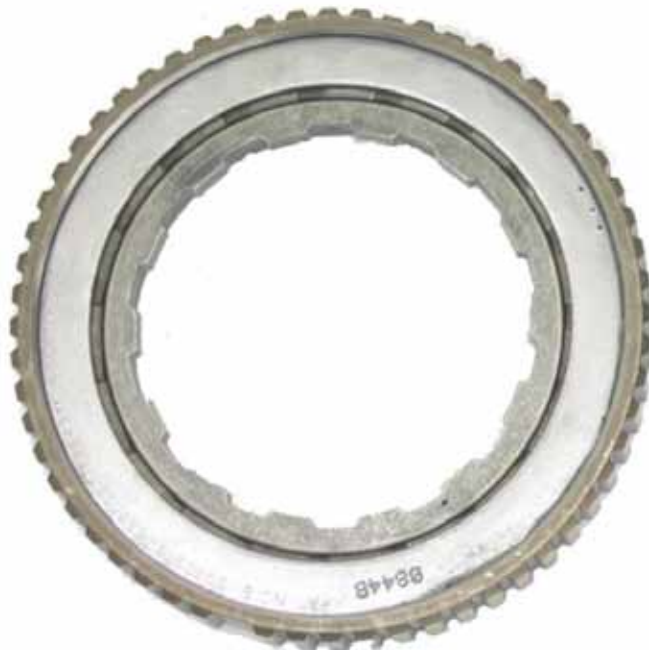
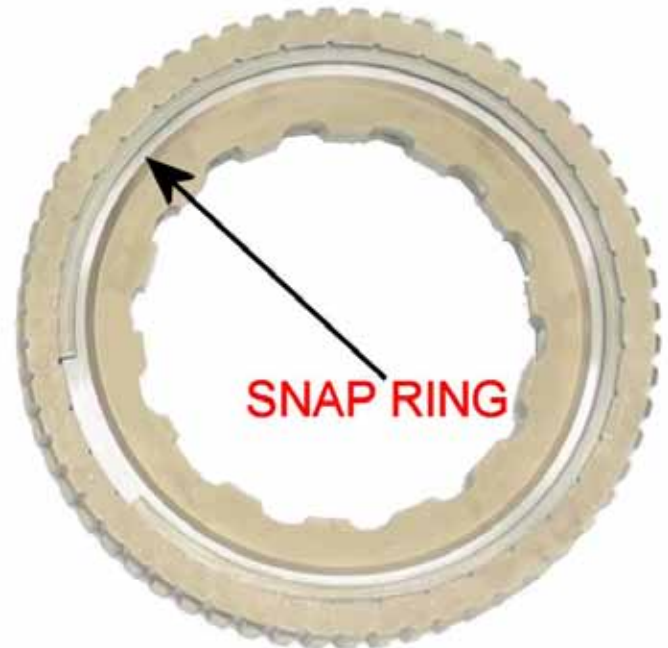
The new diode has a snap ring that holds the element retainer in place instead of the earlier pressed design. Height dimensions have changed slightly where the snap ring rides on the reverse input/OD drum.

The new design diode supersedes the previous design, and when used on any diode-style drum, will increase the clearance between the inner race and the snap ring by about 0.020", this is a normal clearance by design. An aftermarket-designed spiral snap ring should be used in place of the stock snap ring to prevent snap ring failure.

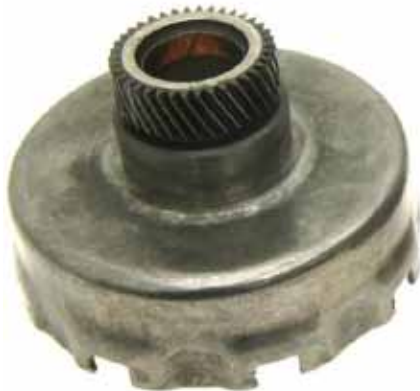
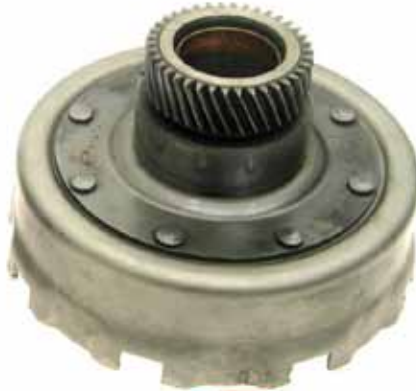
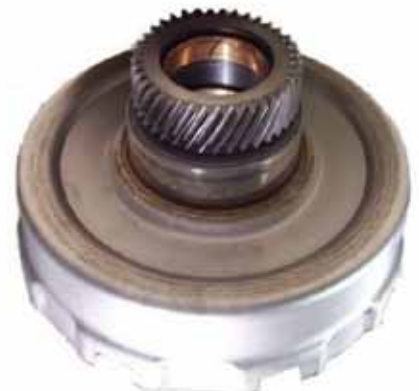
The single most important change with the 4R70E/75E sun shell is something you can not see with the naked eye, but will prevent the transmission from leaving your shop. That is the 4R70E/75E sun shell is non-magnetic. In order for the input speed sensor that the 4R70E/75E's now incorporate to work, the sun shell must be non magnetic so that the sensor can pick up the signal from the stamping on the forward drum. Failure to use a non magnetic sun shell will result in harsh or no shifting with possible ratio and input speed sensor codes.

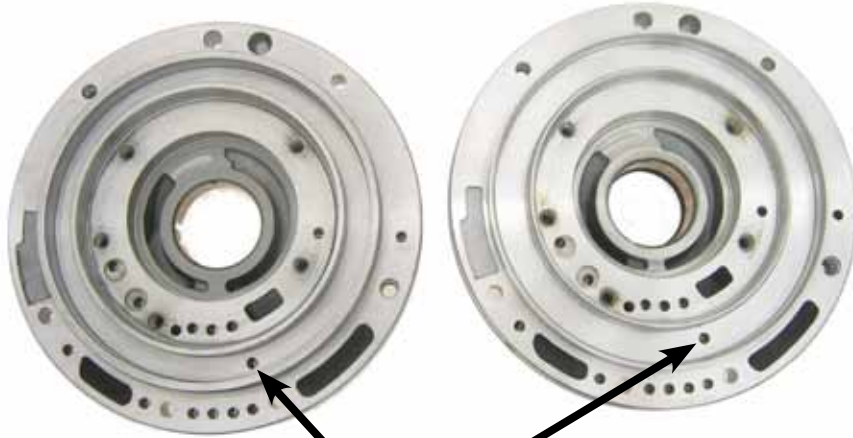
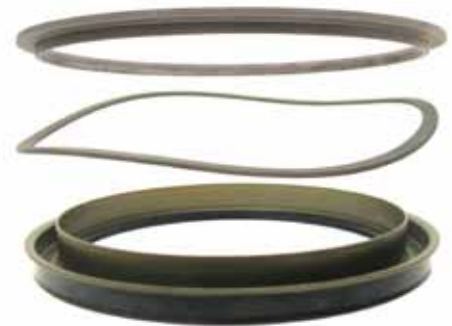
The pump bodies are identical except for the intermediate piston design. The 4R70E/75E uses a bonded rubber piston that is larger in size and will produce more holding power than the aluminum piston design.

A wave style piston return spring in 04-05 models and a one piece in the 06 and up models is utilized on the molded style and cannot retrofit back. The wave style spring requires a seat that sits in the case so that the wave spring does not eat into the aluminum. The later one piece style has a notch that indexes at 12 o'clock in the case and is placed with the springs facing up towards you.

Area for the Intermediate Piston is larger for the molded rubber style

**2006-on uses the single piece retainer**

The two different designed pumps can be interchanged from one another without any issues, but as a complete set. You cannot interchange intermediate pistons or springs with one another. If you choose to use a 4R75E pump in place of the early 4R70W, make sure to install the wave spring retainer into the early case or damage to the case will occur. If using the 06-up one piece design spring, no retainer is needed.

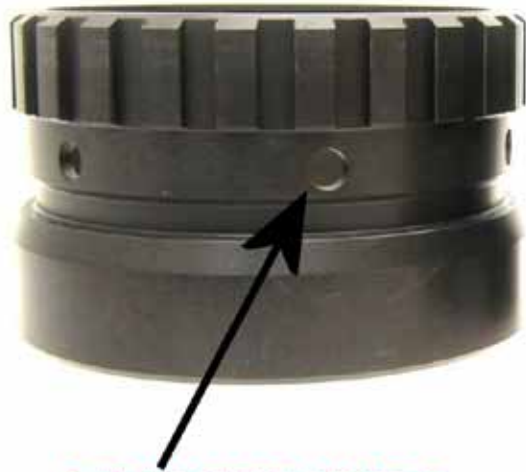
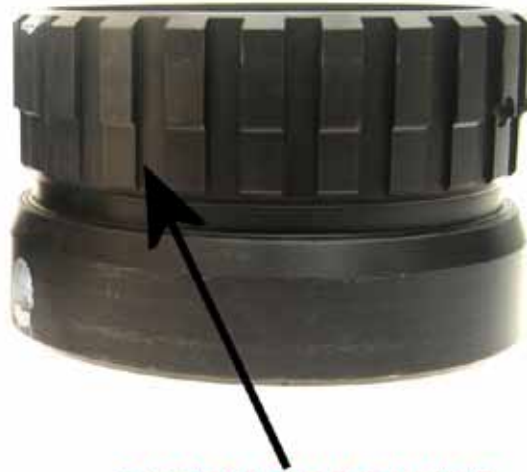
A new designed output speed sensor was incorporated for the 2004 model year. The new sensor uses the exciter ring from the 24 extended parking pawl lugs as where the old sensor uses six (6) holes that are machined around the ring gear.

Mismatching an early ring gear in a late transmission will result in a 75% reduction in the output speed sensor signal and will not let the trans shift out of first gear. Using a late ring gear in an early transmission will produce an output speed signal 400% faster and shift the transmission into fourth gear by the time you hit 10 MPH. No interchange possible.

6 RELUCTOR HOLES

24 RELUCTOR LUGS

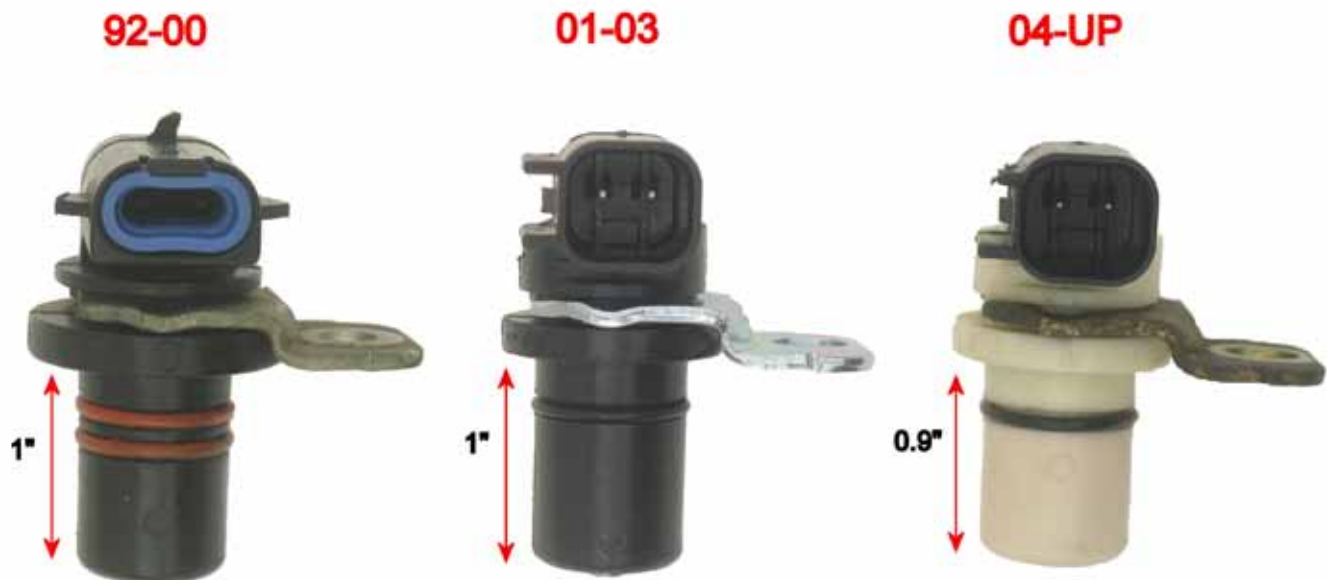
The Output Speed Sensor changed from the oval connector to the square in 2001. The length is the same as the earlier version up to 2004 when the ring gear changed. Installing the shorter late sensor in 01-03 models could create a weak signal and intermittent OSS codes. Installing the early sensor in an 04 and up will cause damage to the sensor.
