2010

**TECHNICAL
SEMINAR**

This manual has been developed by the Automatic Transmission Rebuilders Association (ATRA) Technical Department to be used by qualified transmission technicians in conjunction with ATRA's technical seminars. Since the circumstances of its use are beyond ATRA's control, ATRA assumes no liability for the use of such information or any damages incurred through its use and application. Nothing contained in this manual is to be considered contractual or providing some form of warranty on the part of ATRA. No part of this program should be construed as recommending any procedure which is contrary to any vehicle manufacturer's recommendations. ATRA recommends only qualified transmission technicians perform the procedures in this manual.

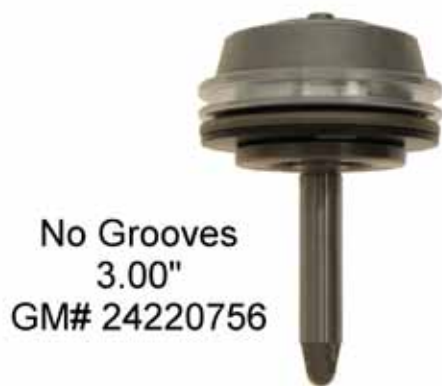
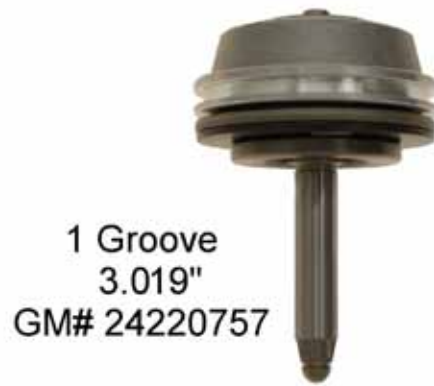
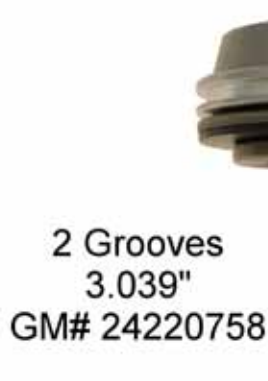
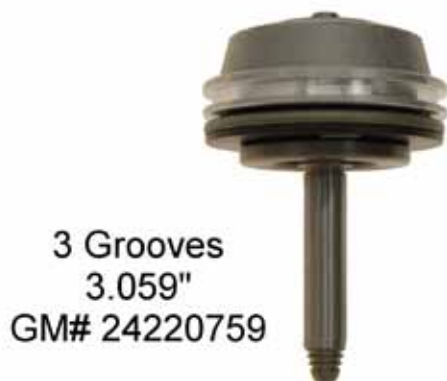
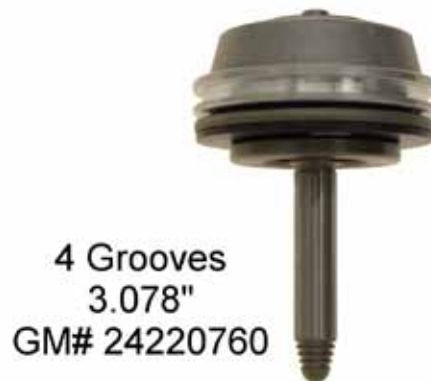
A 2-3 flair is a common complaint after overhaul. Usually the flair can be associated with valve body wear and pressure related issues. The third gear band clearance can also contribute to the flair condition. Install the servo and band anchor with the case half removed and adjust the servo travel to 0.250". The servos are selectable.

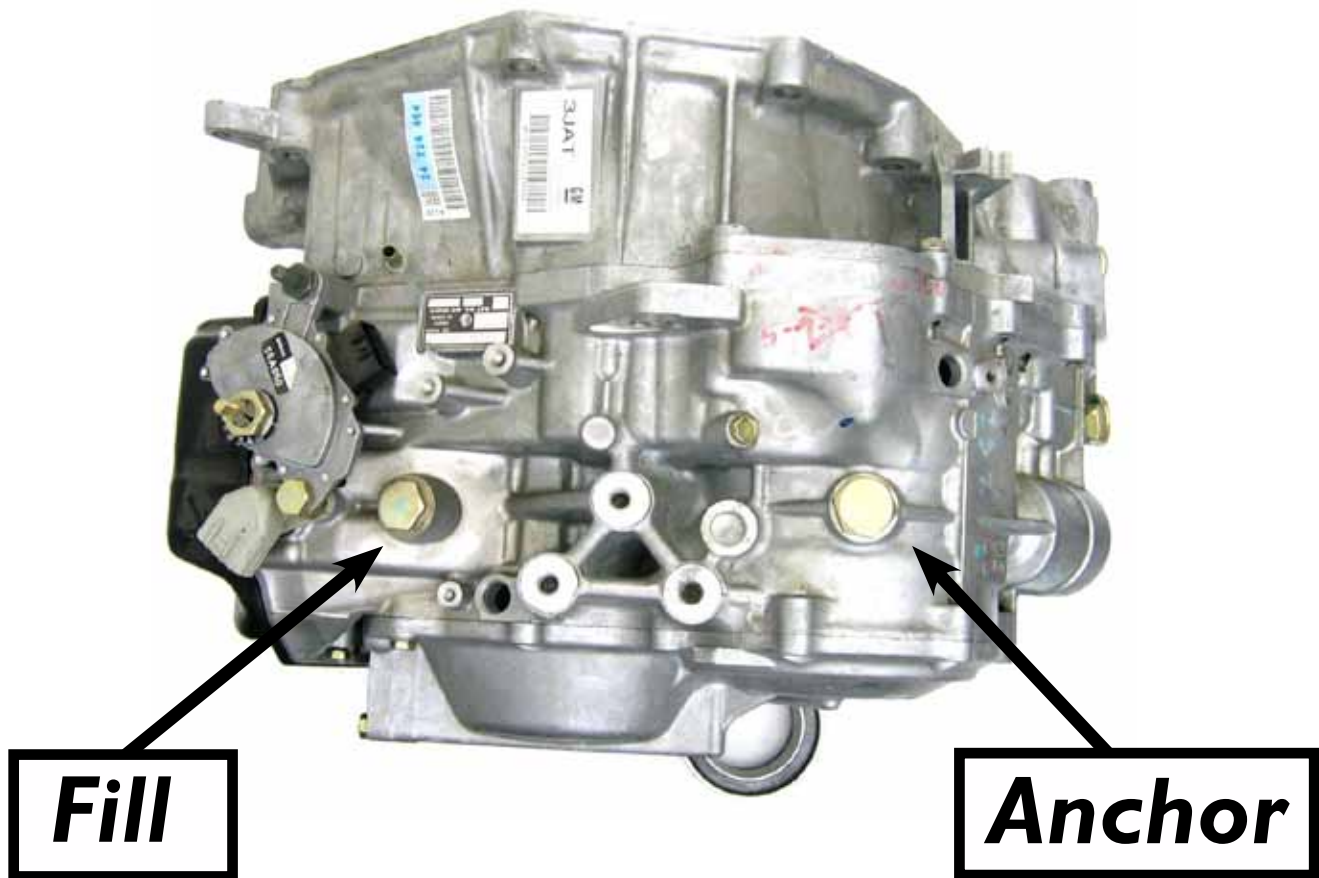
The AF 23-5 used in the Saturn Ion and the AF 33-5 used in the Saturn Vue, Chevrolet Equinox and Buick Torrent applications may experience a slipping complaint or a no 3rd gear concern after the transmission fluid has been serviced or after an internal repair has been performed.

The technician may have removed the wrong bolt to adjust the unit's fluid level. If the technician removed the 3rd gear band anchor bolt instead of the fill bolt, it may allow the anchor to fall out of place leading to the concern. If the technician has removed the wrong bolt, the transmission will need to be disassembled to correct the concern.

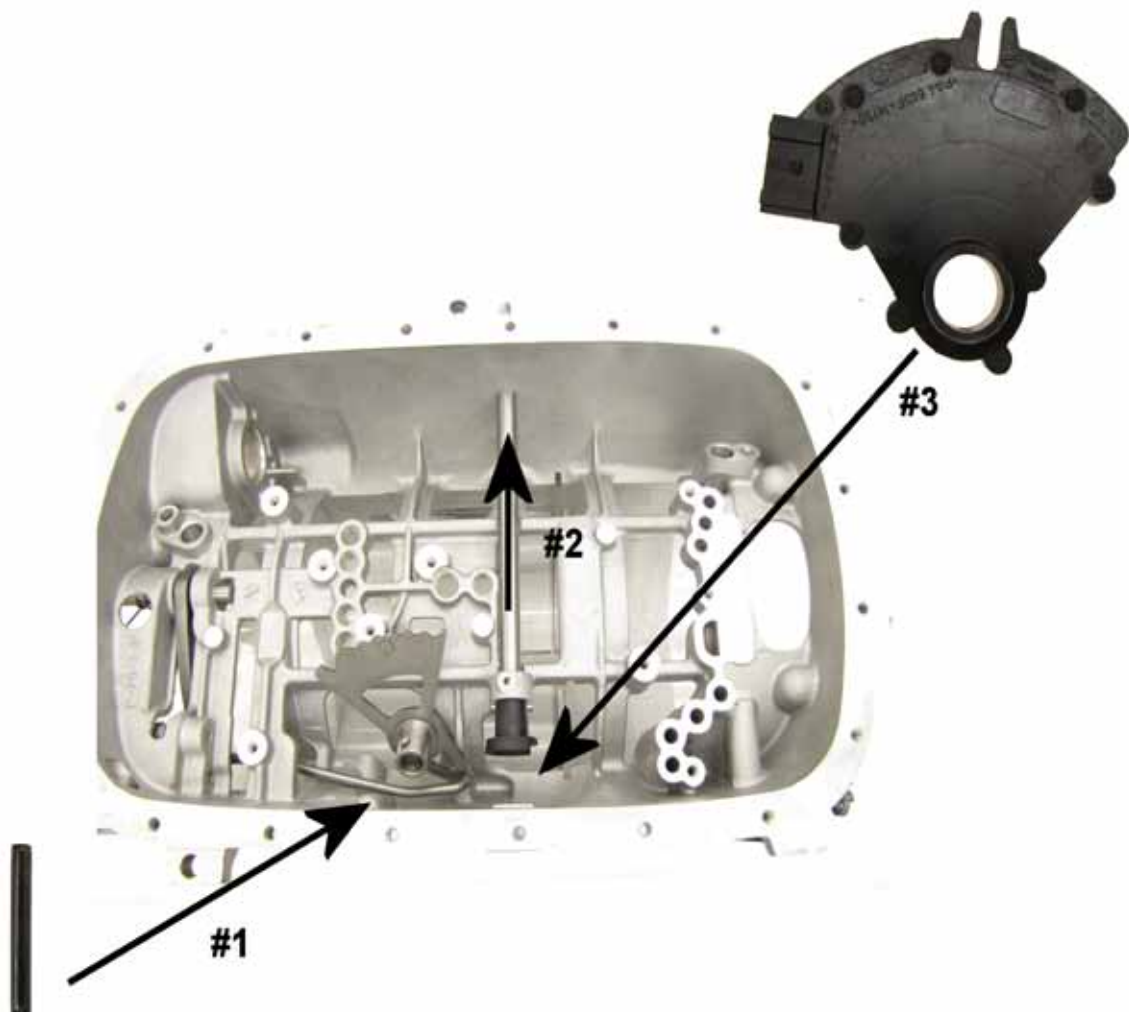
A 5L40E experiencing an intermittent no reverse may be caused by a faulty Internal Range Sensor most common in BMW vehicles. Use scanner data to see if range sensor readings are correct. If the transmission goes into reverse when the main connector is unplugged, reverse is being electronically inhibited. Replacing the Range Sensor will repair this concern.

1. Remove the roll pin.
2. Carefully slide the manual shaft out of the rooster comb/range sensor assembly.
3. Remove and replace the range sensor.

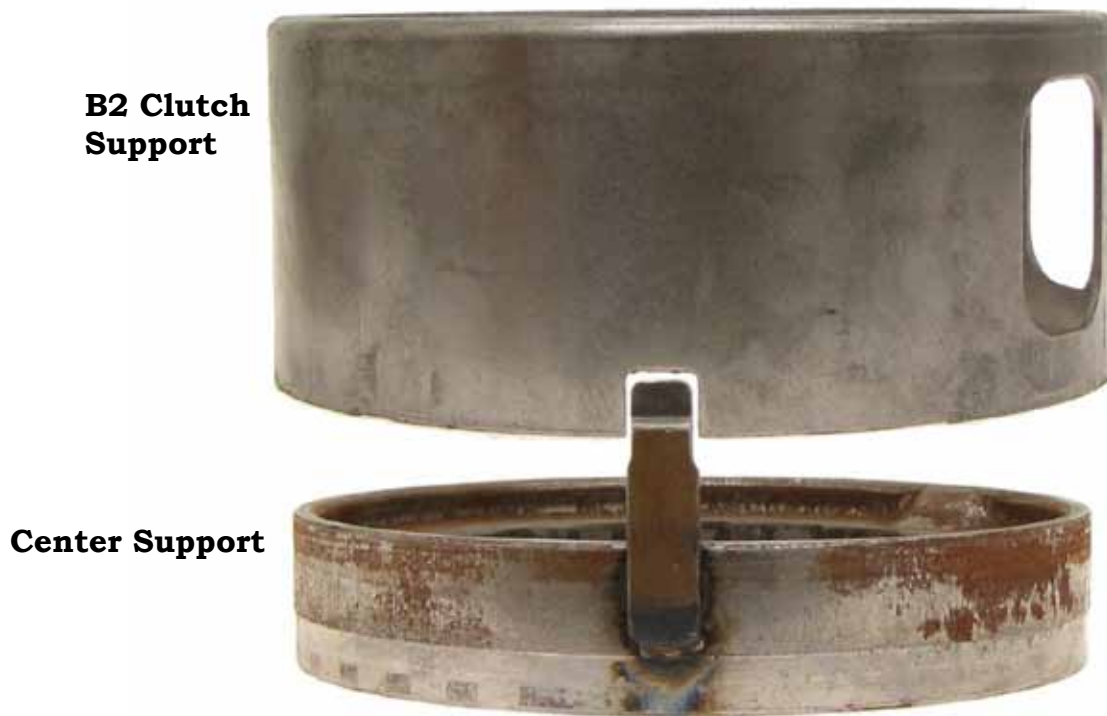
01M, 096, 01P New Beetle, Jetta, Eurovan vehicles with a bind in reverse and 2nd gear starts may be caused by the B2 clutch support not being indexed properly.

The notch in the support must key into the alignment “leg”.

The notch in the support must key into the alignment “leg” at the 5 o'clock position on the center support. Once the pump is tightened, make sure the differential can be turned in the reverse direction.

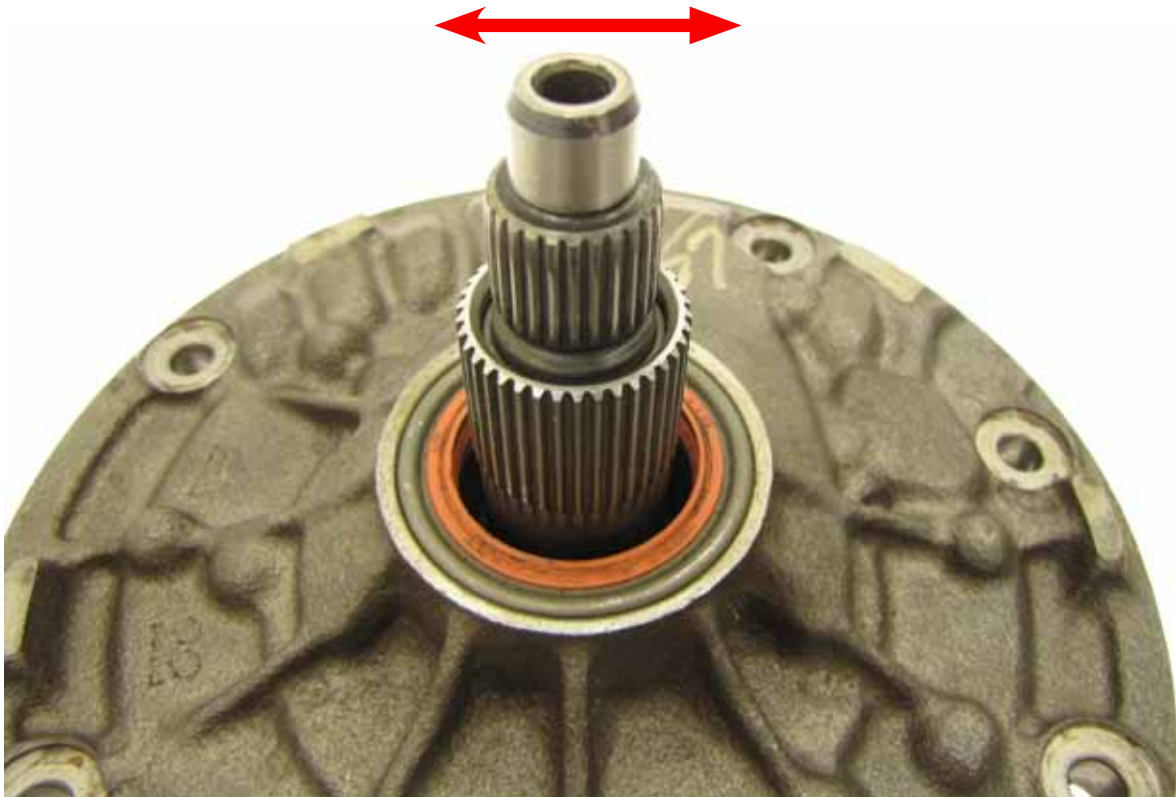
The most common cause for the P0770 is wear in the front Stator Support Bushing. This can cause premature failure of the lockup clutch. The bushing must have no more than .003" clearance around the input shaft. In most cases of a repeat P0770 code, over .020" of wear has been seen in this area.

Check for wear at the front Stator Support Bushing

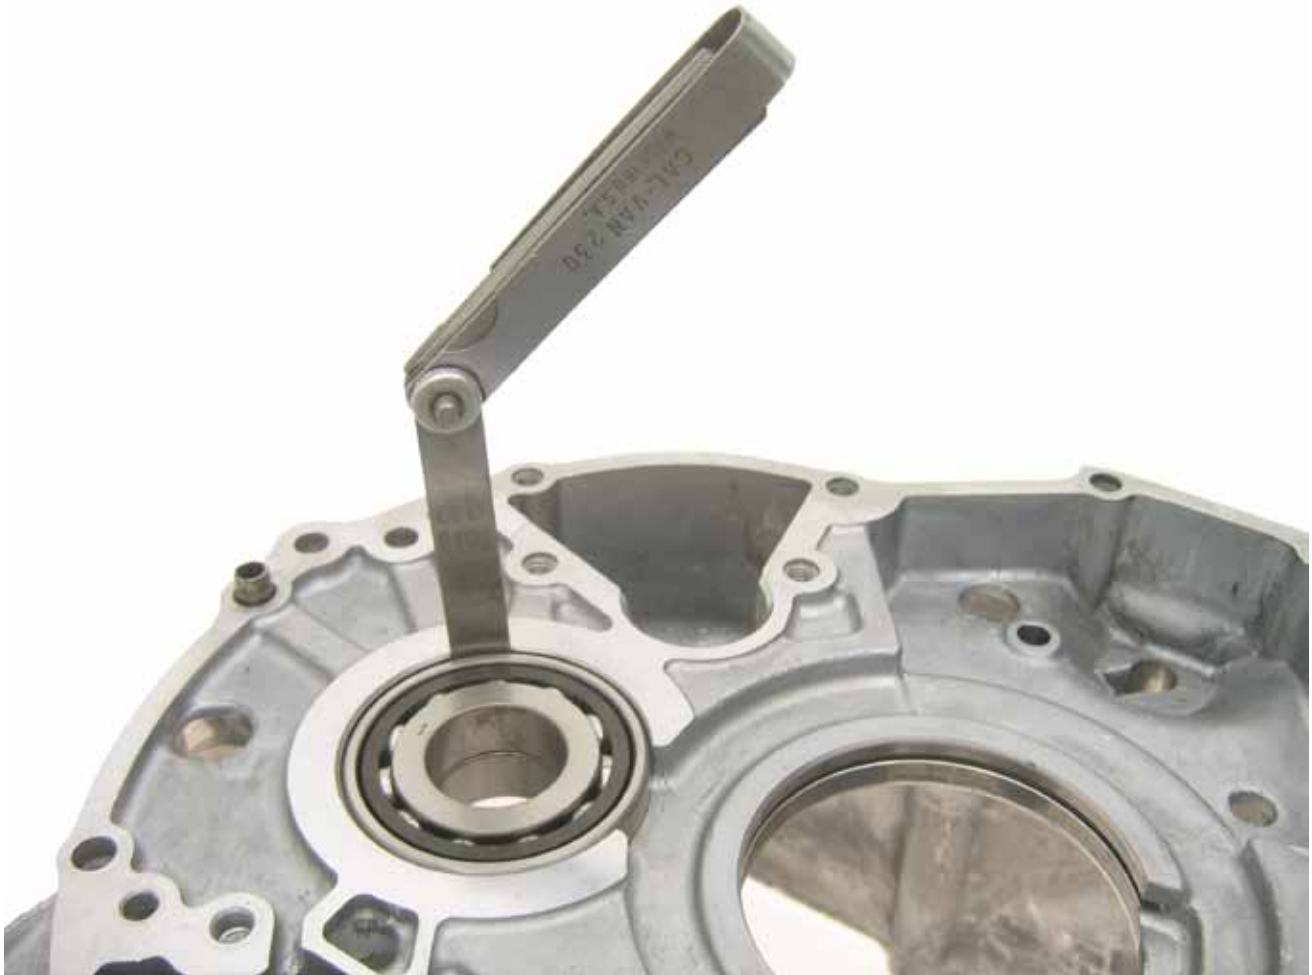
Any movement of the bearings in the case is unacceptable. The wear seems to be most common on the Main (Input) shaft bearing pocket in the rear case half, but reports of wear on secondary and counter shaft bearing pockets have been made. Complaints from this wear can range from bind ups in reverse, whine noise and/or gear facing damage. There are machine shops offering case repair by boring and installing a sleeve in the worn pocket.

Note: Whenever case wear is present, the apply bushings in the shaft will be worn and must be replaced along with case replacement/repair.

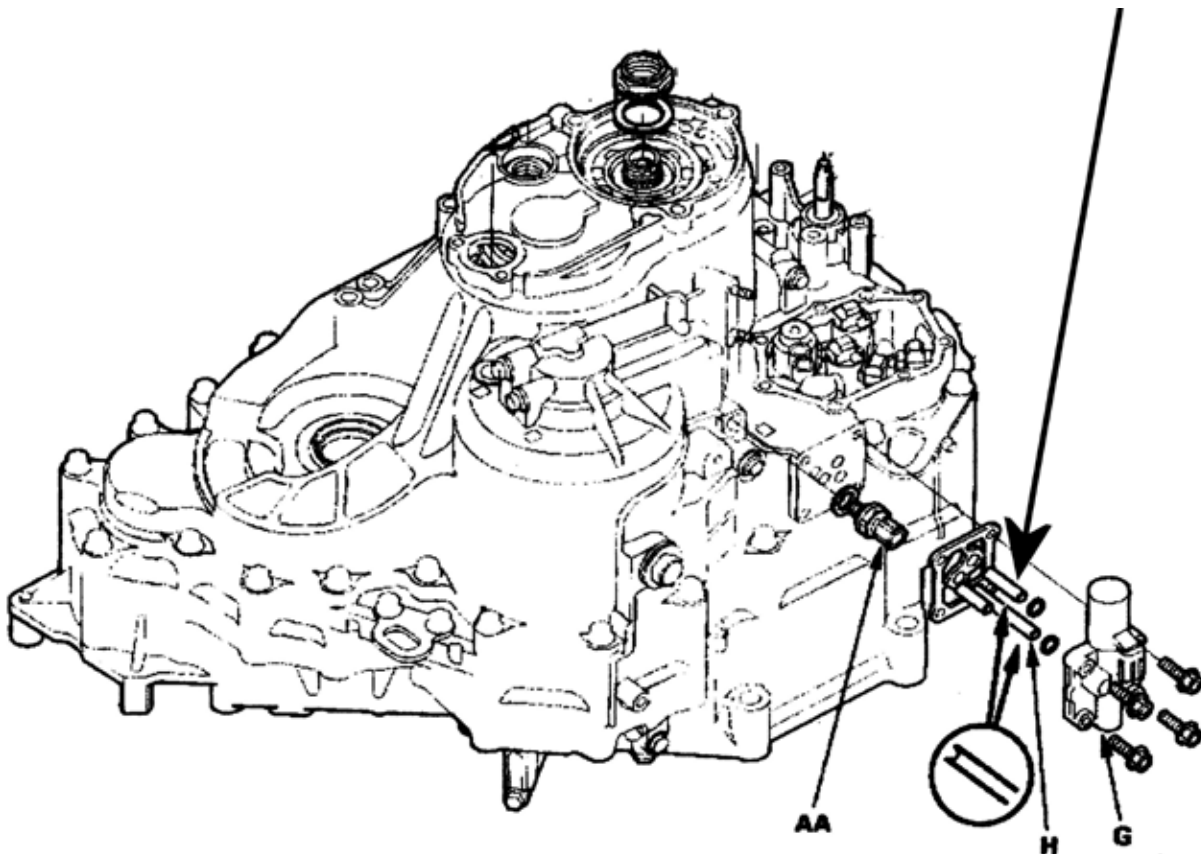
Remove CPC C feed tubes prior to case separation to prevent feed tube damage. These tubes fit into the valve body inside the case. If the pipes are damaged they are available from the Acura dealer.

Always remove these 3
pipes before splitting the
case halves

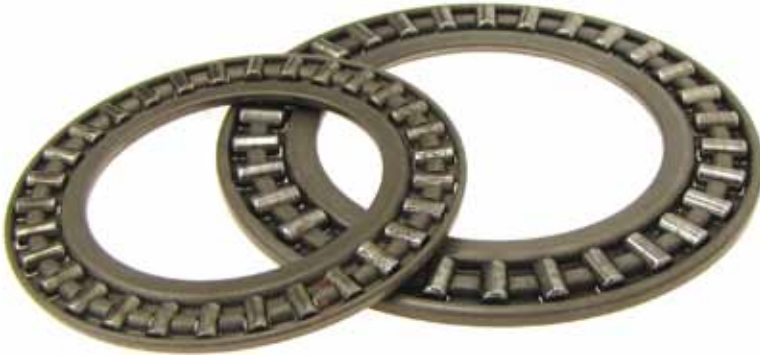
Closely inspect needles and bearings for pitting. It is common for the needles to pit, but not damage the races.

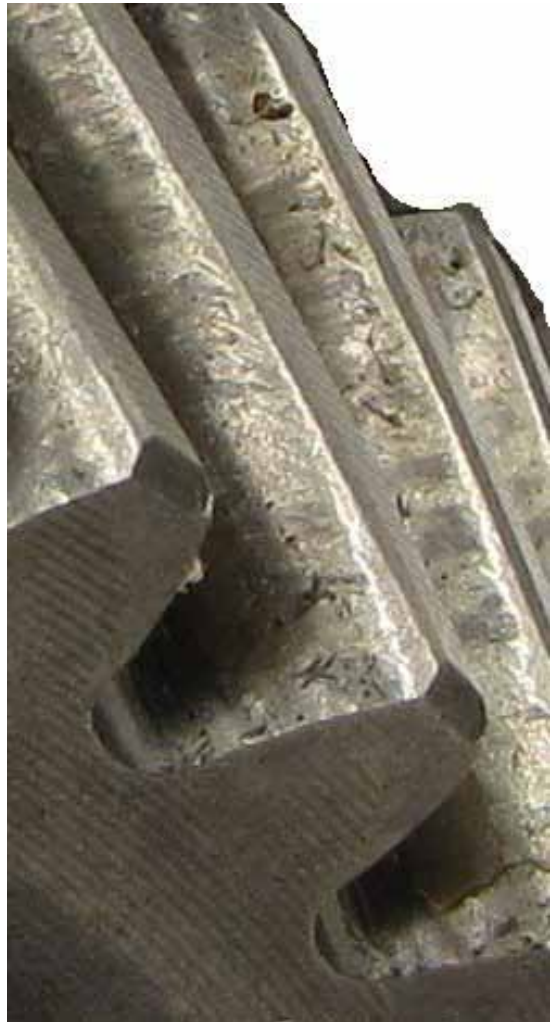
Gear facing should be inspected for galling when any bearing or case wear at the bearing pockets occur.

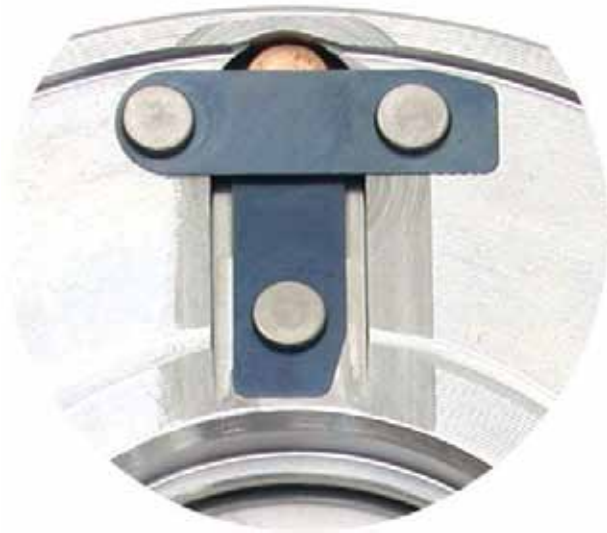
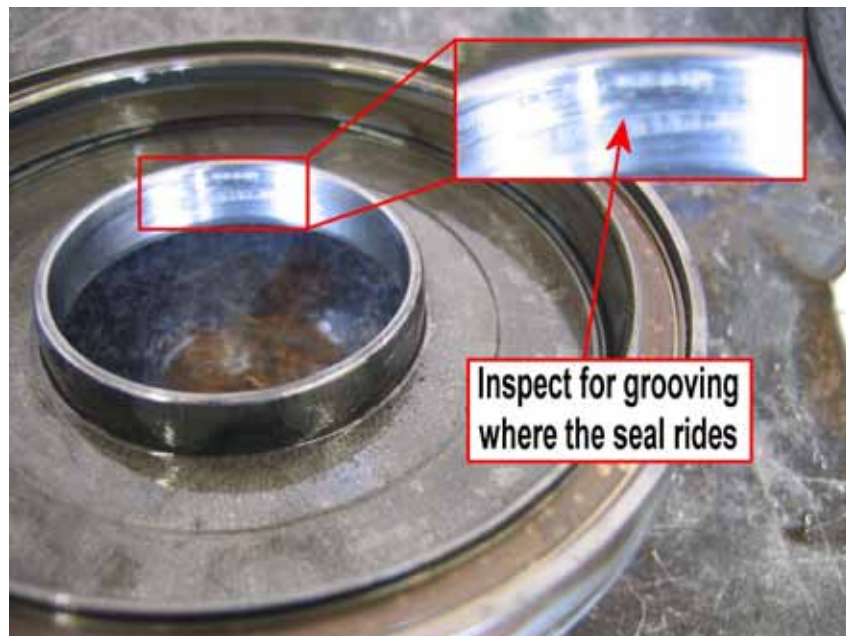
Thoroughly clean the reed valves in the pistons. Pistons must be replaced when grooved at the seal surface.
