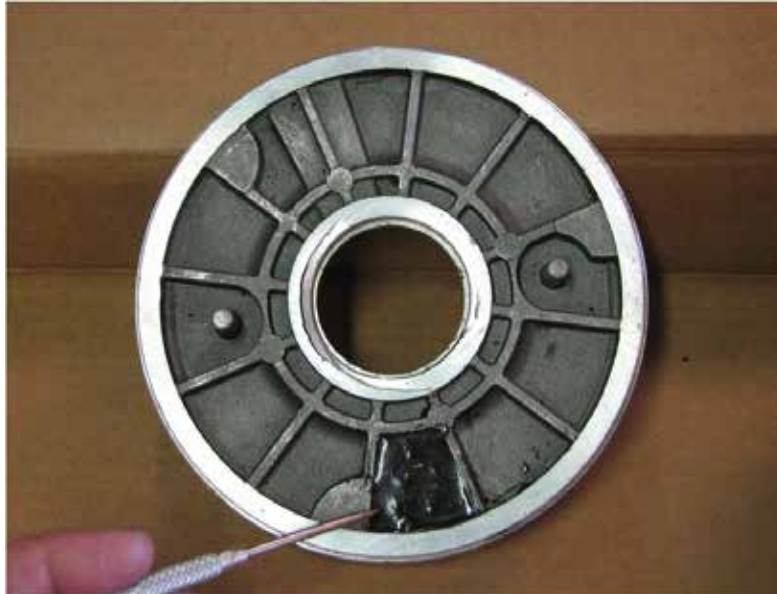
Burnt overdrive clutches can be caused by a bad piston casting. Check the piston for proper machined area. If the area has not been machined follow these simple steps.

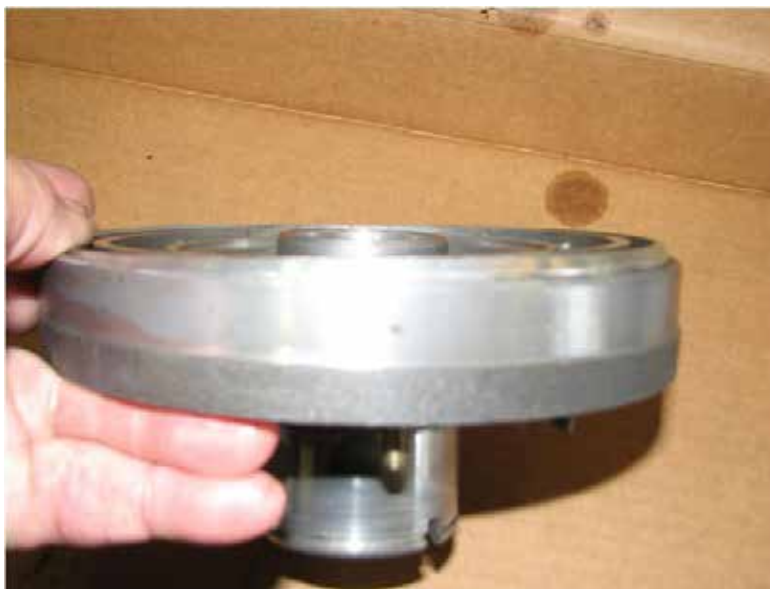
If the piston is not machined properly the piston will be wobbly when installed. You can replace the piston or if you choose to repair the piston follow these simple steps:

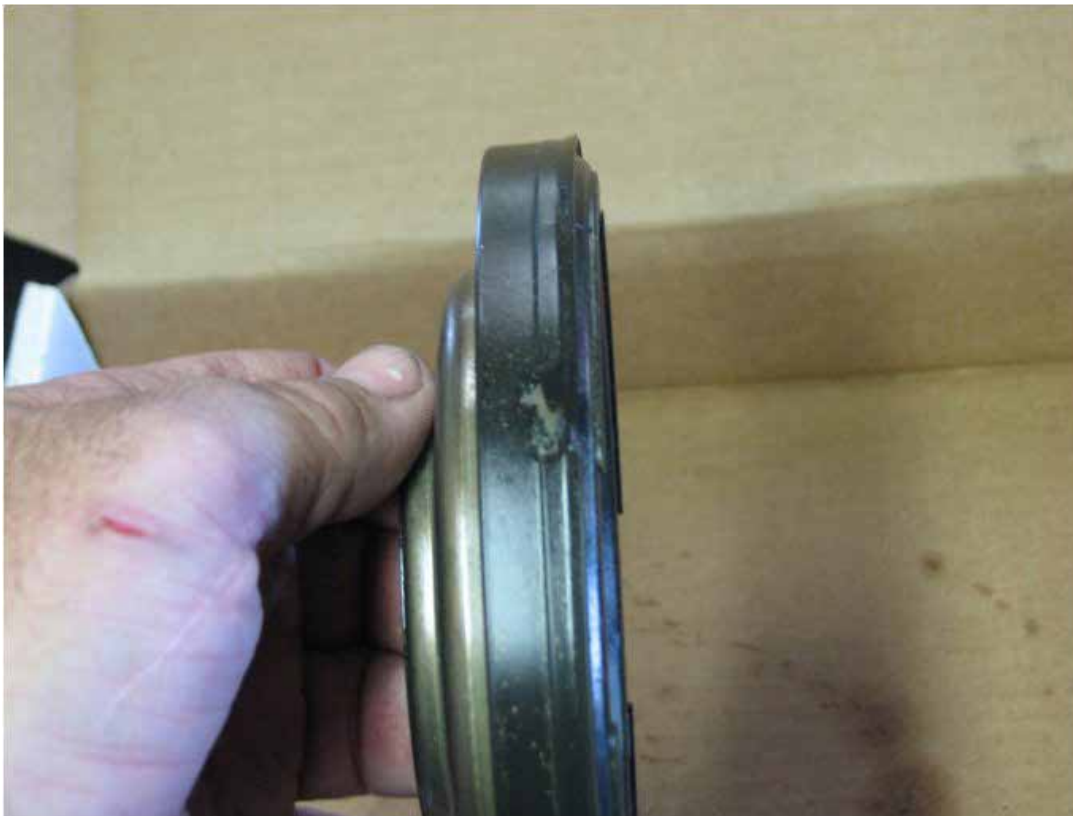
A no forward movement condition can be caused by the underdrive molded piston seal being ripped. You might even see the input drum full of burnt clutches from the underdrive drum assembly. The underdrive piston assembly fits into the drum very tightly. There are cases of this piston being torn in brand new vehicles.

Check the clutch retainer drum for wear or internal issues that can cause the piston to fail. To correct this concern you need to replace the piston and the drum, to help you with the installation try following these simple steps.

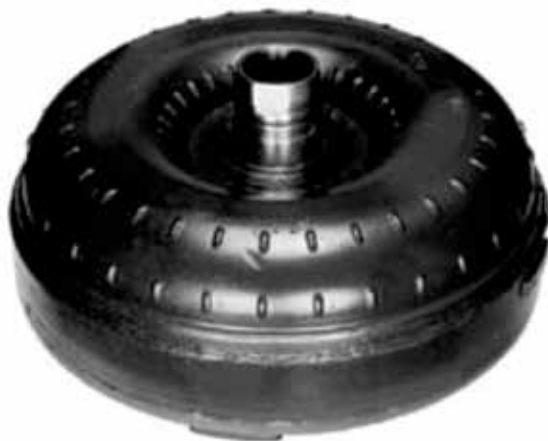
Medium Stall

After overhaul on a 2006 or later Dodge truck with a Multi Displacement 5.7L Hemi engine may have a complaint of TCC shudder during lockup apply. This may be caused by installing the wrong converter.

**Smooth Clutch Lining
Outer Damper Spring
Assembly**

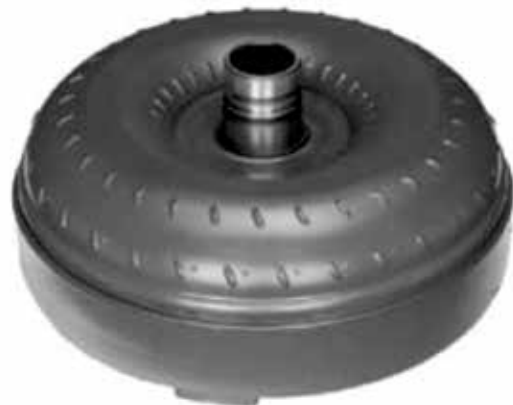
Low Stall

**Grooved Clutch Lining
Outer Or Inner Damper Spring
Assembly**

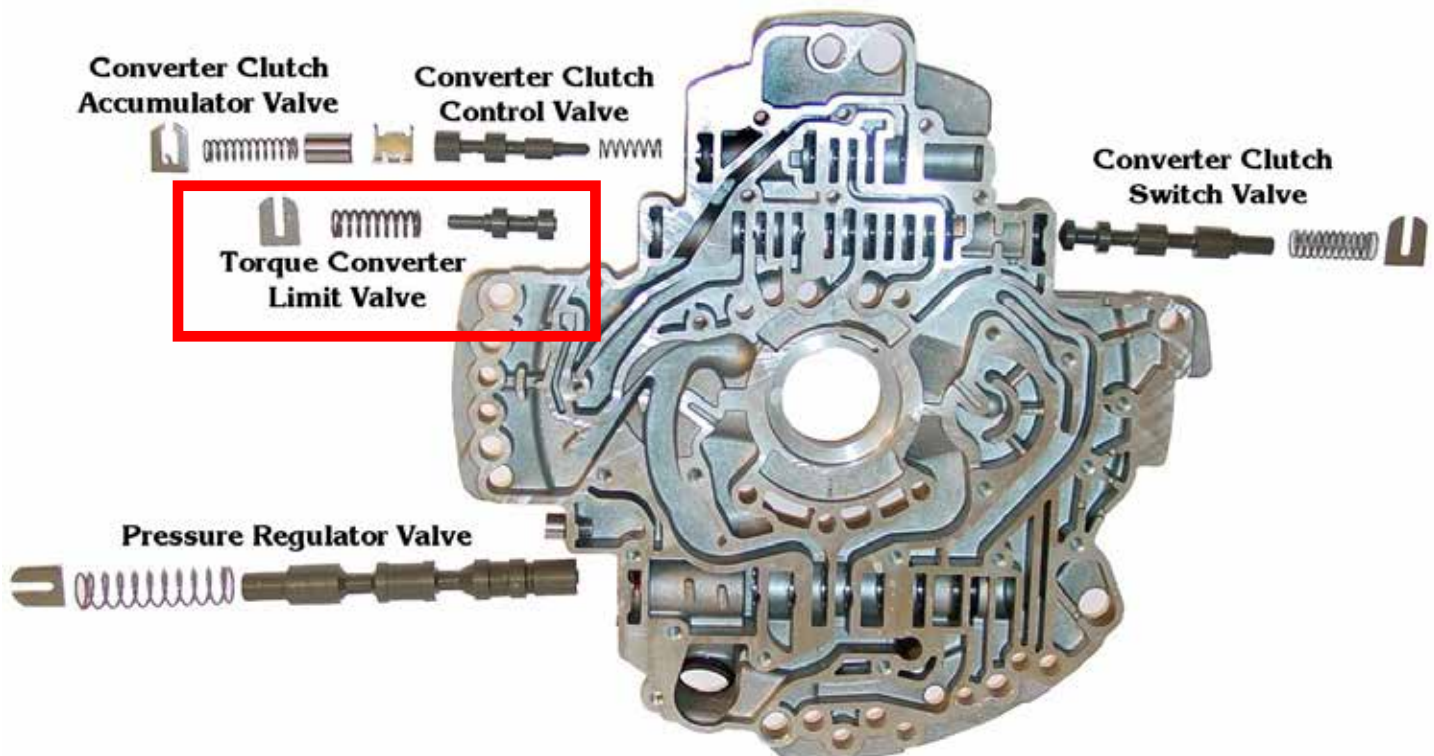
The torque converter limit valve and bore is subject to high wear problems, don't just pick this valve, remove clip and spring and move valve side to side to inspect! Some after market kits will address this problem. But only if the wear is not excessive.

The torque converter limit valve serves to limit the maximum pressure supplied to the front side of the torque converter clutch. A worn valve will cause converter drain back, TCC shudder, and low line pressure.

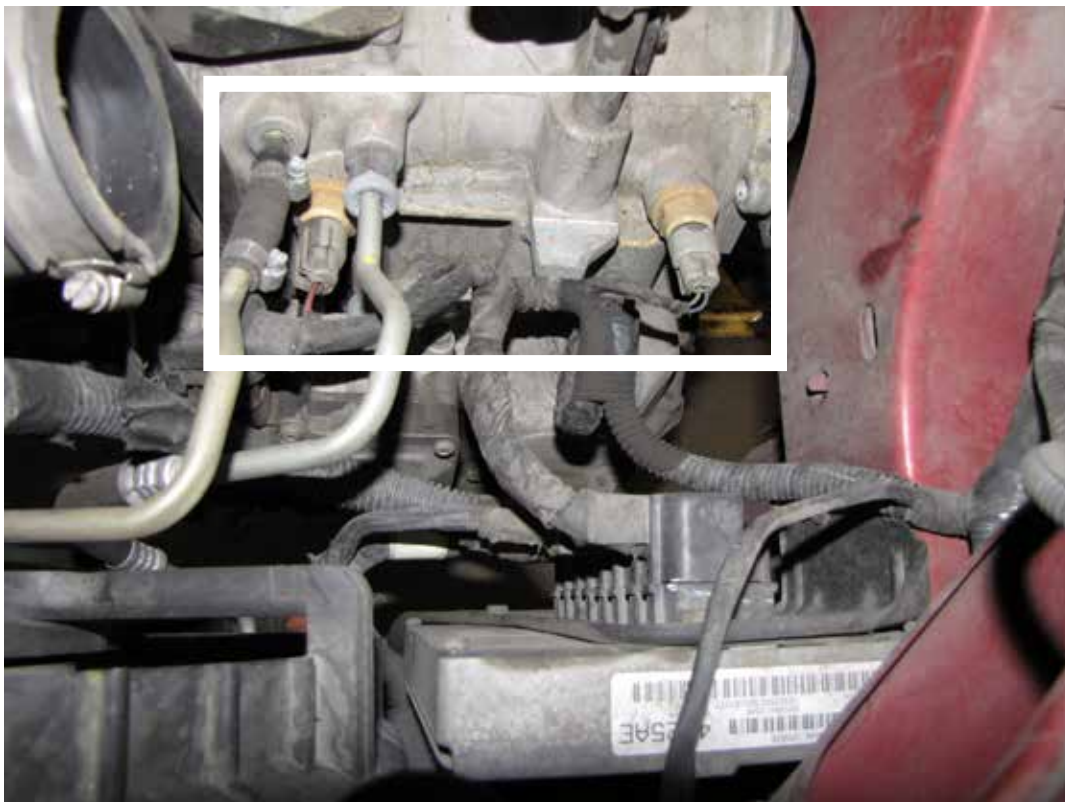
It's common for the speed sensor wires to break internally in the harness. Inspect the wiring harness for problems within a few inches of the speed sensor connectors and where the harness wraps down around the pan area near the drivers side tire. If the wiring is damaged at the sensor replace the connector with a pigtail assembly. If the harness is damaged in area of the case/pan, repair the damaged wiring using weather proof butt splices.

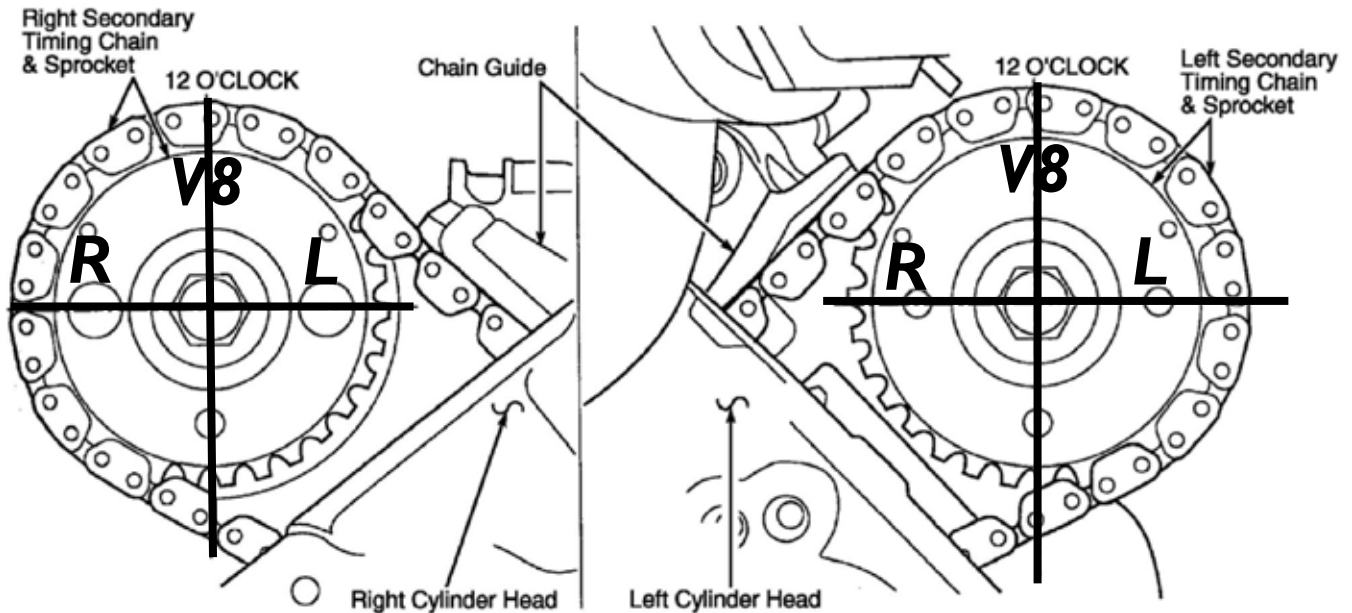
Inspect the cam bolt torque, if the bolt torque is correct inspect the cam dowel. The cam dowel is wearing on these engines leading to retarded cam timing. Inspect the cam dowel for wear and replace if a worn dowel is found.

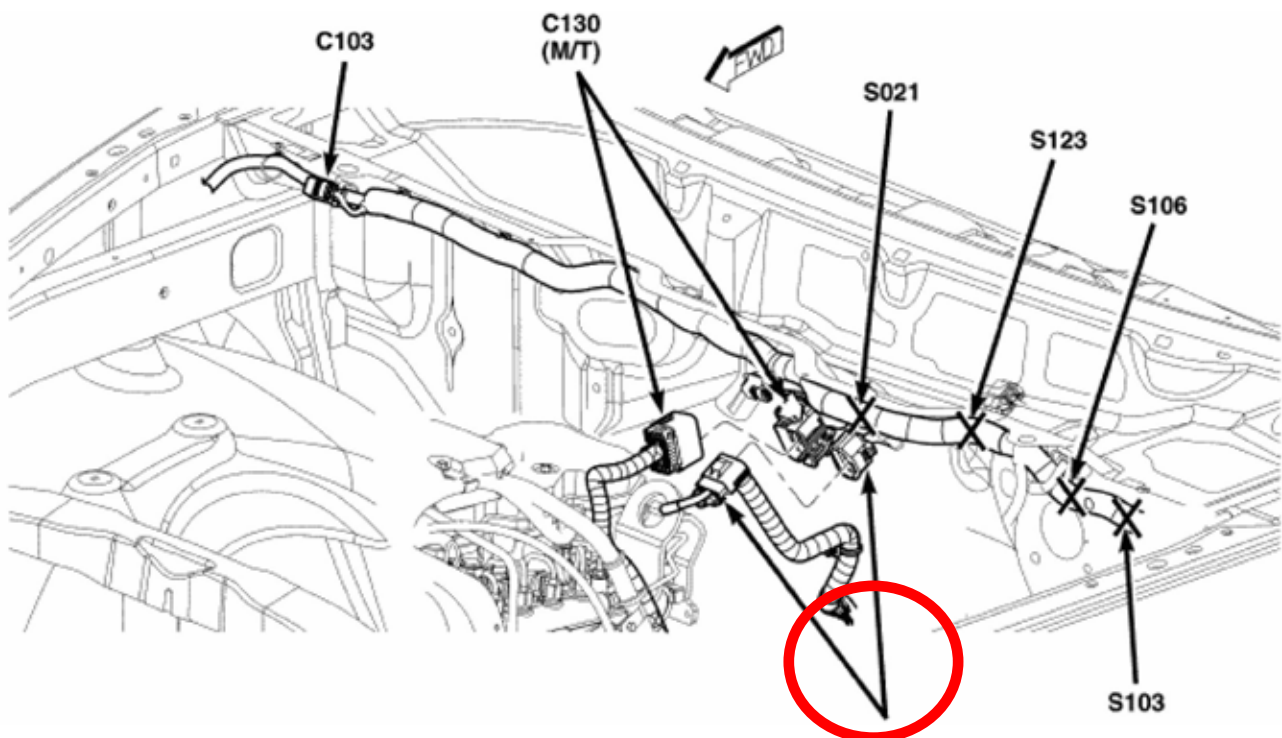
All of the above conditions can be related to problems with the K900 sensor ground. The K900 sensor ground is used for a multitude of sensors and can be accessed through the C132 connector. When inspecting the circuit for proper operation, note if reference voltage (5V) is available on the signal circuits for many of the vehicles sensors on vehicle that exhibit the concerns.

This indicates a ground problem exists in the vehicle related to those circuits. You can isolate the ground issue by measuring the voltage drop between circuit K900 and the battery negative terminal. If voltage drop exceeds .2 volts repair the ground issue. If a bad ground is indicated inspect connector C132 (located at the bulkhead) for corrosion and pin tension issues.

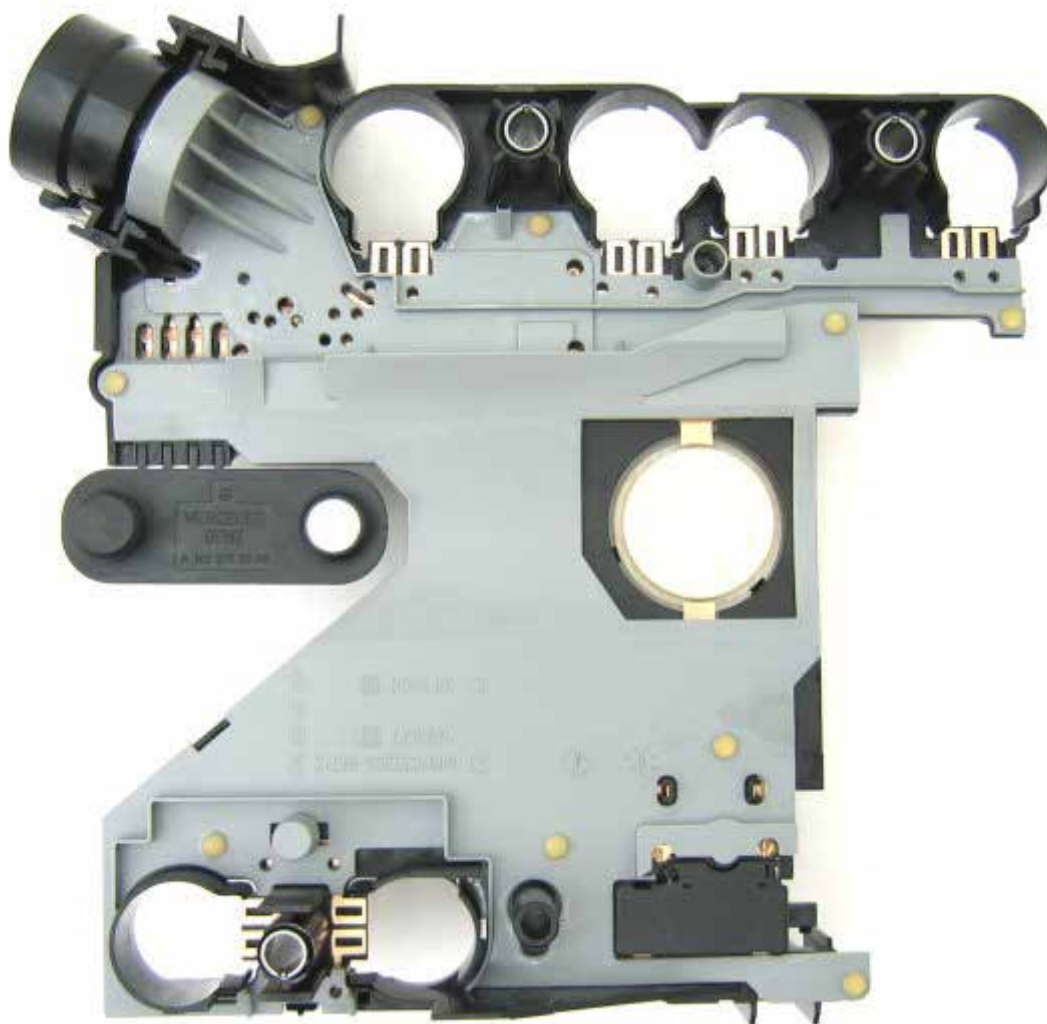
Some Chrysler applications using the 722.6 (NAG 1) transmission may experience a P2767 DTC related concern. P2767 is set if the TCM fails to see a signal from the turbine B sensor. This concern is likely to be intermittent and may be difficult to duplicate.

Replace the “Lead Frame Assembly”. The lead frame assembly houses the speed sensor and is now available as a separate part (Part number 68049181aa). Take care when tightening the screw as you can twist and damage the wires.
