# Welcome To Today's Presentation 6L80/6L90

Steve Garrett  
ATRA Service  
Engineer

6L80 6L90 Webinar ©2017 ATRA. All Rights Reserved.

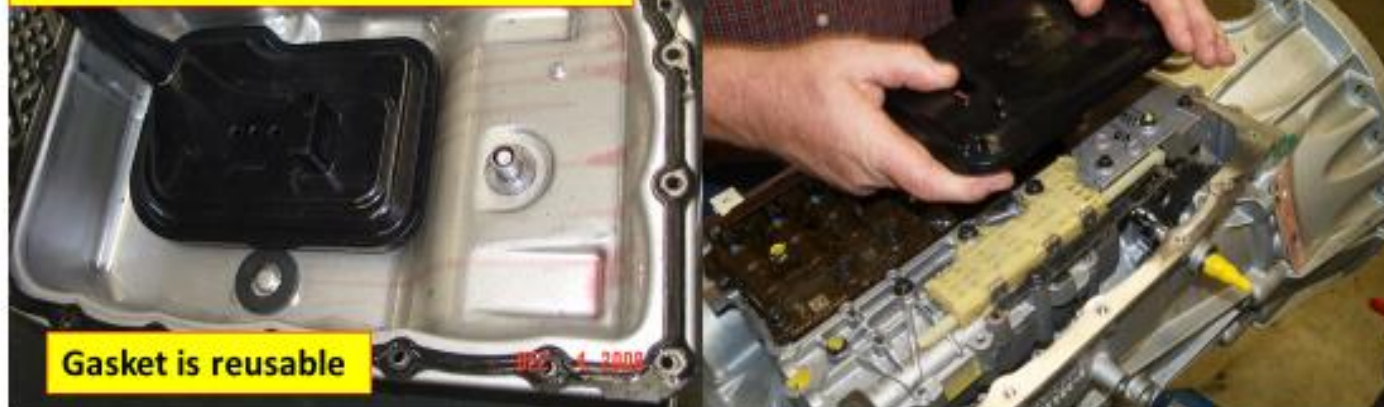
## Split Filters

**NOTE:** If the filter is split or broken it is NOT likely a problem with the filter or it's design, unless you are using a cheap import filter. Rather the issue is a pressure spike into the suction side of the pump/filter leading to filter damage. If this is the case, the pump and/or valves will require repair or replacement.

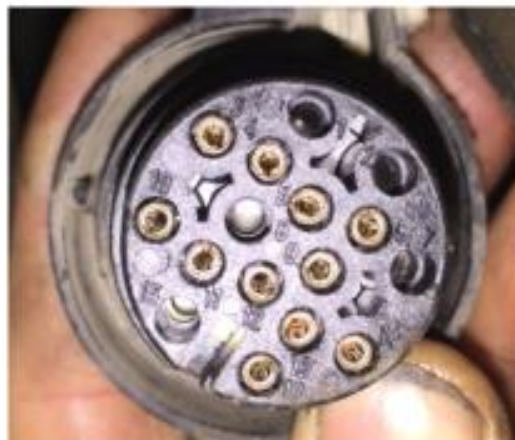
# No Crank, No Communication, PRNDL Inoperative

**Concern:** The vehicle may experience a No Start, or No Crank condition. In addition you may notice that the PRNDL display is blank although the IPC seems to function correctly. When a scan tool is attached to the vehicle you will likely be unable to communicate with any of the main modules such as the ECM, BCM or TCM.

**Cause/Correction:** Unplug the transmission electrical connector. If transmission fluid is present, the concern is likely caused by the fluid leaking into the electrical connector leading to a short to ground in the bus communication circuit. Clean the chassis side transmission electrical connector, replace the TEHCM.

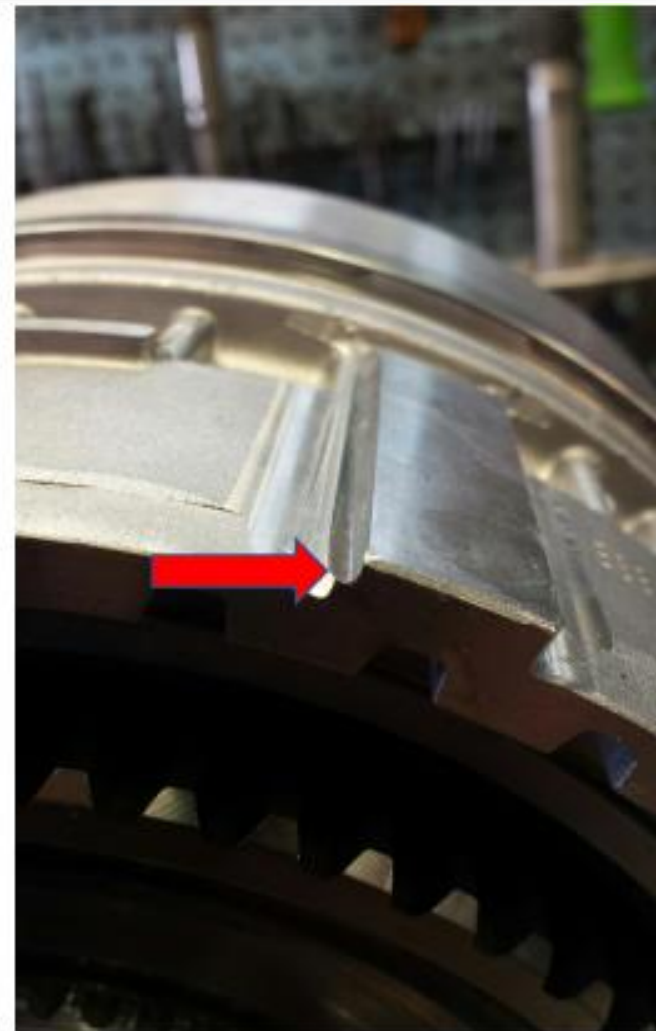
## Burned 2-6 Clutch, Inspect the Support For Wear

The supports are different  
part numbers for a 6L80  
verses a 6L90.  
And again different in a  
6L45-6L50.

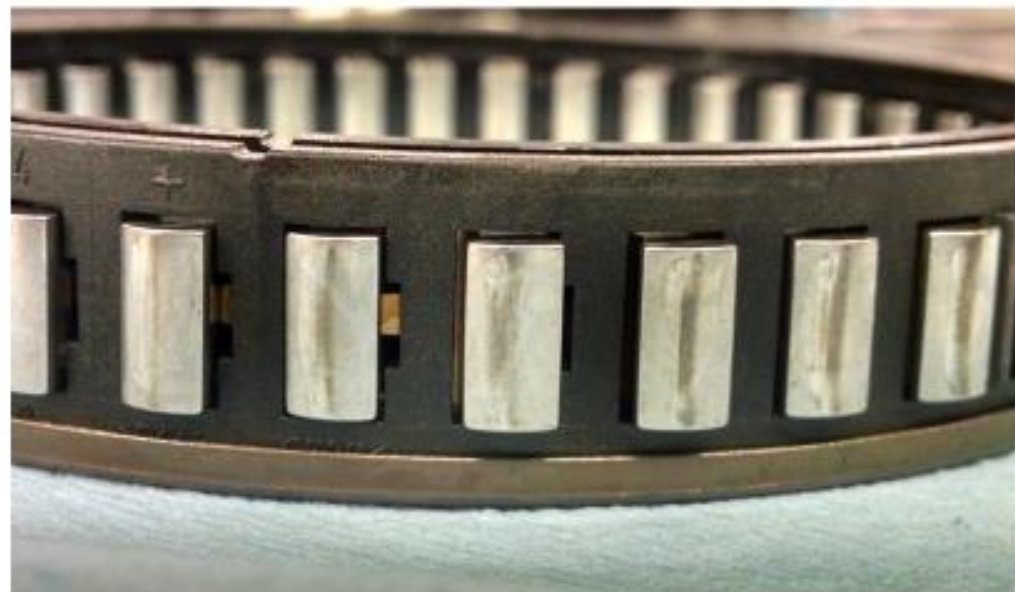
Failed Low Sprag

The chart should read ON/OFF in 1<sup>st</sup>.

- **Cause/Correction:** Monitor the command for Shift Solenoid 1. During initial launch in OD range, you will note that the solenoid is commanded into the ON position. As soon as the vehicle starts to move, the transmission will go to neutral and your scan tool will indicate the solenoid has been commanded into the OFF position. It should be noted that the command strategy indicated above is correct based on current calibration strategies being used. It should also be noted that the service and technical support information available for this unit does not include information about this solenoid command strategy. The objective of this strategy is to turn on the Low/Reverse clutch during initial launch and then to cycle the clutch off as soon as the vehicle is in motion. This is designed to improve durability of the Low Sprag. If the Low Sprag has failed, the transmission will go into neutral at road speeds above approximately 2 mph. In this instance inspect or replace the Low Sprag.

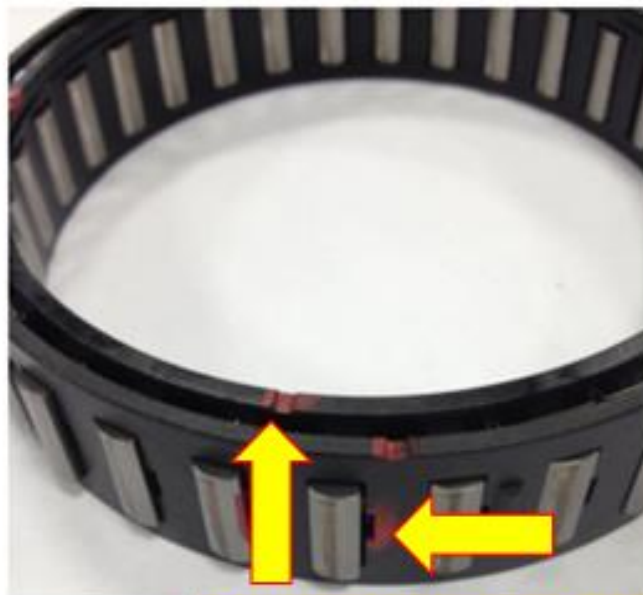
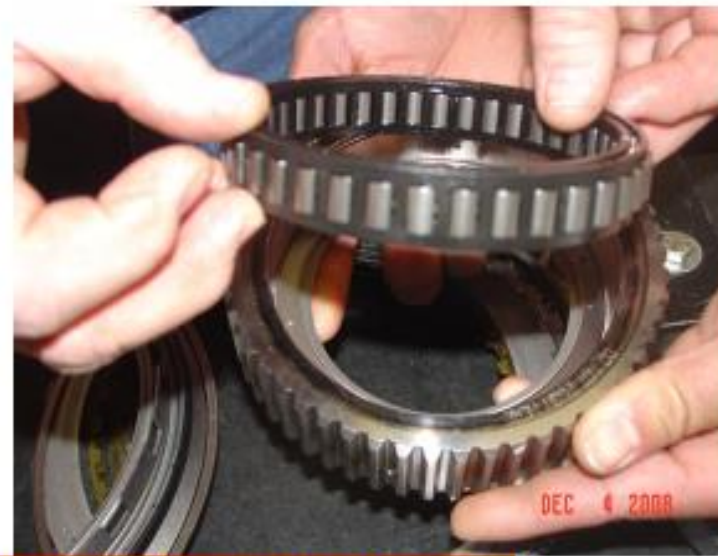
# Sprag Direction

Disassemble and inspect the sprag component, The sprag cage notches on the top face Up in the outer race.

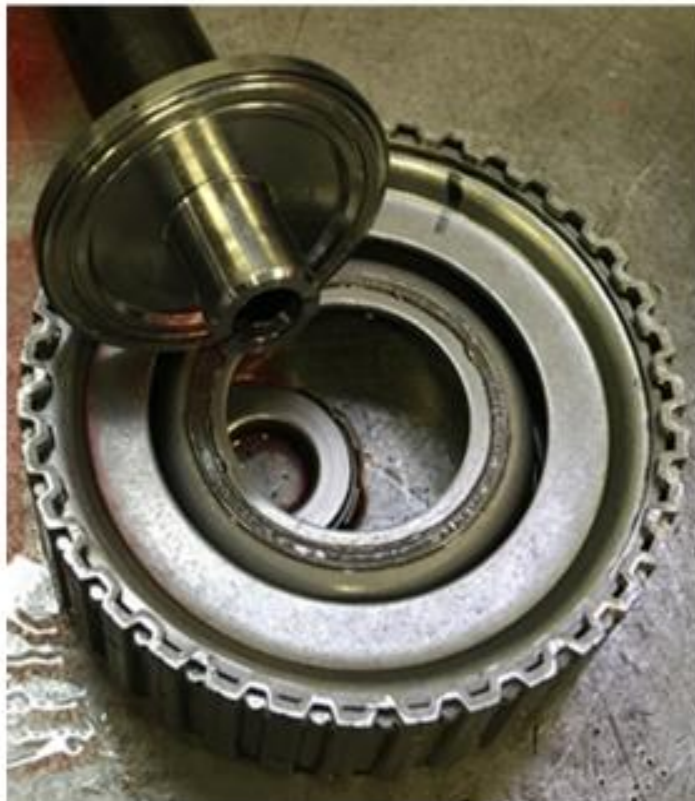
# P0796, No 4<sup>th</sup>, 5<sup>th</sup> 6<sup>th</sup>

Concern: No 4<sup>th</sup>, 5<sup>th</sup> or 6<sup>th</sup>, Possible P0796 set PCS 3 stuck off, MIL ON

Cause Broken 456 dampener drum

Correction: Replace the 456 dampener  
Inspect all dampeners for cracks

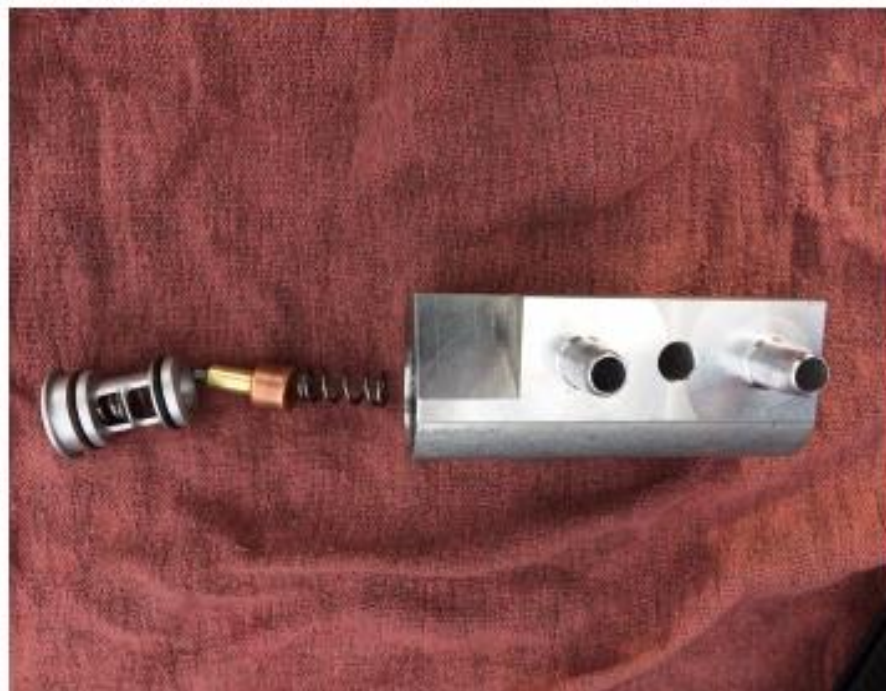
# Burnt 456 Clutch

- As we are aware damage to the 456 clutch is common on 6L series transmissions. While there are several causes, one that is typically over looked is a problem with the cooler bypass valve mounted to the case of some 6L transmissions. If the bypass valve is stuck transmission temperature can climb leading to premature failure of the clutch. Anytime you have a vehicle equipped with the bypass valve you will need to inspect the valve for proper operation. If the valve is found to be faulty it should be replaced.

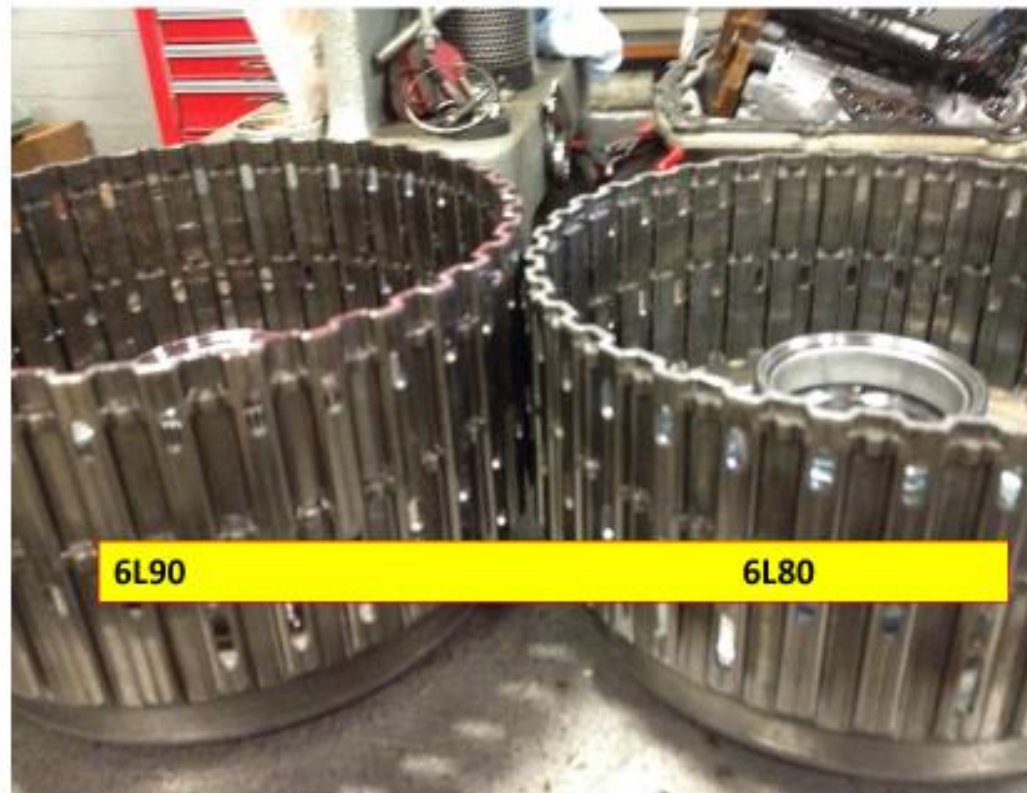
## 6L90 6L80 Drum Comparison

If you are having problems with clutch stack up and clearance after you replaced the 1234/35R drum it is likely due to someone giving you the wrong drum. The 6L80 uses a different drum than the 6L90 and a different clutch pack stack up.

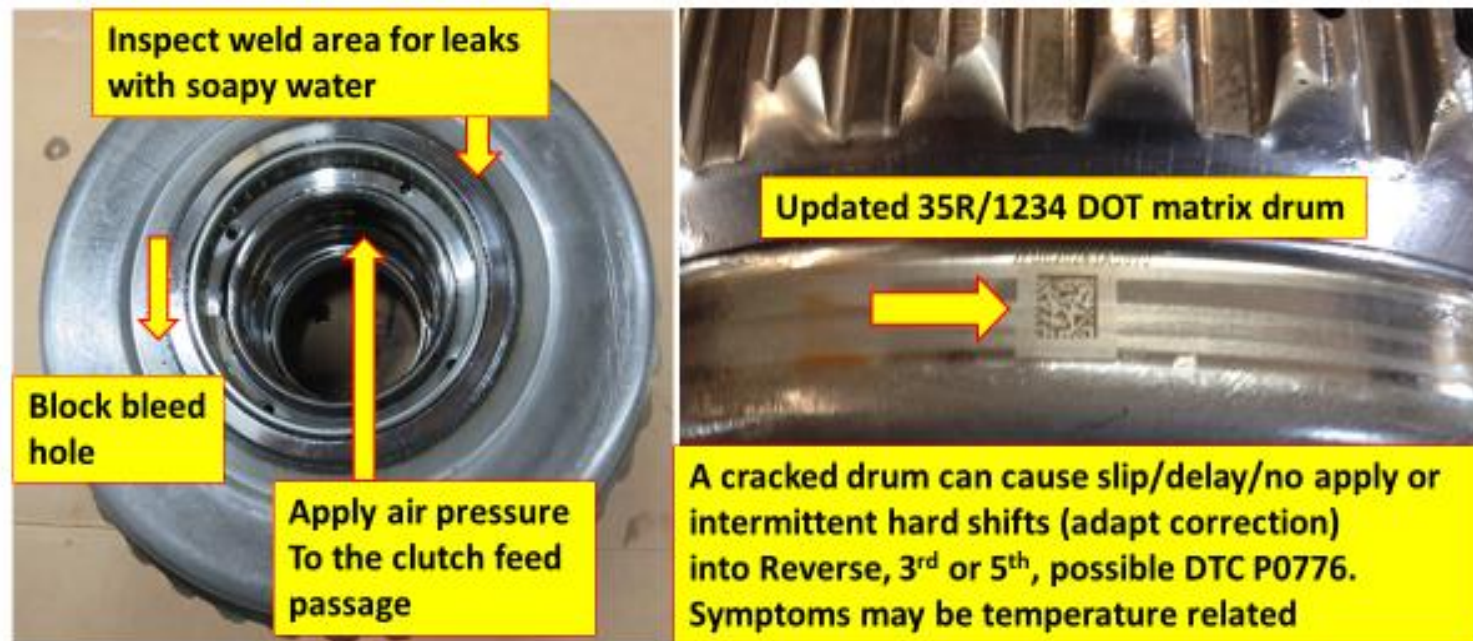
# 1-2-3-4/3-5-R Clutch Issues

Cracks in the 1<sup>st</sup> design drum were common leading to a burned clutch. To check the drum use air pressure and soapy water. Install the updated drum with the DOT matrix.

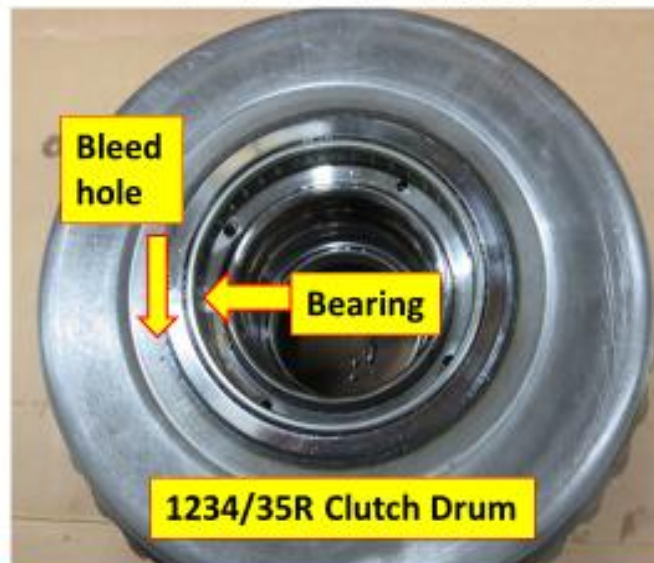
## 1-2-3-4/3-5-R Clutch Issues

Clutch piston designs changed in 2008. Clutch piston capacity was reduced by 20% for the 1-2-3-4/3-5 Reverse clutches. This updated piston is designed to limit the amount of oil volume required to stroke the piston. It is not designed to back service as Calibration was also updated with the change

When replacing the 1234/35R clutch drum make sure the bearing is installed in your new housing. Some housings do not include the bearing and it will need to be installed prior to transmission assembly.

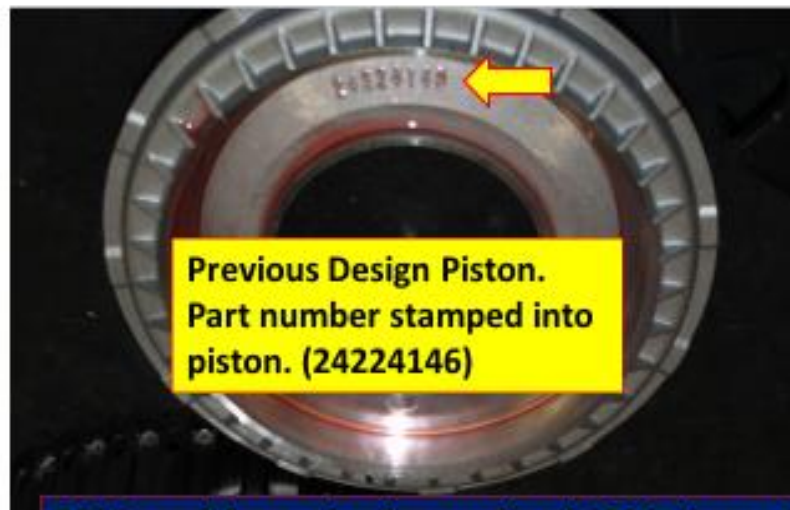
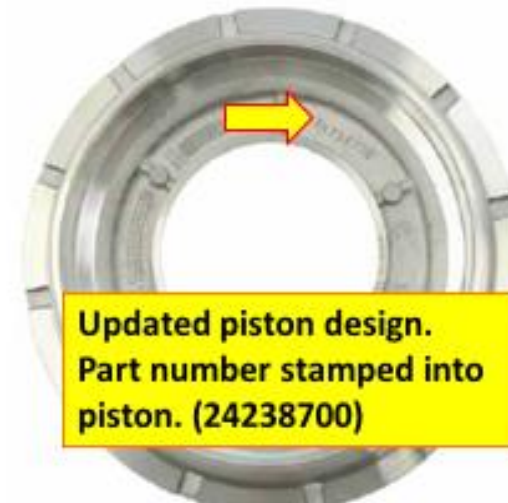
# 1-2-3-4 Clutch Issues

2011 models received an updated 1234 piston. The update was due to cracks developing in the piston leading to leakage and failure. (No movement forward/slips going forward, DTC's set) The updated design has the ribbing redesigned to address piston breakage issues. The updated piston has part number 24238700 cast into the piston. The updated design will back service 'most but not all' models and years. NOTE: The updated piston is also cracking, just in a different area, so you may want to consider using the aftermarket billet design piston.

**Always inspect the 1234 piston  
for cracks no matter which  
version piston you have**

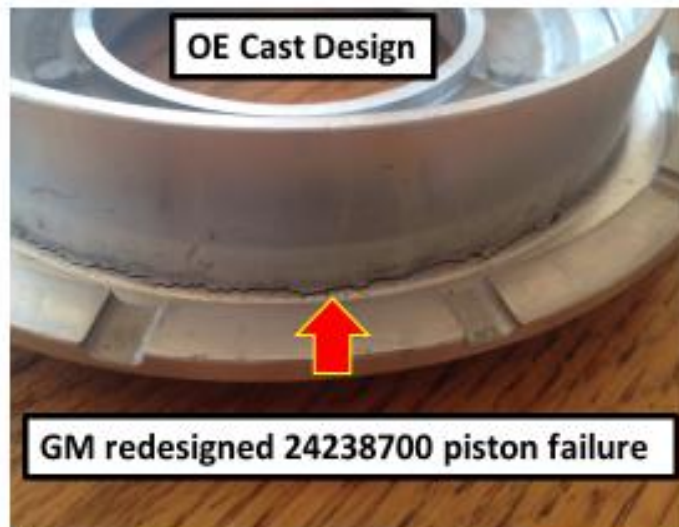
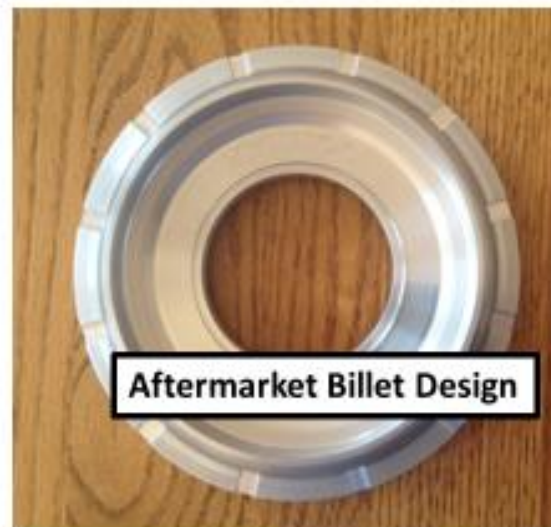
# 1234 Piston

A broken or cracked 1234 clutch piston is a common failure leading to burnt 1234 clutches and a slipping or no movement in 1<sup>st</sup> gear. GM redesigned the piston for this issue. The updated piston is still cracking with one exception, rather than a crack in the piston cavity, the updated design may crack where the piston contacts the plates or it can be cracked in both locations.

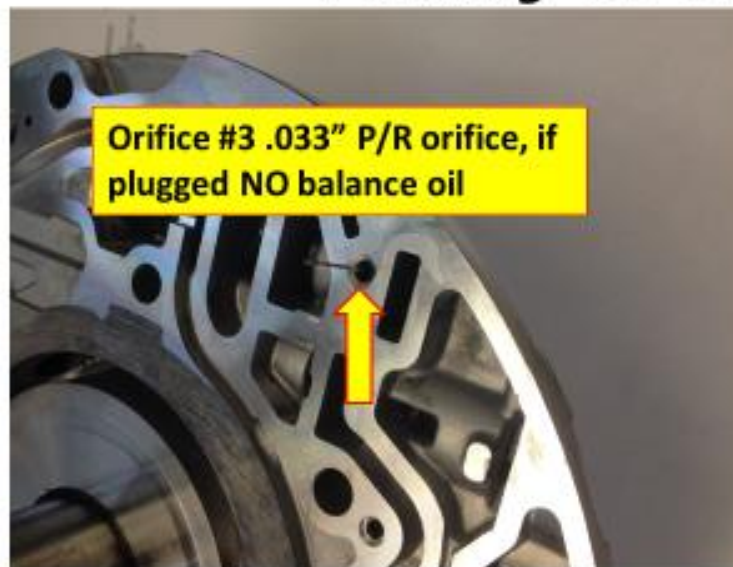
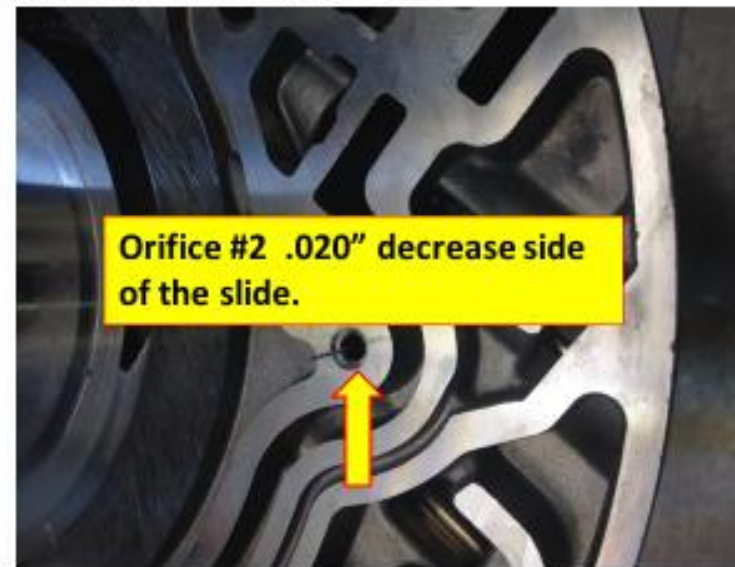
## Restricted Orifices are an Issue on the 6L Family of Transmissions

Converter damage can lead to restricted orifices.  
Always check and clean ALL pump orifices

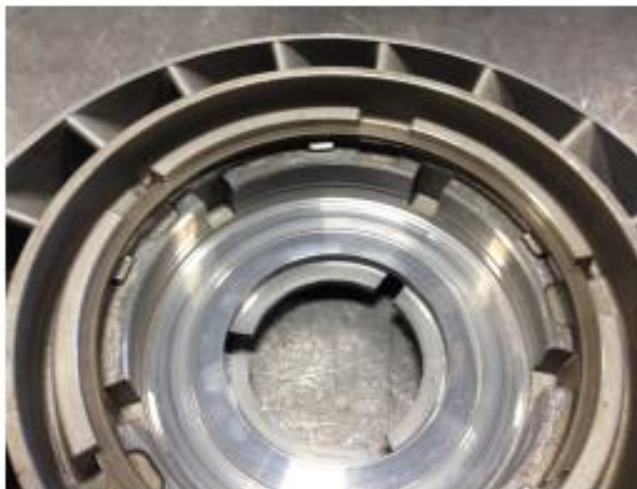
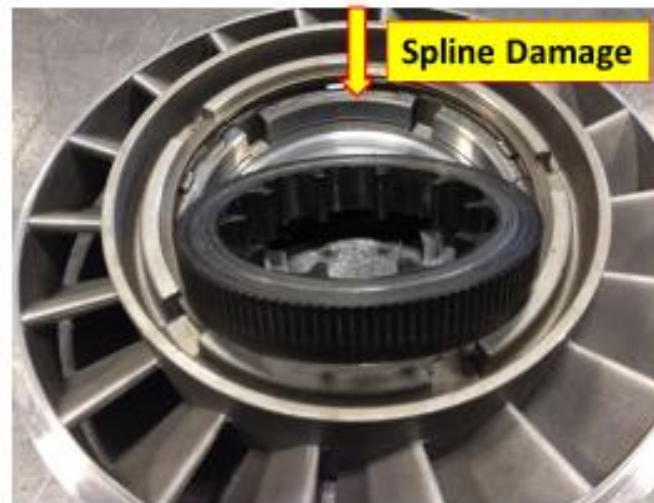
## 6L80/6L90 Converter Failure is Common, Flush/replace the Cooler, Clean the Pump Orifices

One Way Clutch outer splines damaged in the stator clutch pocket.

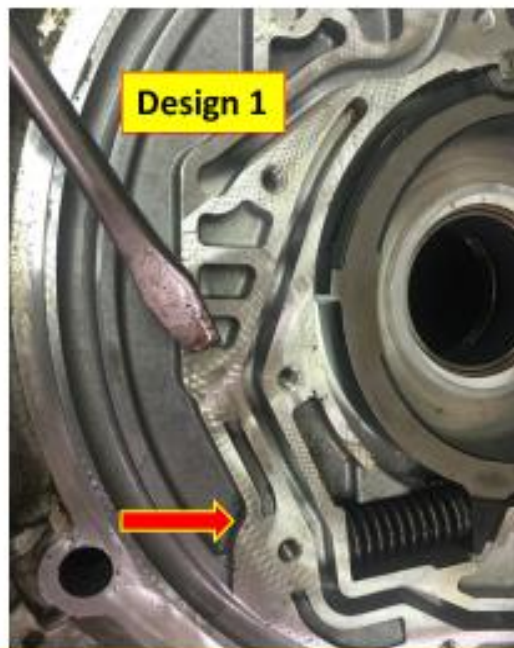
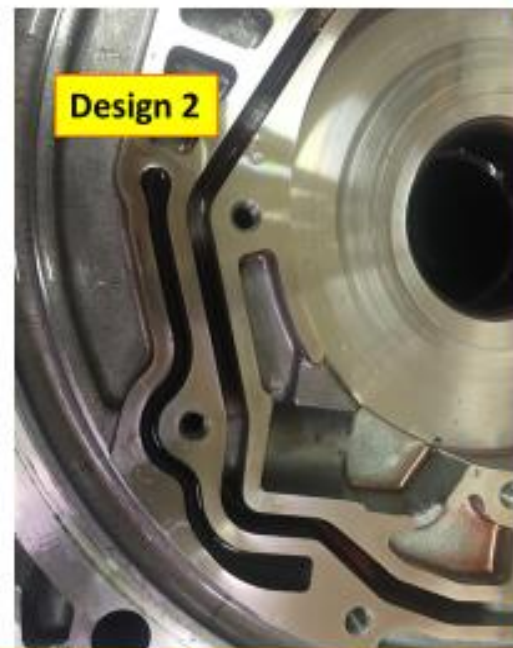
## Pump/Bell Housing Differences, Design 1 and 2 Castings Can Be Interchanged

**Note:**  
All new 6L pump components are coated with a corrosion inhibitor. This inhibitor needs to be removed with brake clean. Valve sticking or orifice restriction issues may occur if not removed.

Always inspect the passages in your new pump half for restrictions due to machining issues. We have seen several instances where there is no boost after pump half replacement.

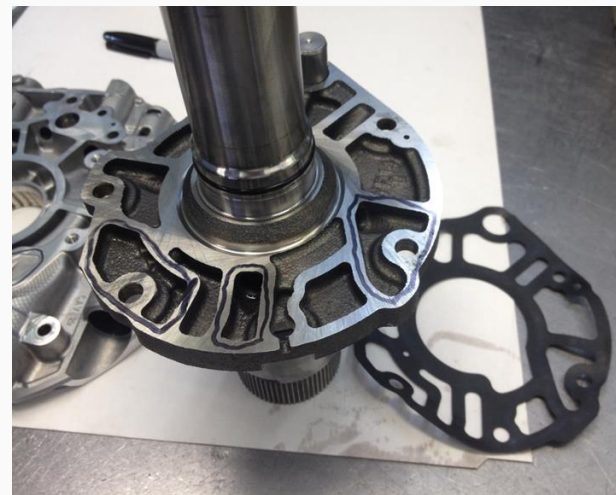
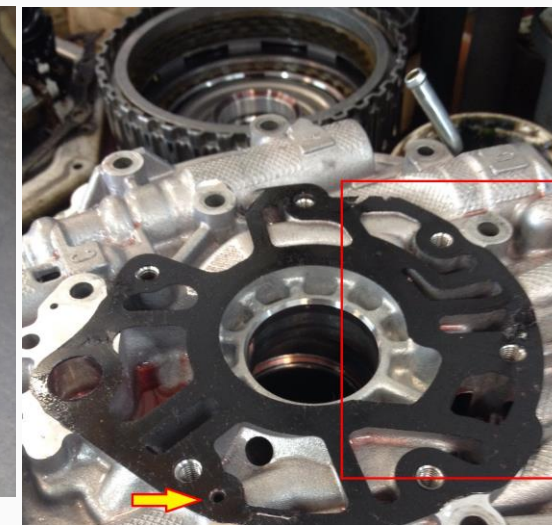
# 6L80/6L90 Delayed Engagement, Slip, Shudder, Clutch Damage

Inspect the gasket in the area shown for damage. Note; Do not lose the orifice shown by the arrow as it can create an overheat condition can occur.

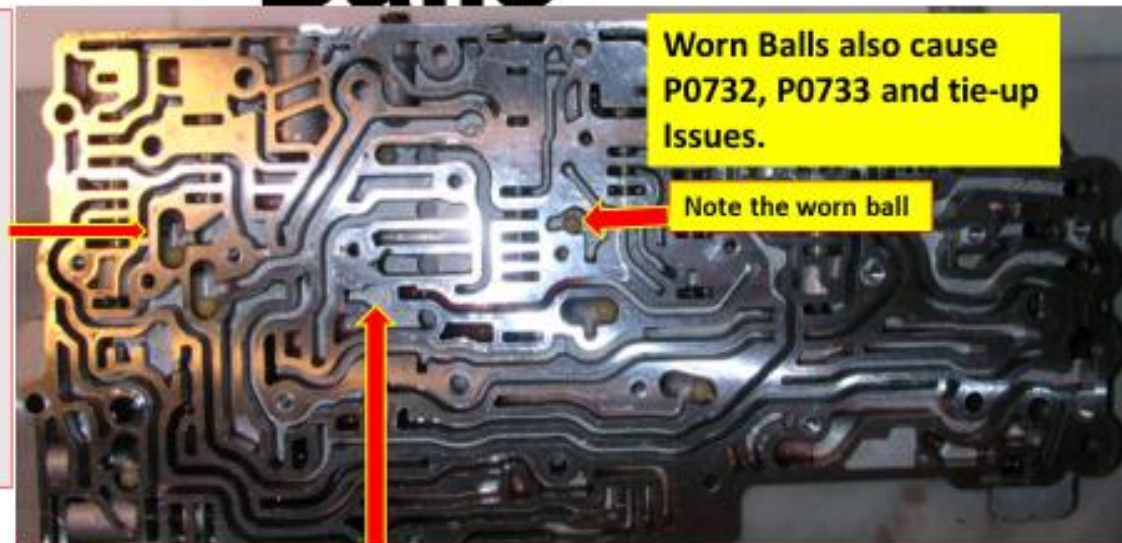
Check ball wear is common on the 6L series applications. Wear may cause the ball to stick in the spacer plate hole. The most common ball to wear is check ball #1. This may lead the transmission to a neutral on the 1-2 shift, no forward or a slip during forward operation. The conditions may be intermittent.

Check ball #8 Update. #8 ball was added for the 2014 model year. The valve body contains a pocket where the #8 ball was placed, although on previous model year applications the pocket never housed a ball. To utilize the ball, the spacer plate was also updated. This update is designed to address a acceleration/deceleration clunk, garage shift engagement and DTC issues that some customers may find objectionable. 4 different plates were produced, 1<sup>st</sup> design, 2<sup>nd</sup> design P0751, 3<sup>rd</sup> design, glue change, 4<sup>th</sup> design 35R volume reduction. Updated plate 24272467 will fit 2010-2016

Plate 24245720  
Should be used on  
09 and earlier  
applications.

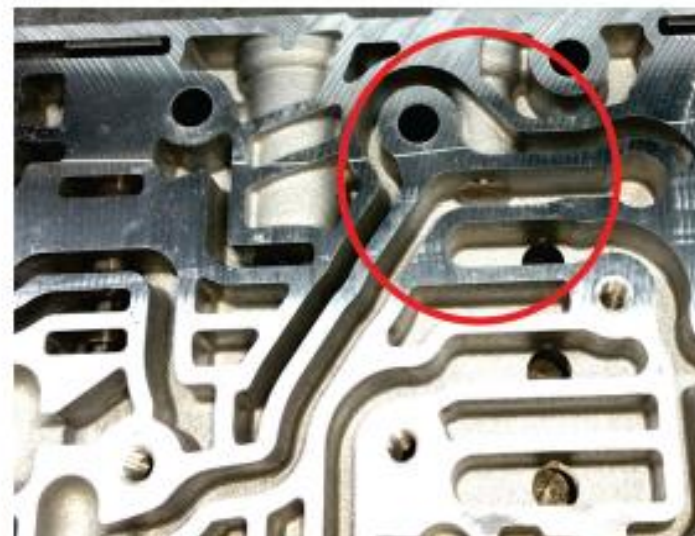
# Delayed 3<sup>rd</sup> or Reverse After Repair

The 2 bolts that mount to the “Side” of the TEHCM are a different length as compared to the other attaching bolts. Using the wrong length bolts in this location may lead to problems with clamping the TEHCM and Valve body tightly together leading to a slight leak and possible VB channel damage.

The 2 side bolts are 53mm (2.08”) long, while the other TEHCM mounting bolts are 55mm (2.16”) long.

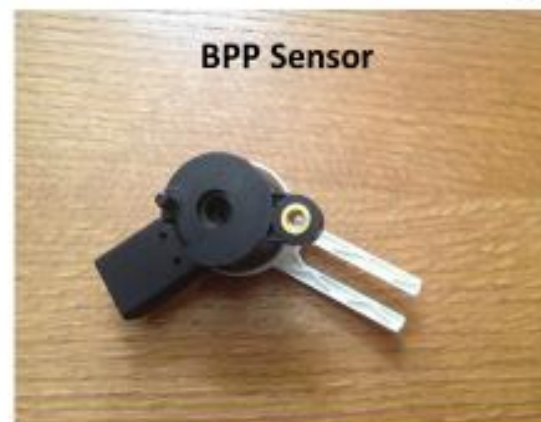
BPP Sensor

The above parameters indicate the current BPP sensor voltage is now 1 volt and at some time it has been as low as .5 volts. Since the ECM compares the learned value to the current sensor voltage value the ECM thinks the brake pedal is partially depressed (22%).

If a problem is indicated inspect the sensor 5 V reference, circuit 5359 and the sensor signal circuit 5361 for opens and shorts to ground prior to replacing the sensor.
