# ATRA WEBINAR

## 6T70 Product Issues and Updates

Presented by:  
Steve Garrett  
ATRA

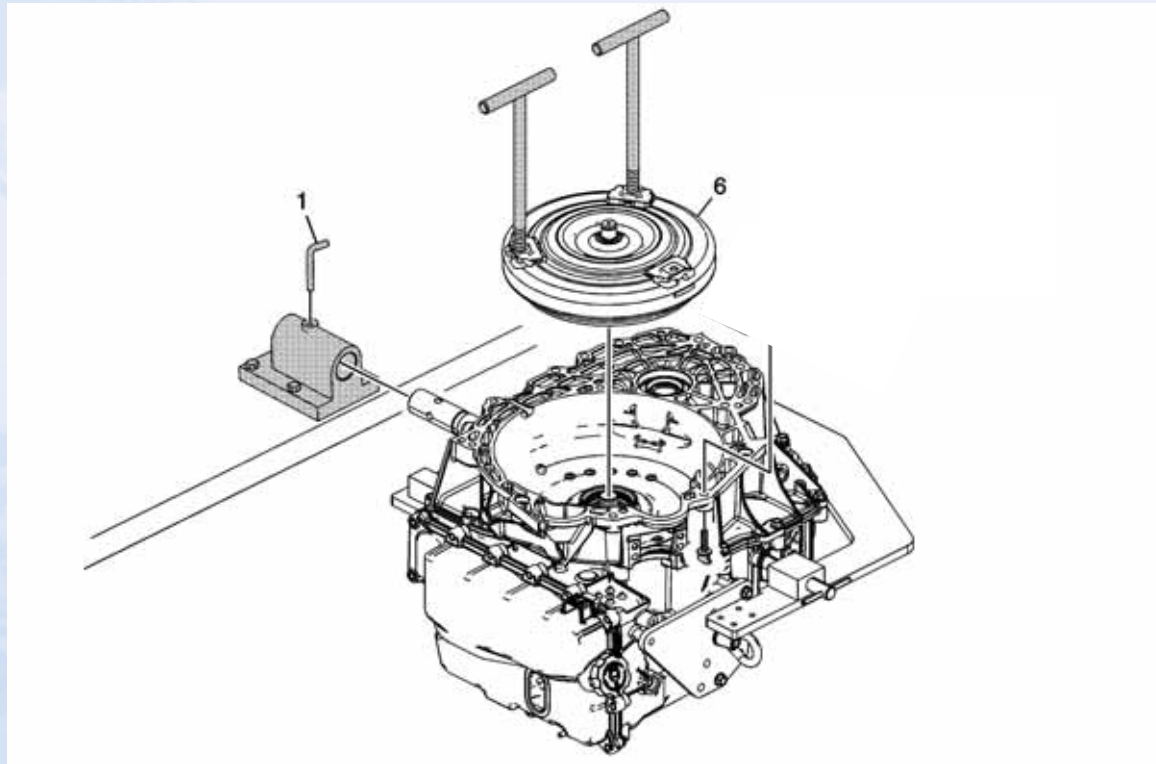
Torque Converter needs to be raised vertically

No seal on turbine shaft, lip seal is located inside of converter and can be damaged if converter is removed or installed horizontally

Use J-46409 to lift Torque Converter

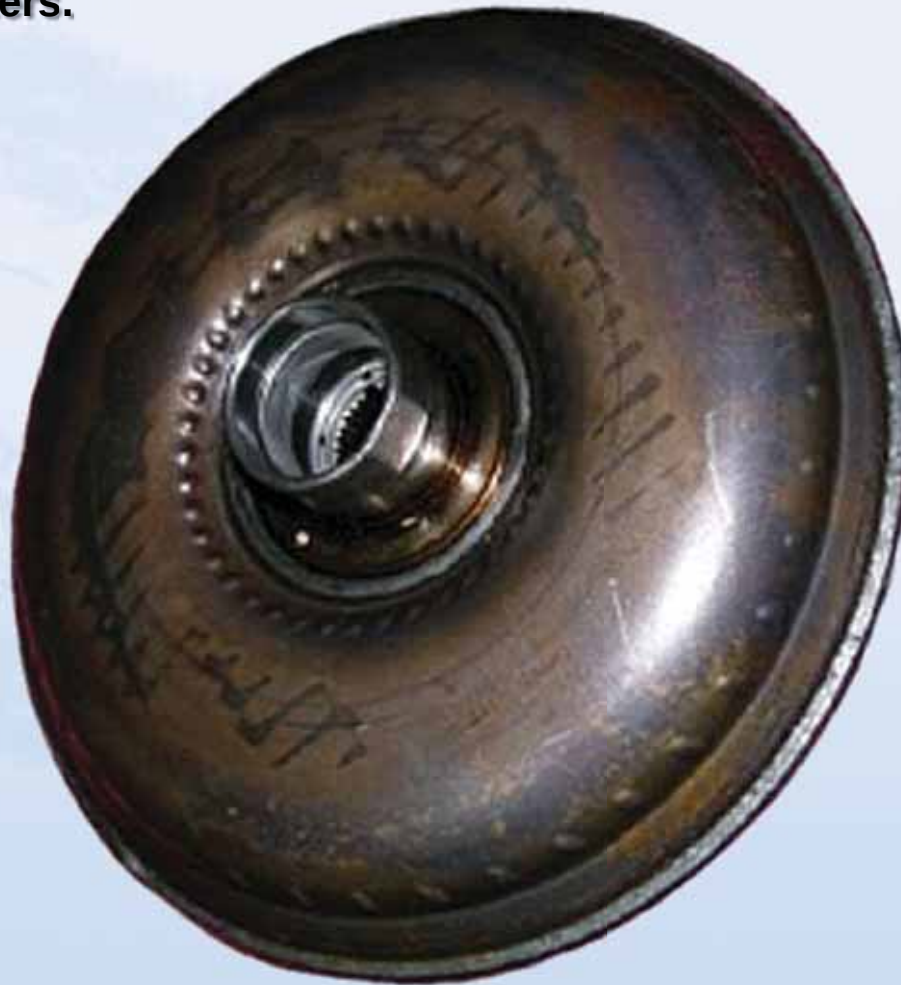
## Converter Discolored

Some 6T70 applications (RPO MH2, MH4, MH6 or MY9) may exhibit a dark or blue color in the metal of the torque converter. You may notice what looks like dark circles in the discoloration. This condition is typically on the hub side of the converter and is not present on all 6T70 torque converters.

If the whole converter is not discolored and evidence of an overheating condition is not present, DO NOT replace the torque converter.

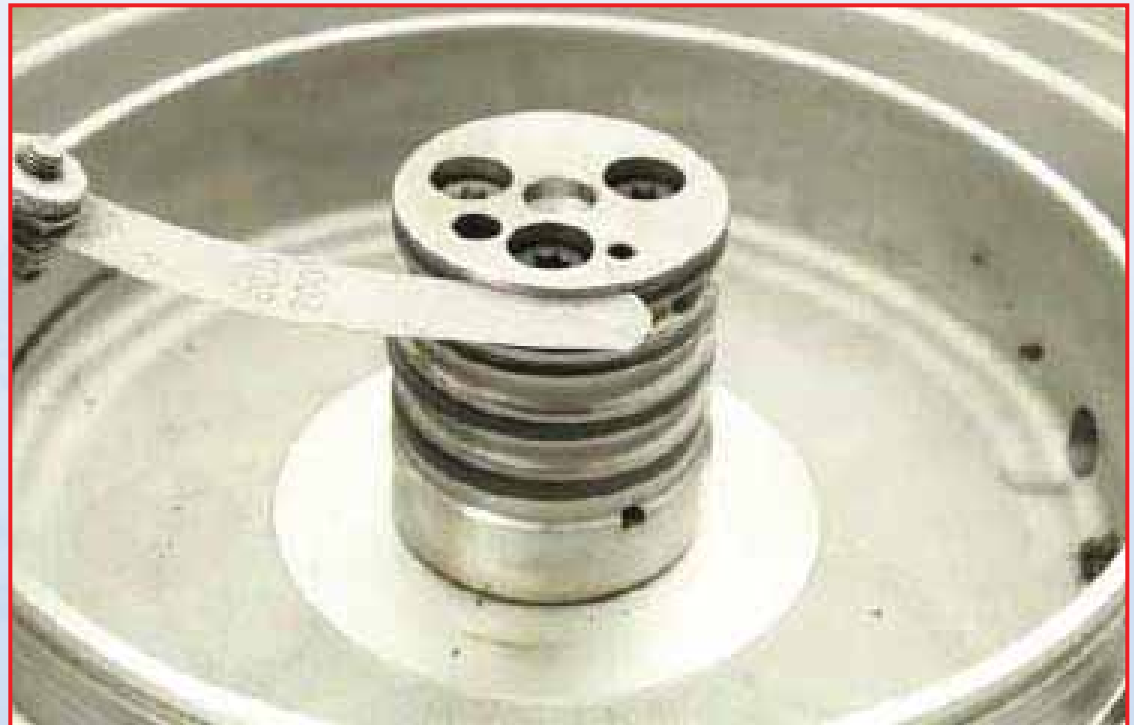
## Binding on a 3-4 and 4-3 Shift, Possible P0797 Set

On 6T70 and 6T75 applications the customer may comment regarding a bind on a 3-4 or 4-3 shift. A worn ring groove on the case cover hub sleeve will result in a leak between the 3-5 Reverse clutch and the 4-5-6 clutch fluid circuits.

This will result in the tie-up condition the customer is experiencing.

Remove the hub from the rear case cover and inspect the ring grooves and rings.

Measure the distance with a feeler gauge between the edge of the groove and the ring (Maximum clearance is .007").

If the distance is too great replace the case cover.

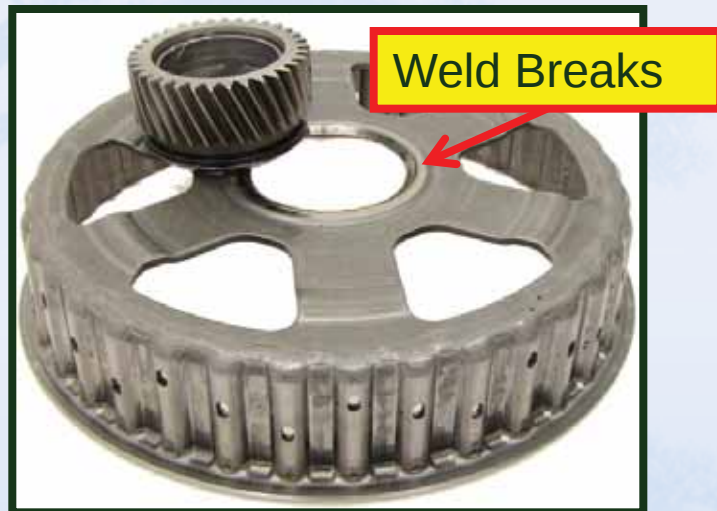
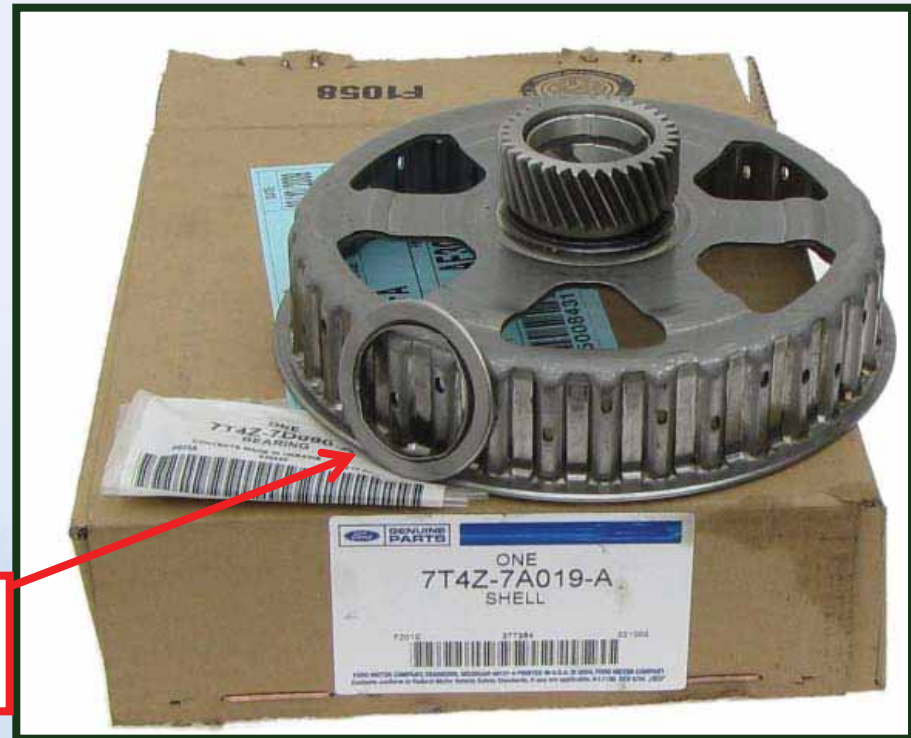
No Reverse, 3<sup>rd</sup> or 5<sup>th</sup> Gears Possible P0776, P2723, P2715 set

This condition primarily affects transmission built prior to the 2010 model year  
Updated parts are available from GM and Ford to address the issue

New Shell comes with the #3 thrust bearing

Keep diagnosis simple:  
Unplug the transmission to see if Reverse is being prevented electrically. If reverse engagement is ok, the shell is not the problem.

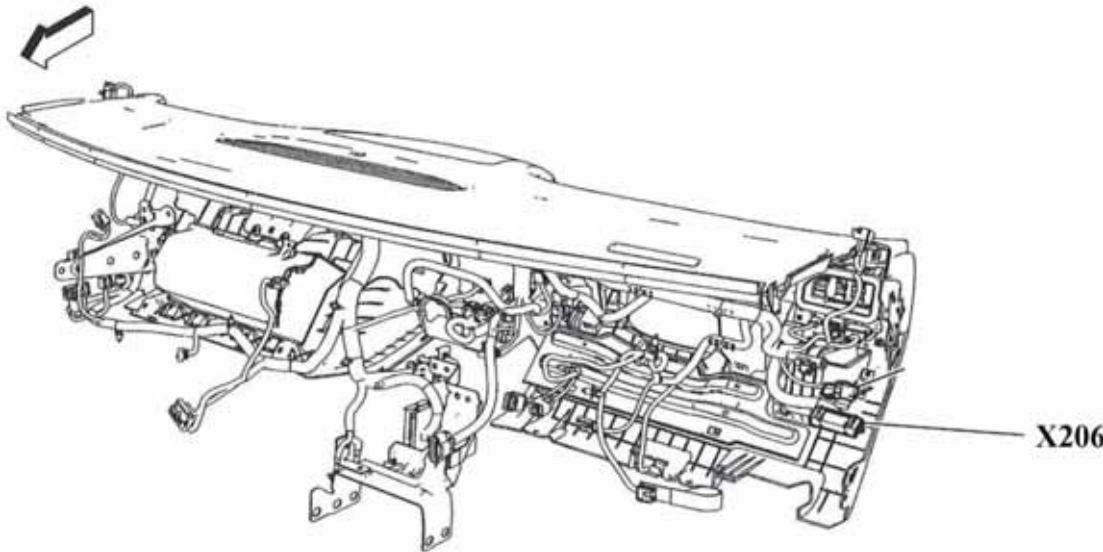
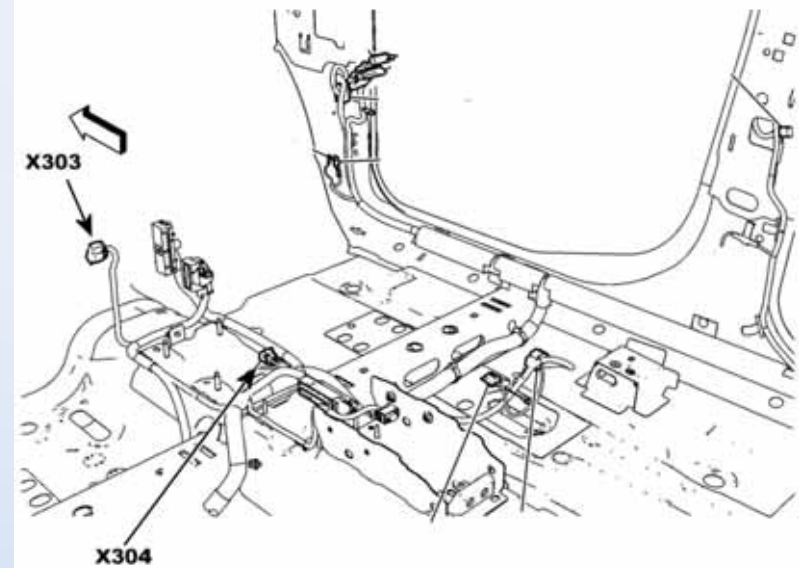
## PRNDL Doesn't Illuminate

GM Z body (Malibu, Aura 6T40/45 (RPO MH7/MHC) 6T70/75 (RPO MH2/MH4/MY9/MH6) applications may exhibit a condition where the PRNDL display does not indicate the gear position the customer has selected.

**This condition in many instances is intermittent and difficult to duplicate.**

Inspect circuits 5981, 5982, 5983 and 5984 for poor or damaged connections between the Instrument Panel Cluster, Body Control Module and the Shift Lever assembly. Inspect connectors X206, X303 and X304 for damaged or loose terminals.

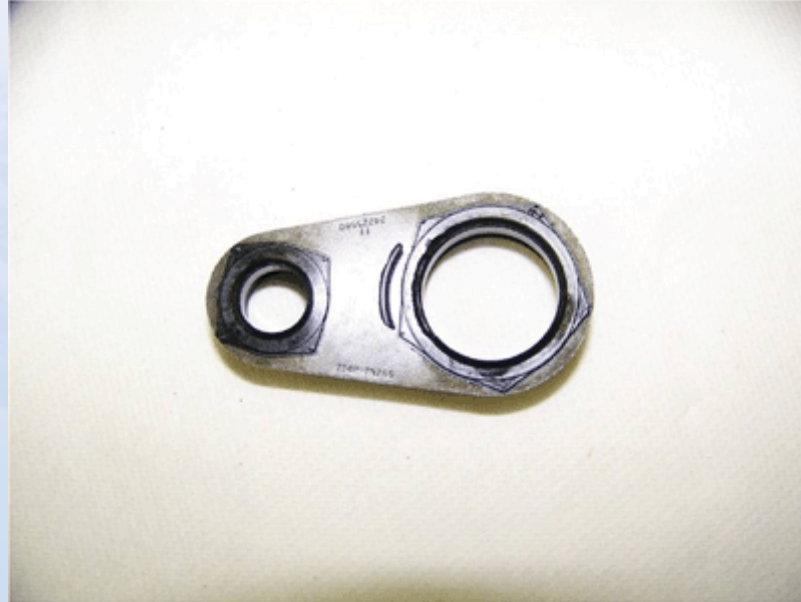
# 6T70-75 Delayed Engagement , Slip Concerns

**Check line pressure at idle, if low inspect the pump outlet seal for damage.**

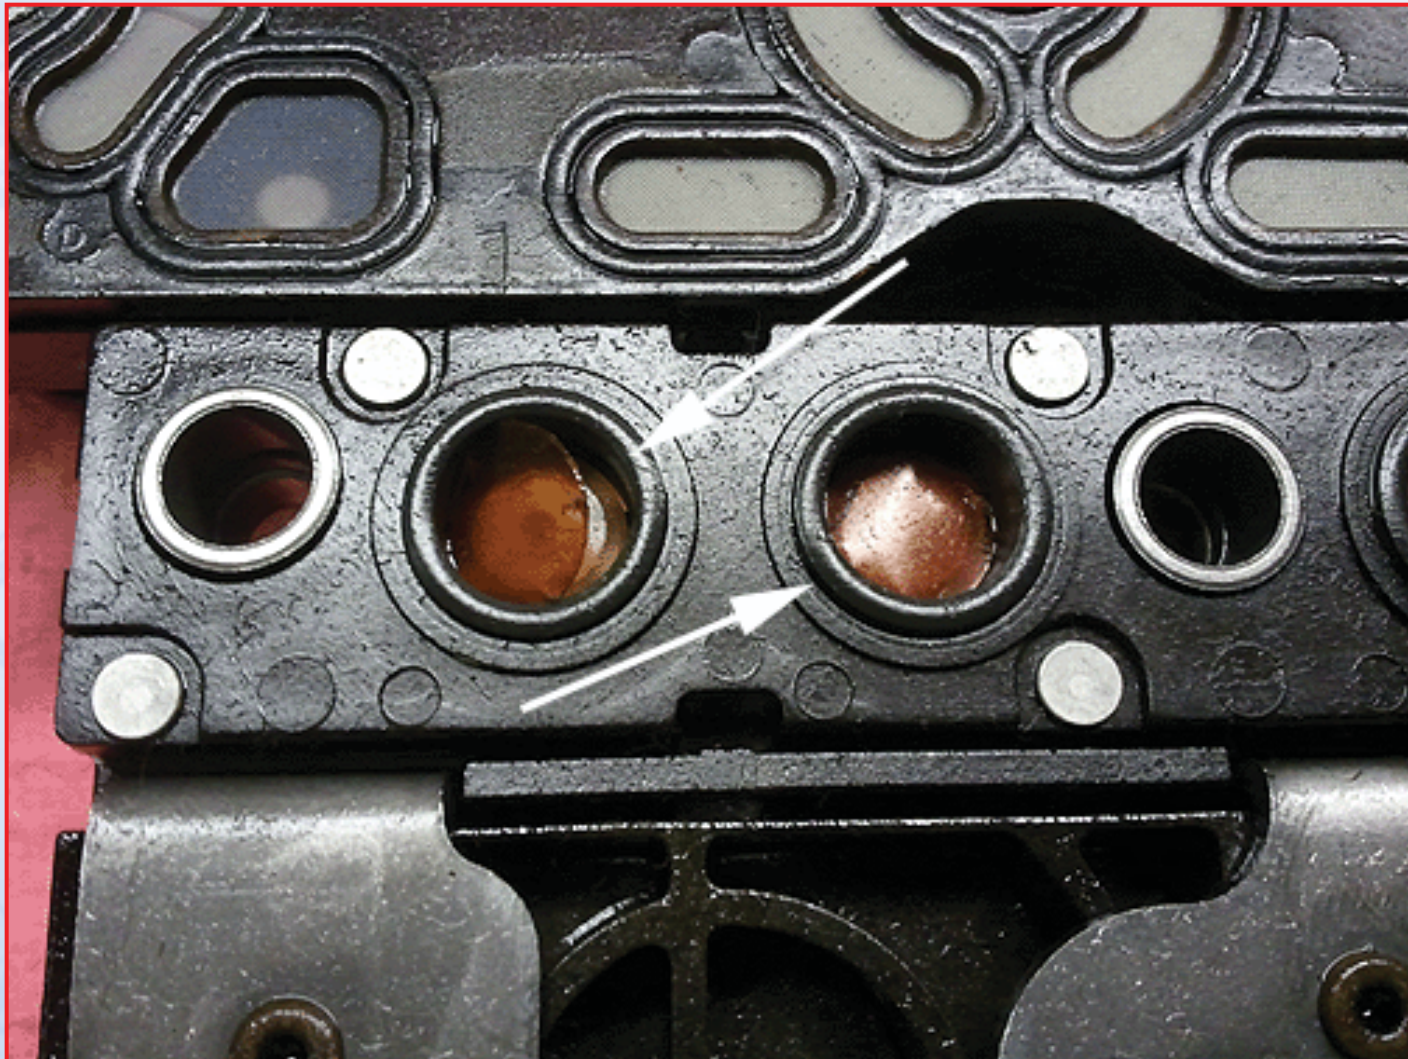
**DTC's P0752, P0872, P0877, P0989, Fluid Pressure Switch Issues**

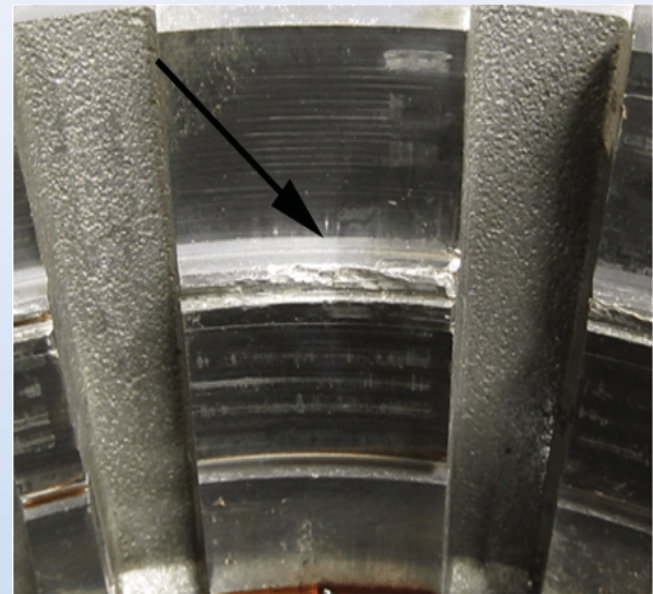
# **3-5 Reverse Wave Plate Broken**

**This condition may be caused by a broken 35R clutch wave plate allowing the apply piston to over-stroke, causing the piston to leak and causing loss of apply**

**Cause for concern**

Install the updated wave plate anytime the transmission is apart for a repair  
If it is a 2010 or earlier application. **P/N 24254103**  
Inspect the case for signs of damage

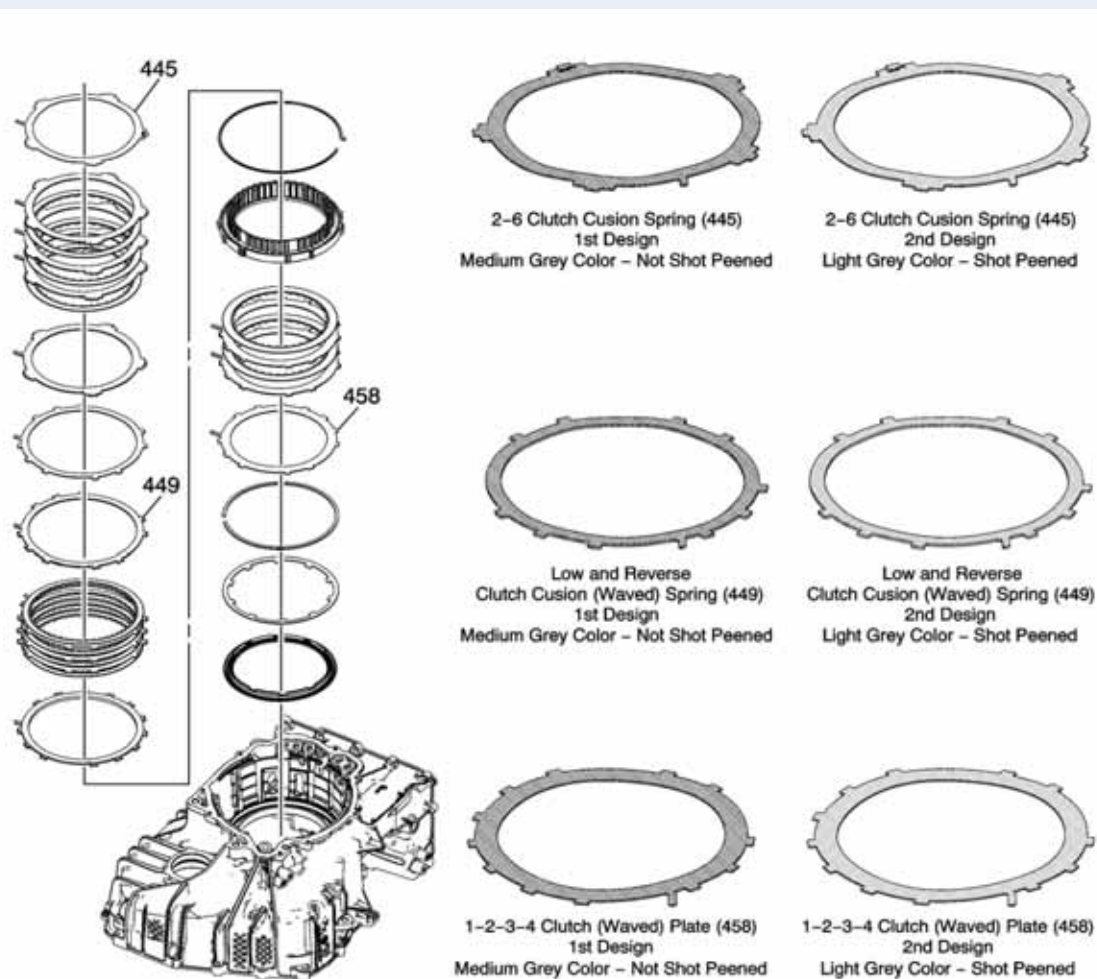
## Planetary Damage Due To Wave Plate Breakage

**THE 3-5 REV**

**WAVE IS THE MOST**

**COMMON ONE TO**

**BREAK**

To prevent damage from occurring to the new gear set or if you are repairing one of these units and the planetary is not yet damaged, you should install the new design wave plates in all of the clutches.

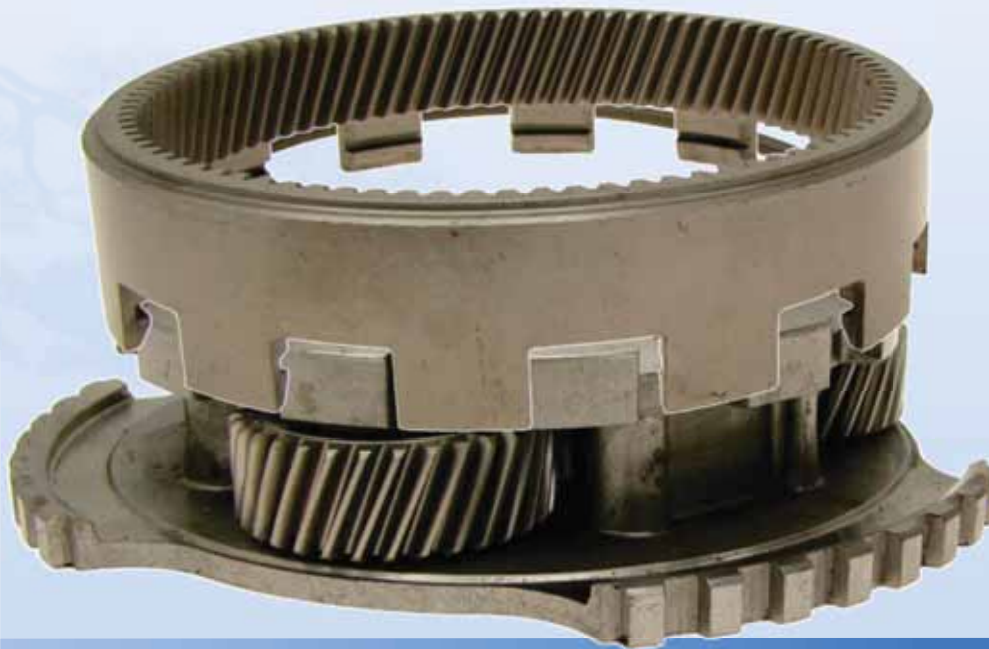
**In many publications the reaction carrier and the input ring gear are shown as a one piece assembly. In reality, the reaction carrier, input ring gear and ring gear snap ring are serviced as separate pieces. If the technician fails to install the ring gear onto the reaction carrier a no drive condition will result. To repair the condition, install the ring gear.**

## Planet Damage, No Movement, DTC 2723

Parts Catalogs Show This  
Planet Assembly As One Piece
