Allison LCT1000

Presented by:
Mike Souza
ATRA Senior Research
Technician

Allison LCT1000 Webinar ©2014 ATRA. All Rights Reserved.

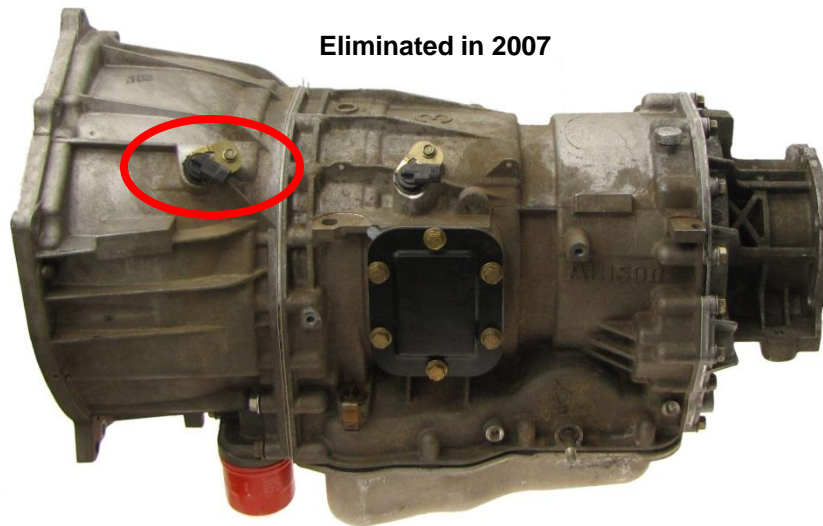
Eliminated in 2007

The Engine Speed Sensor monitors the protrusions (dimples) on the torque converter. The gap between the engine speed sensor and the converter dimples is approximately 0.033”.

Damage to any of the converter dimples will result in an uneven signal from the engine speed sensor to the TCM causing a complaint of torque converter surge without setting codes.

This drop in signal can be monitored with an oscilloscope and may not be caught on scan tool data. This sensor was eliminated in 2007.

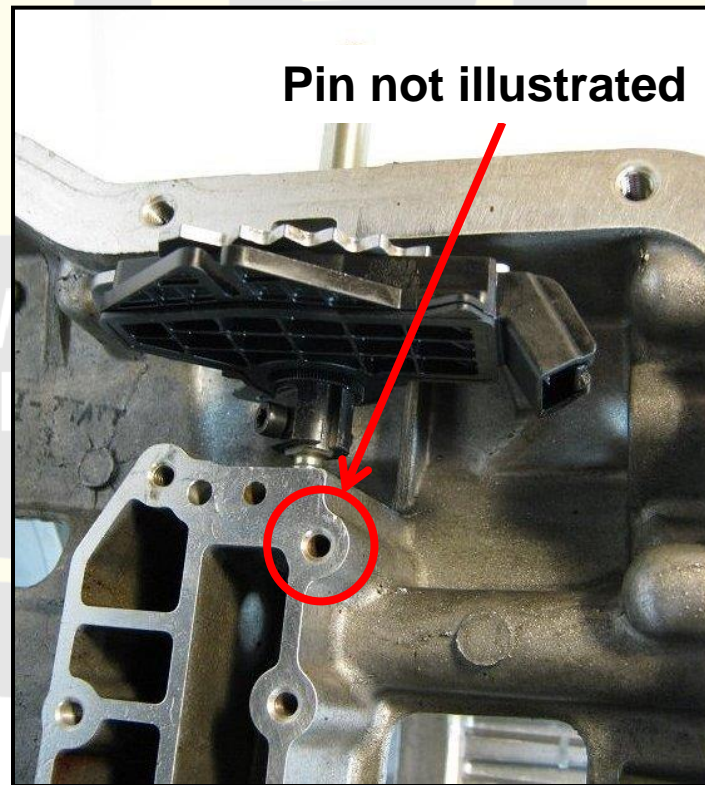
Care needs to be taken when replacing the Internal Mode Switch (IMS) in the LCT1000 units. The retaining pin holding the manual shaft into the case is set at a specific length/height (measure and record). To prevent damage to the roll pin, insert a drill into the roll pin to prevent the pin from collapsing when being removed. When assembling use the following procedures:

- 1: Place the new IMS in position in the case. Rotate the detent to connect the park rod. Install manual shaft through the IMS
 - 2: Seat the shaft and install the spherical pin (remember pre-set)
 - 3: Torque IMS retaining bolt to 92 lb. in. (T27 bit)
- Install the valve body and pan for fill.
- Important: Fast learn adapt procedure must be performed after switch replacement**

Pin installed height is 0.335" to 0.354" above the surface.
Special tool number J43766

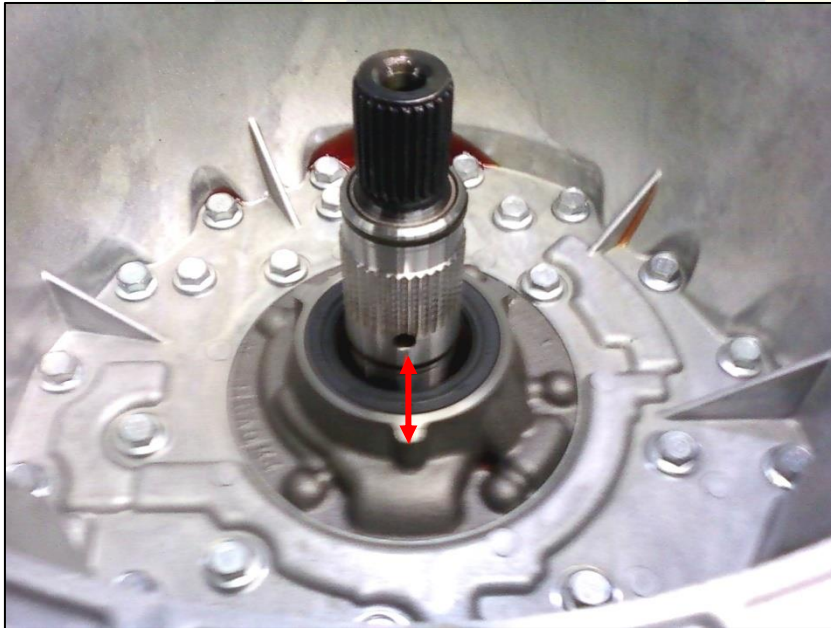
CORRECT – Holes in stator shaft are oriented properly at 12 and 6 O'clock.

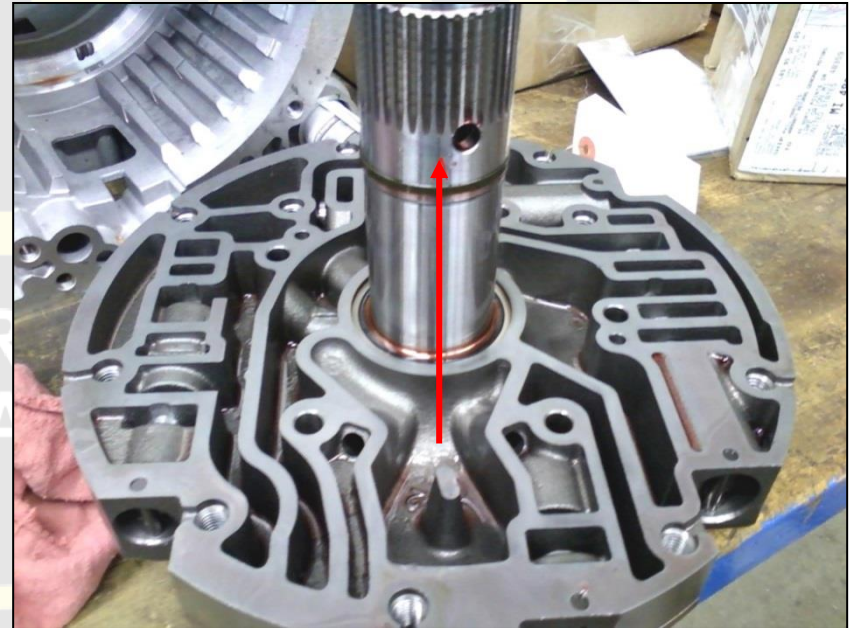
WRONG – Holes in stator shaft are twisted CCW from original position. Improper internal flows result in P0741 and possible P0218.

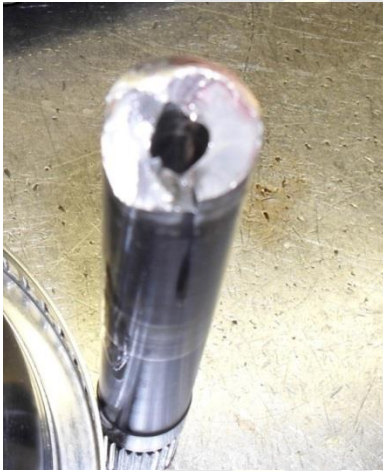
Broken turbine shaft. Examine failure mode. This break was material flaw due to the longitudinal quench crack. A smooth break at the end small spline may indicate *overpower.*

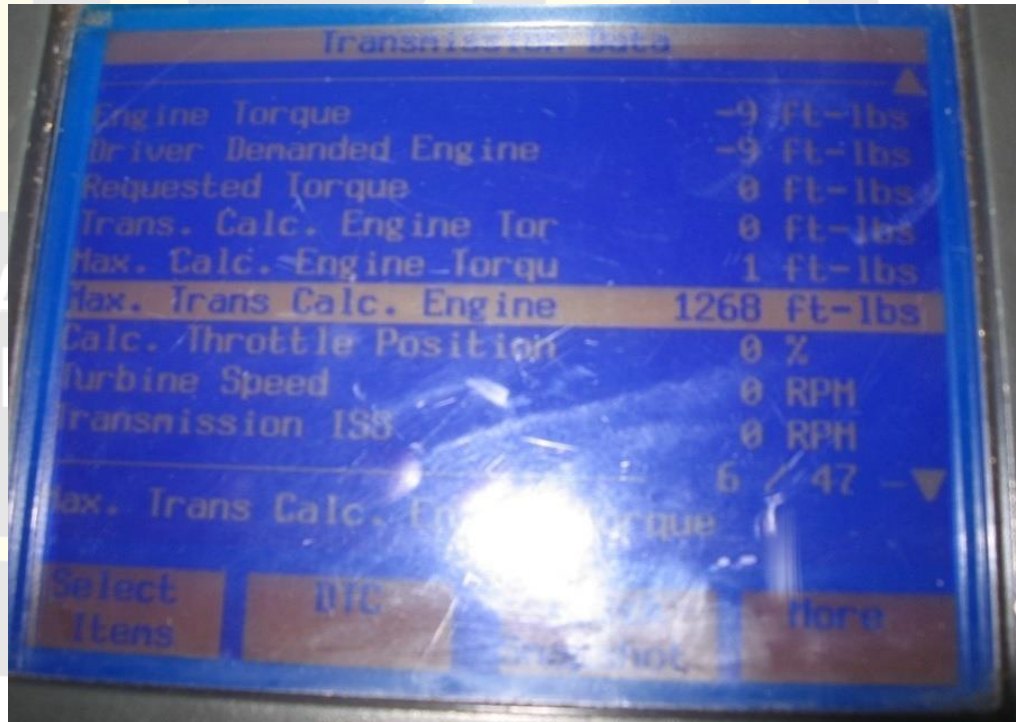
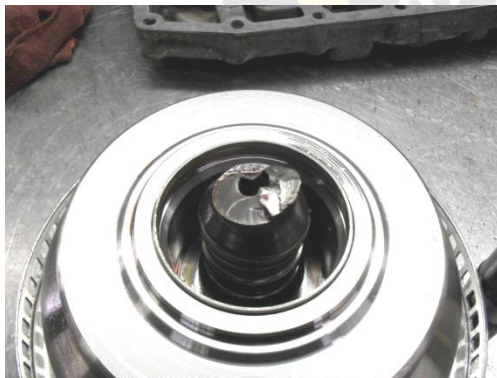
Broken input shaft will record a high max torque value.

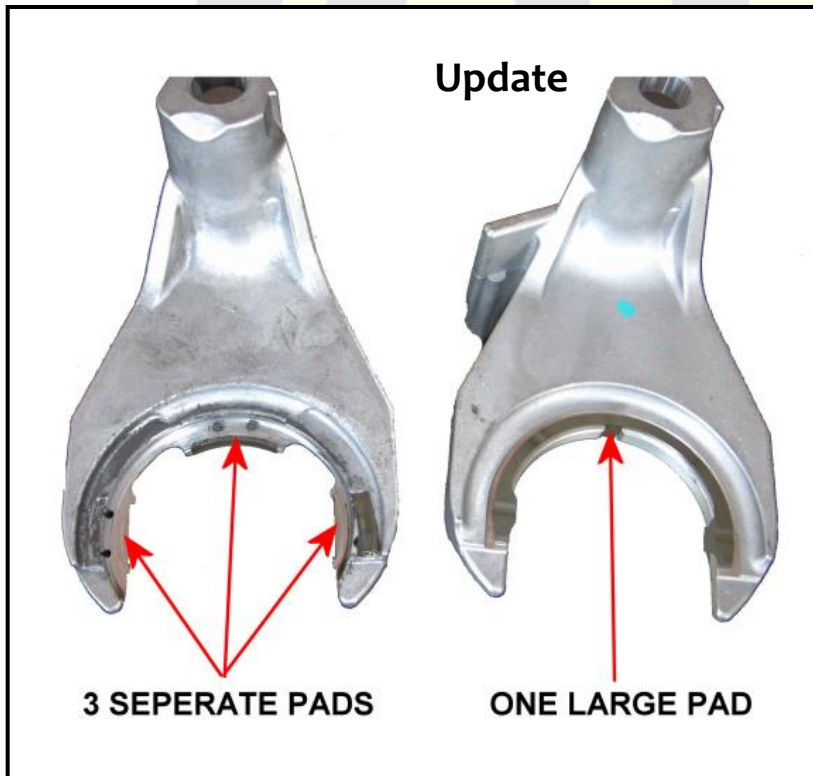
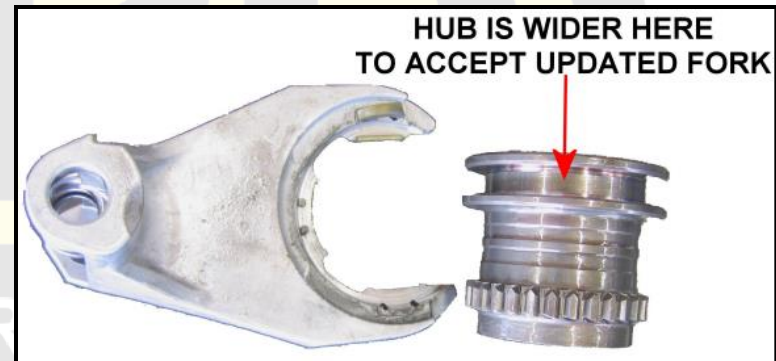
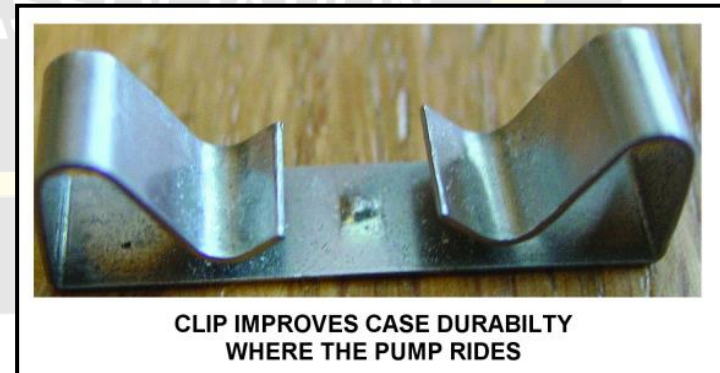
Ratio errors on the LCT1000 often cause neutral shifts and/or no upshifts. Depending on the model LCT1000 this may happen in 5th gear (2001-2005) or 6th gear (2006-On). The main cause of this is wear in the transfer case assemblies causing “erratic VSS signals”. Typical wear areas include the Slider and Fork assemblies, Bearing and Rear case assemblies, Chain and pump retainers in the case. ATRA TSB #1256

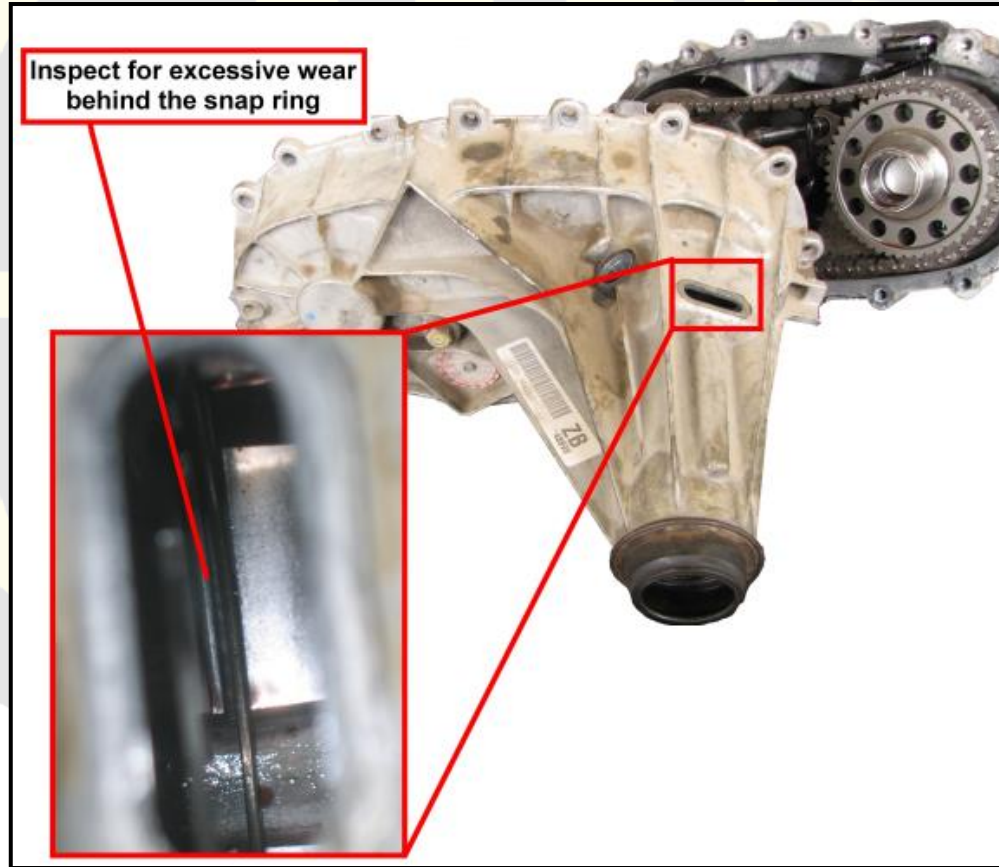
The snap ring groove in the rear case half for the output bearing is also wearing out. Make sure the snap ring does not have excessive clearance allowing the shaft to move back in forth causing erratic speed signal references.
