Technical Bulletin Listing 2008

Technical Bulletin # 1172

Transmission: *RE5R05A*

Subject: *Installing Low/Reverse Clutch Sealing Rings*

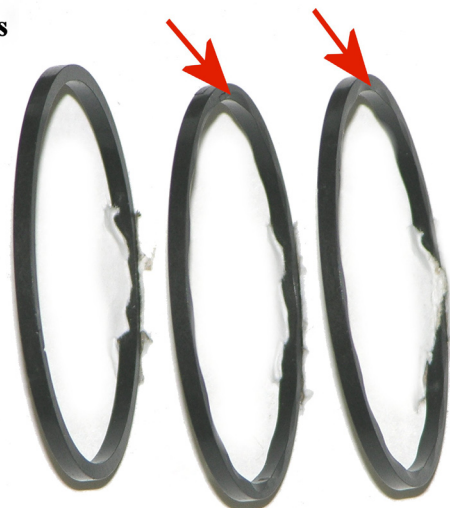
Closeup of rings
compare smooth with
scallops on inside

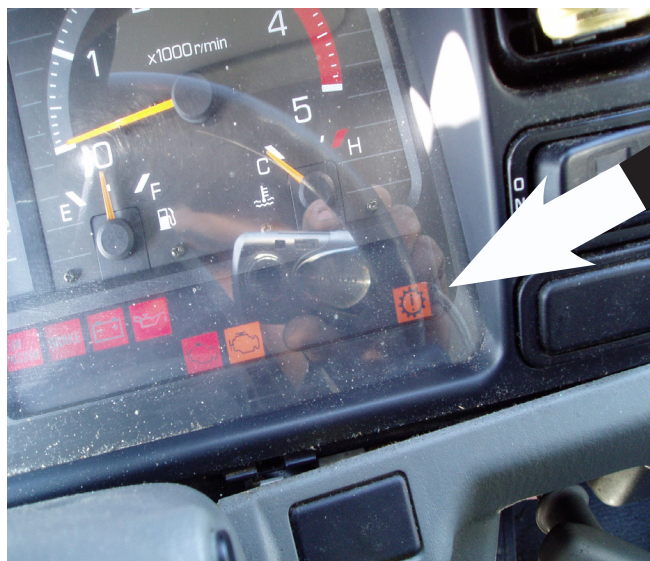
Gear Fault Light

Read the flashes from the gear fault light at the bottom right of the instrument cluster.
