Technical Bulletin #1705

Transmission: *RFE Series*

Subject: *Delay or Double Bump Forward*

Technical Bulletin #1706

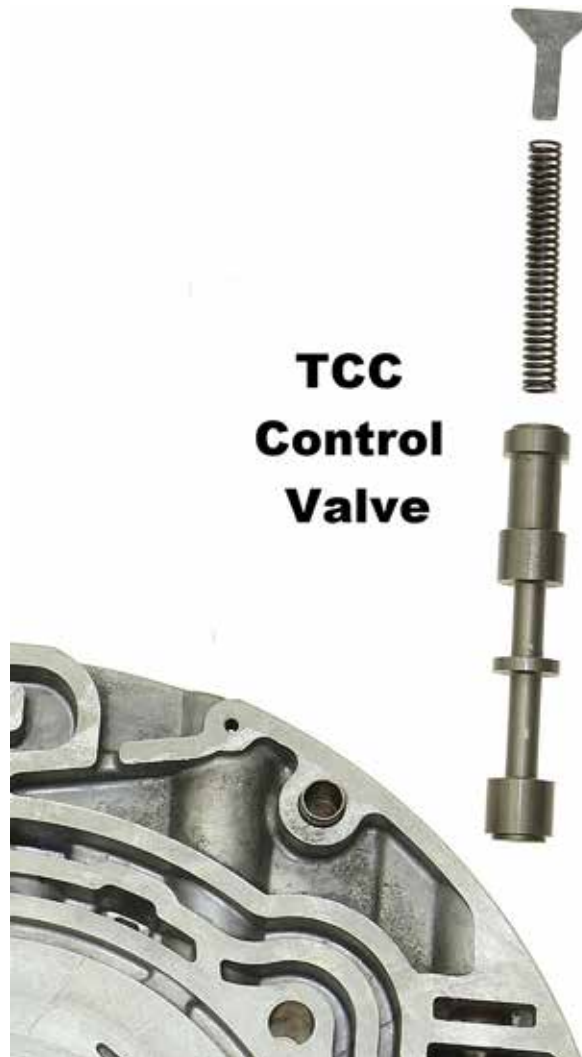
While working on a GM vehicle equipped with a 6L series transmission, you may encounter erratic TCC operation, harsh TCC apply, excessive TCC slip, harsh shifts, overheated fluid, codes 218 (over-temp), 741 (TCC off) & 742 (TCC stuck on) may set. These concerns may be caused by a worn TCC control valve located in the pump.

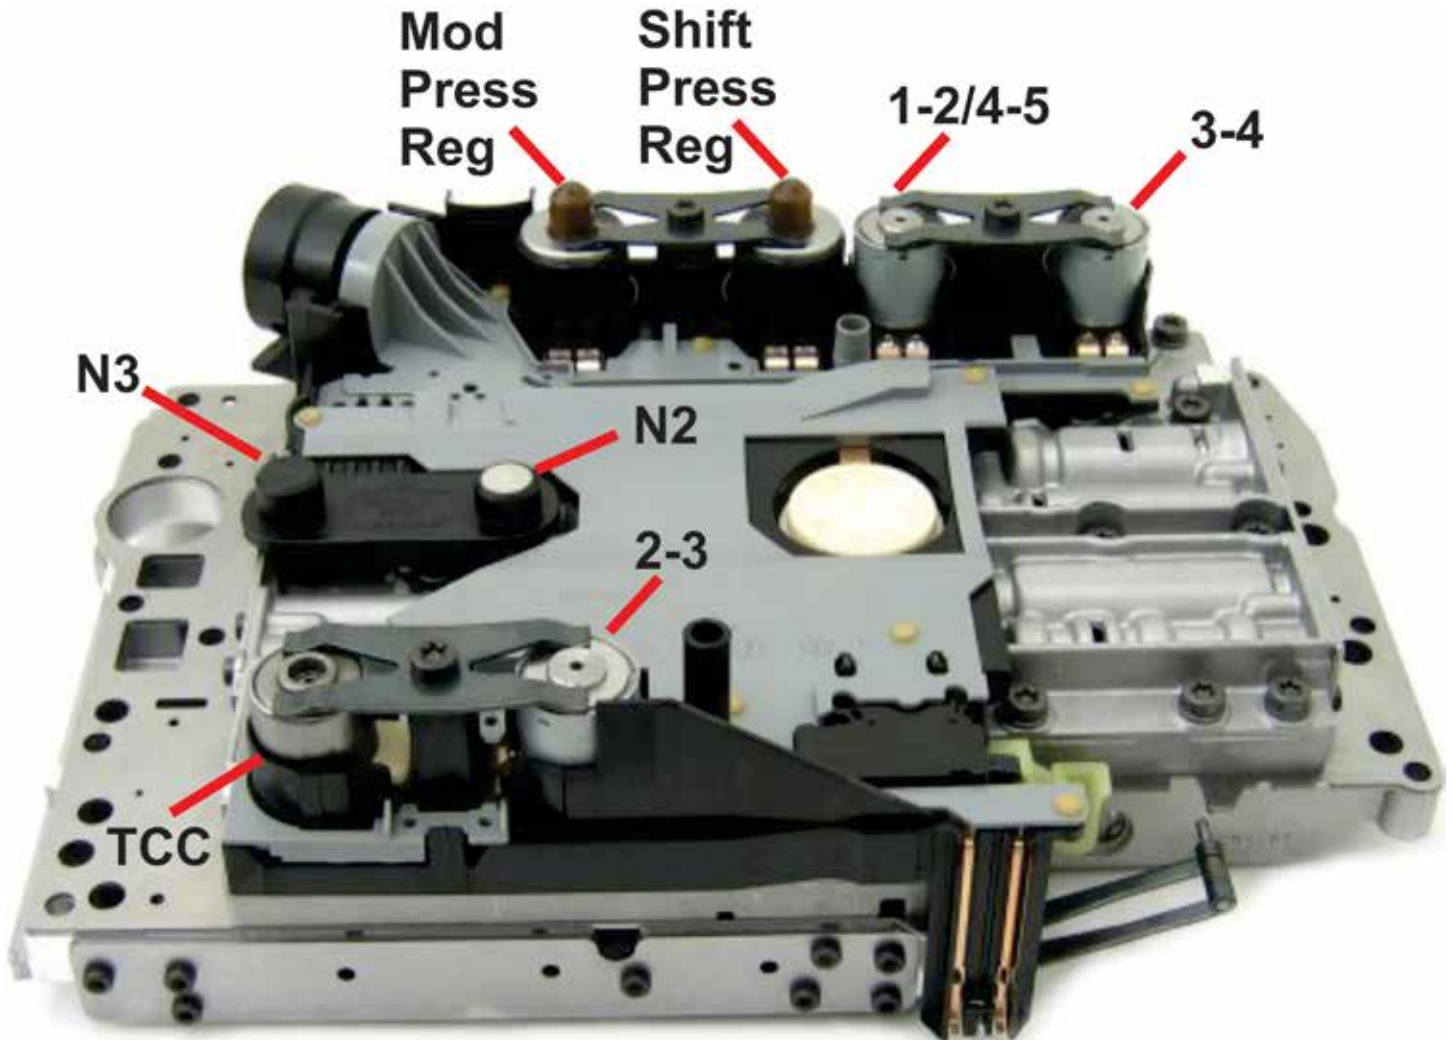
Figure 1

The N3 RPM sensor is located at the front of the conductor plate on the valve body. The N2 sensor is located next to the N3 towards the rear of the valve body (figure 1).

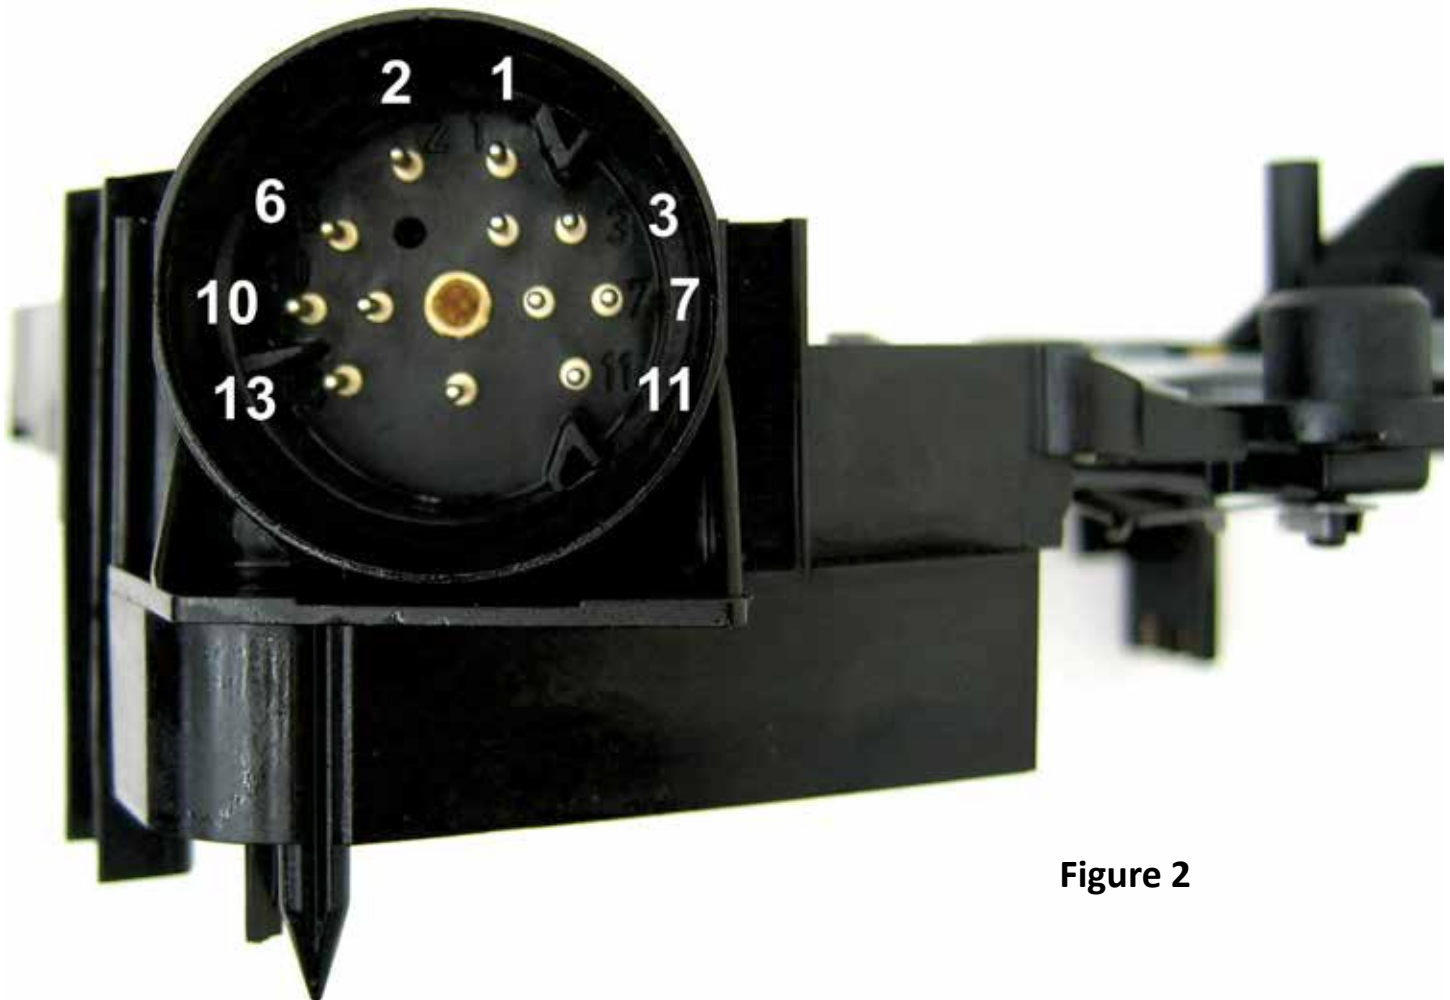
Figure 2

The N3 and N2 RPM sensors are both Hall Effect type sensors. They are supplied 4-8 volts and grounded by the TCM. The RPM sensor signal is a pulsed square wave (DC Hz) to the TCM. The approximate resistance of both sensors is 4.5 ohms (figure 2) see chart below.

- 1: N3 RPM sensor signal (pulsed voltage)
- 2: Modulated Pressure Regulator solenoid (Y3/6y1) (5.5 Ω)
- 3: N3 RPM sensor signal (pulsed voltage)
- 4: ATF Temperature sensor / Starter Lock-Out
- 5: Not Used
- 6: Solenoid supply voltage (system voltage)
- 7: RPM sensor supply voltage (4-8 volts)
- 8: 2-3 Shift solenoid (Y3/6y5) (4.5 Ω)
- 9: 3-4 Shift solenoid (Y3/6y4) (4.5 Ω)
- 10: Shift Pressure Regulator solenoid (Y3/6y2) (5.5 Ω)
- 11: PWM TCC solenoid (Y3/6y6) (2.7 Ω)
- 12: Sensor ground (0.1 volts or less)
- 13: 1-2/4-5 Shift solenoid (Y3/6y3) (4.5 Ω)

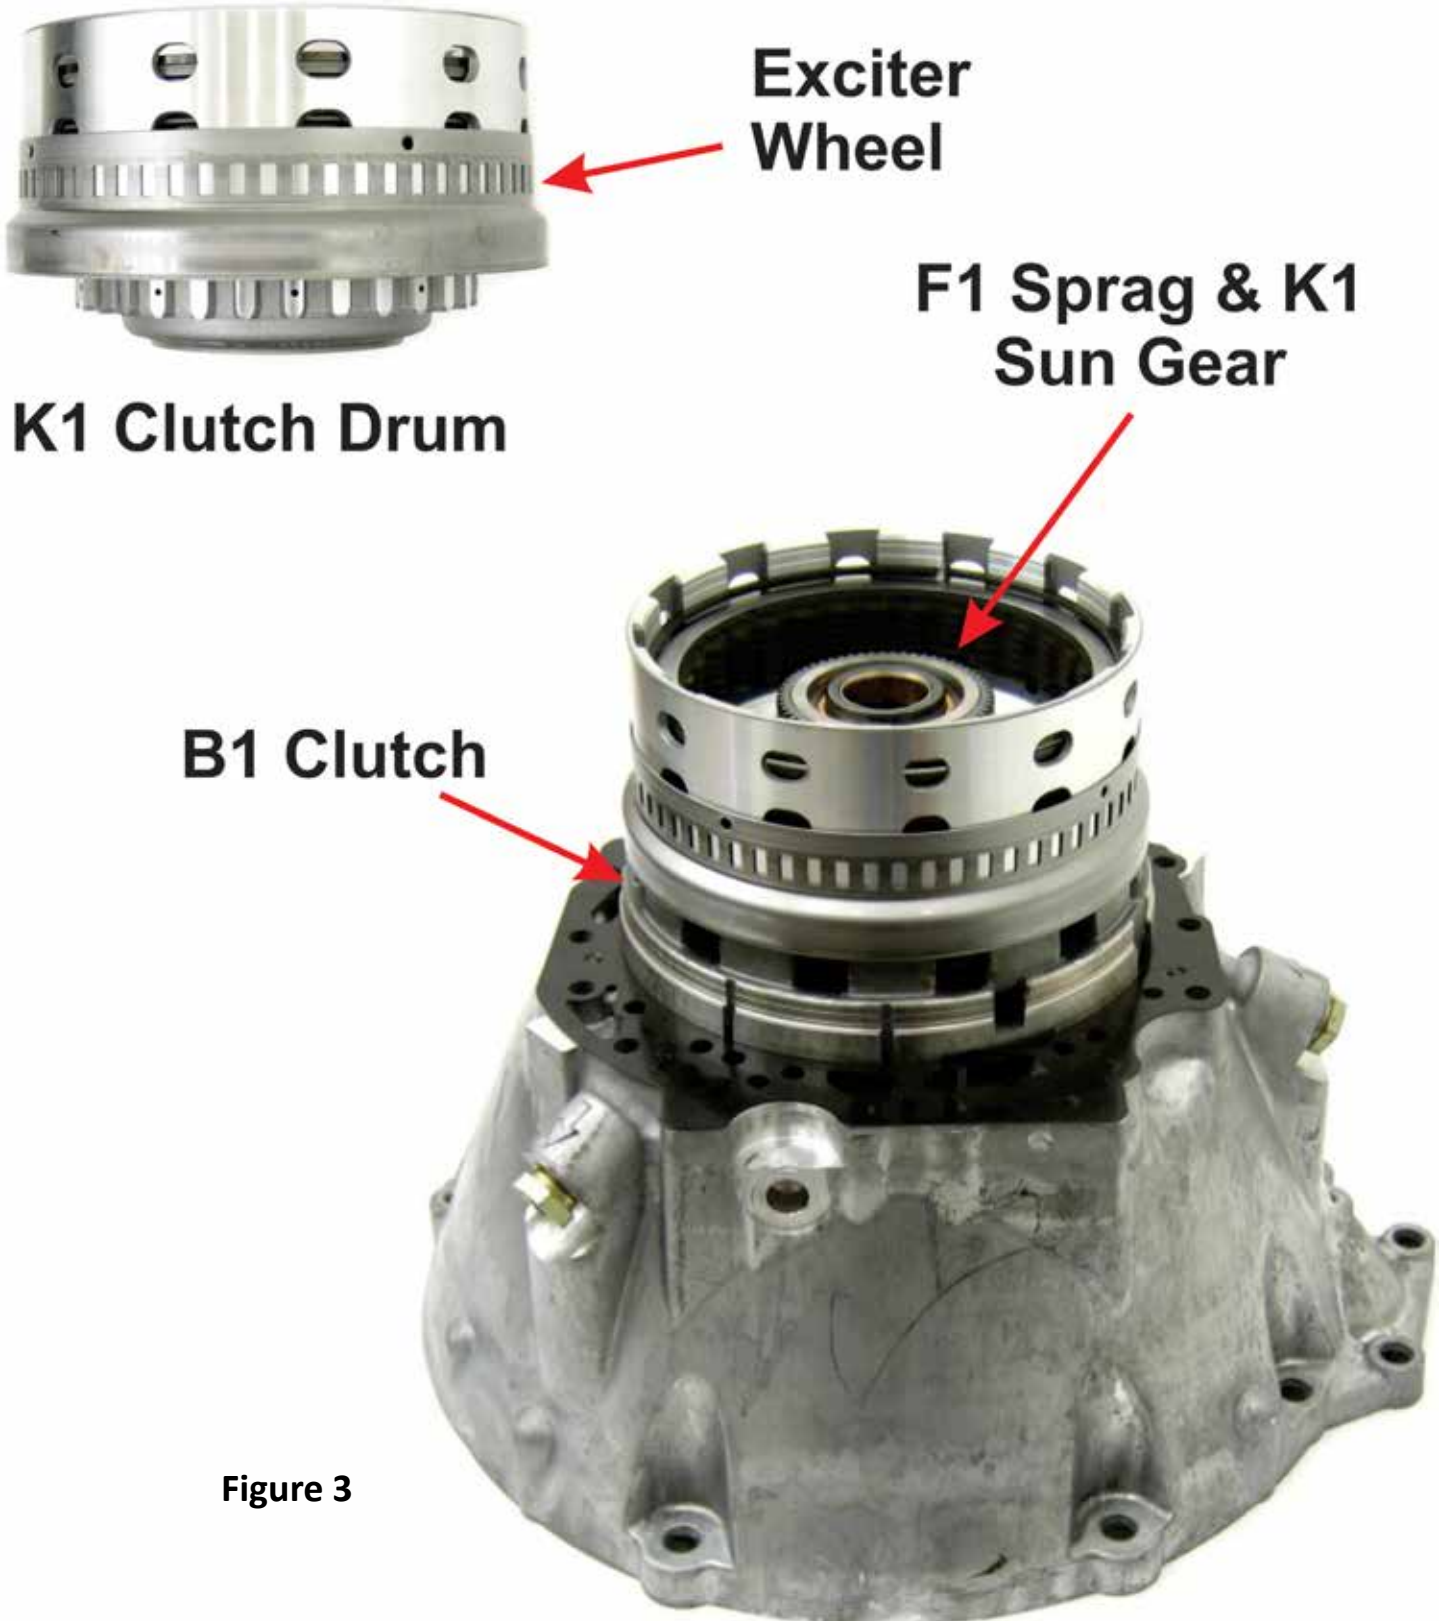
**Figure 3**

The N3 sensor reads the exciter wheel on the K1 Clutch Drum which contains the F1 Sprag and the B1 Clutch Hub (figure 3). The N2 sensor reads the exciter wheel on the Front Carrier assembly and Shell that rotates around the Front Sun Gear (figure 4). The Front Sun Gear is part of the K1 Drum.

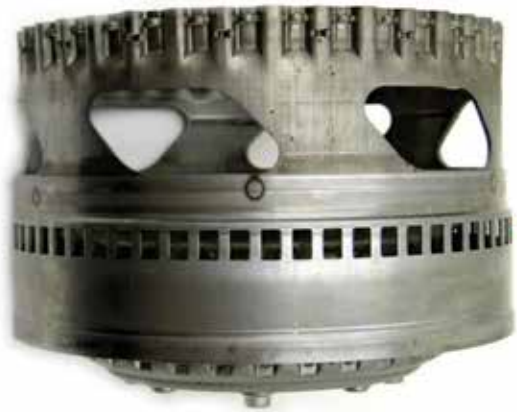
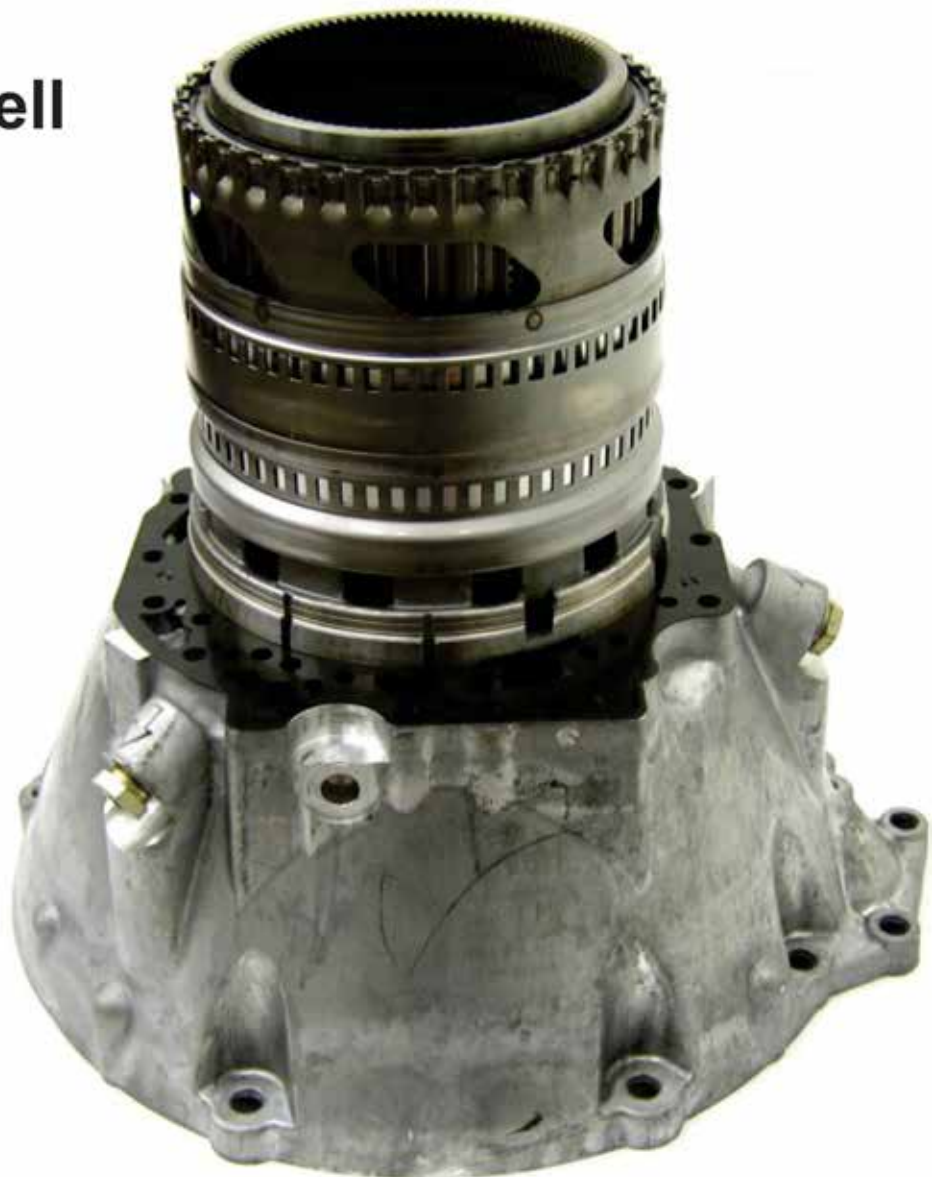
Figure 4

Exciter
Wheel

Front Carrier
Assembly & Shell

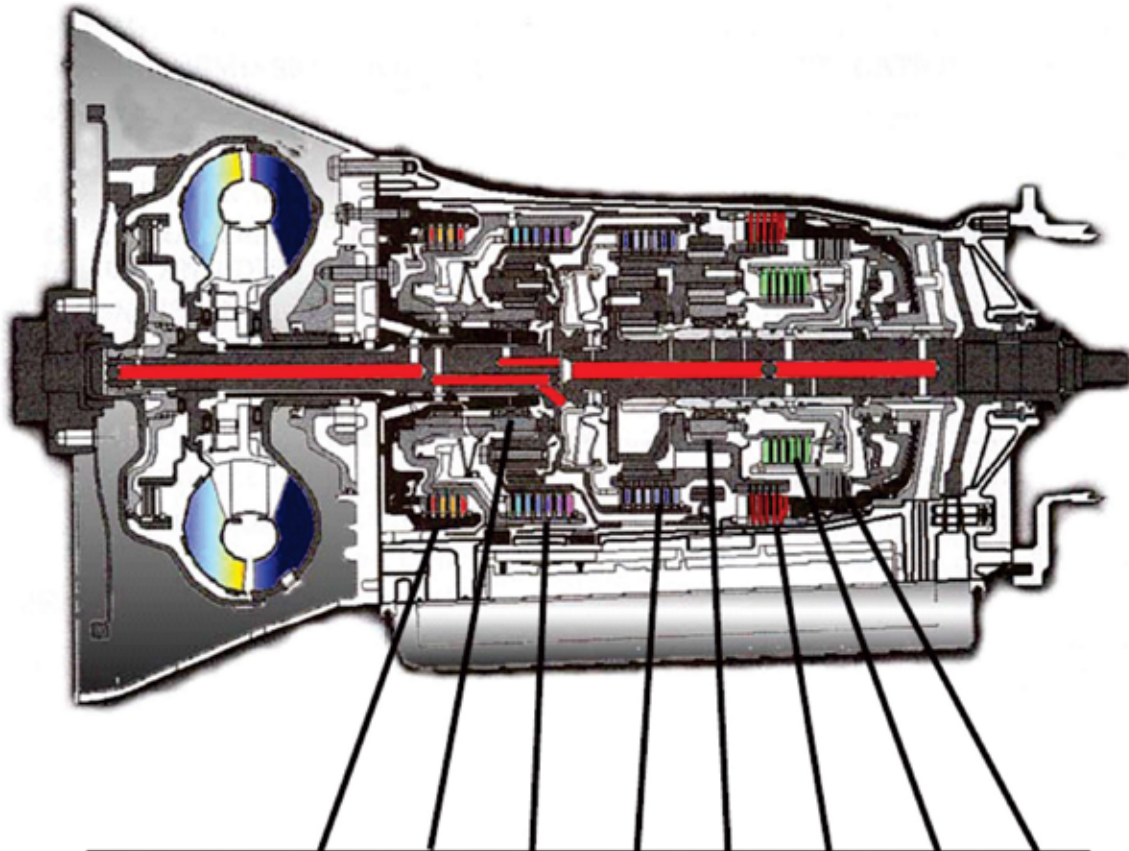
Figure 5

Both the N3 and N2 RPM sensors read the same in 2nd 3rd & 4th when the K1 clutch is applied (figure 5). N3 does not read in 1st & 5th (reverse in winter mode/4X4 if equipped). N2 will read turbine RPM when the K1 clutch is applied. N2 sensor reads in 1st through 5th and reverse.

Gear	B1	F1	K1	K2	F2	B3	K3	B2
1	X ⁽¹⁾	X	○		X		X ⁽¹⁾	X
2 ⁽²⁾			X		X		X ⁽¹⁾	X
3			X	X				X
4			X	X			X	
5	X	X ⁽¹⁾	○	X			X	
N	X		○				X	
R	X ⁽¹⁾	X	○			X	X	
R ⁽²⁾			X			X	X

(1) For engine braking
 (2) When in 4X4 low (if equipped) or Winter mode (if equipped)

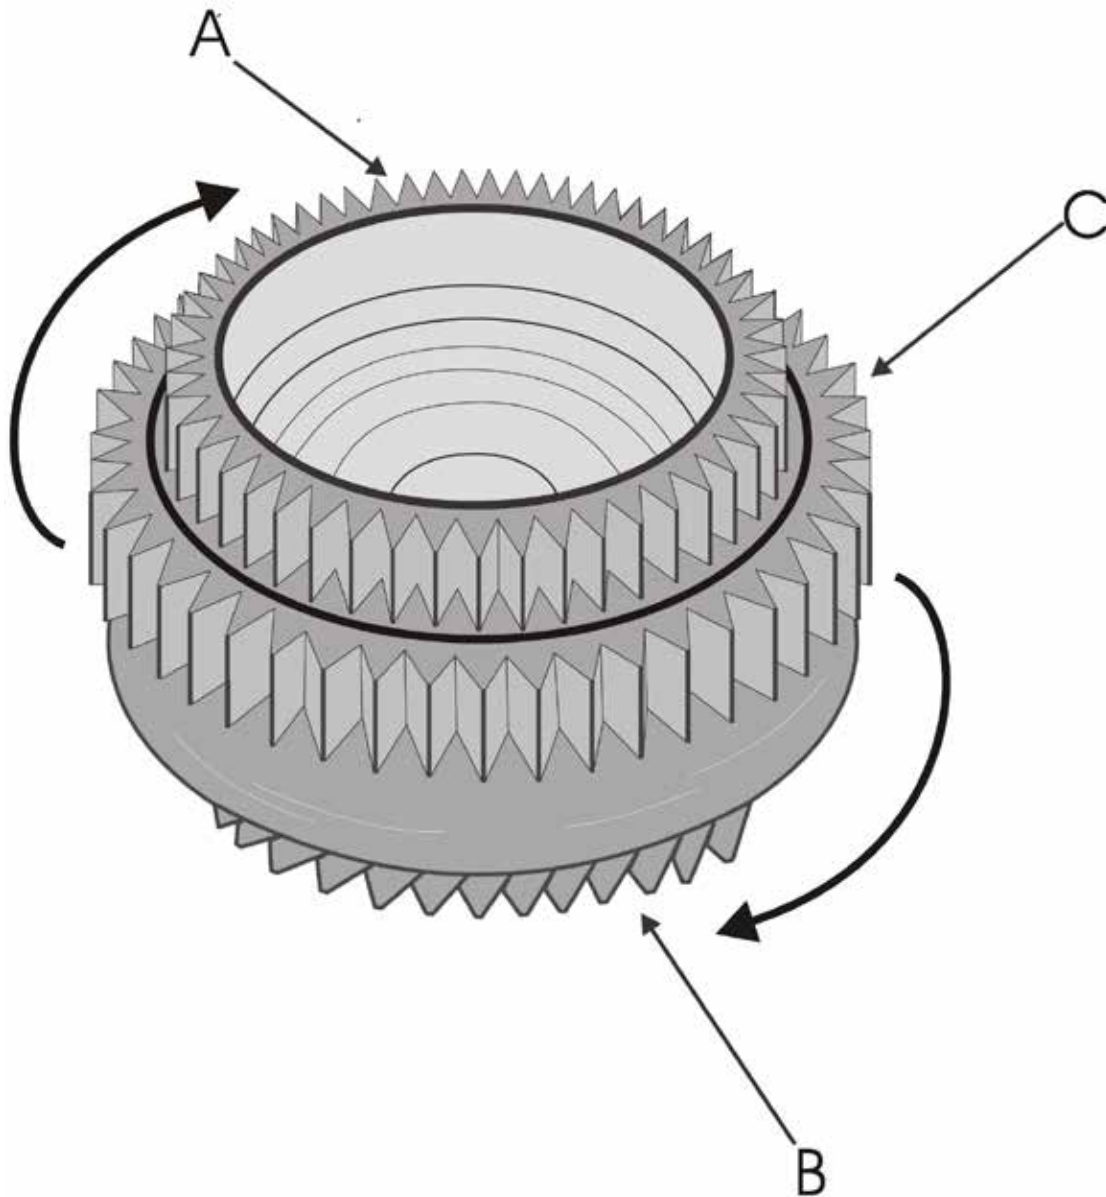
When checking the one way clutch on a BVGA unit on a Honda Transmission mounted on a Pilot; you can either hold hub A or gear B. Hub C should turn freely in the direction of the arrow shown. Also always make sure it locks in the opposite direction.
