Little Benz with No 3-4 Shift

by Pete Huscher

Recently, I received a call from Daniel on the ATRA Hotline. Daniel was working on a 93 Mercedes Benz 190E with a 722.4 transmission. The car had already been to several other shops, but they couldn't fix the problem, so the owner brought it to Daniel.

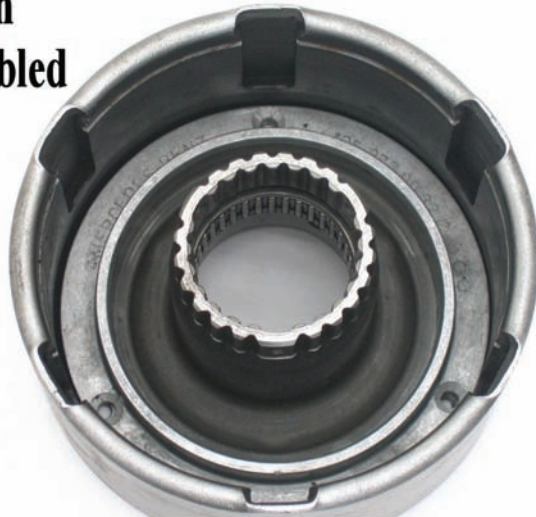
K2 Clutch Disassembled

Figure 3: K2 clutch disassembled, inner seal hard and broken

Daniel removed and disassembled the transmission to inspect the K2 clutch. During disassembly, Daniel air checked the K2 clutch circuit and found it was leaking. The inner clutch seal was hard as a rock, broken and leaking (figures 3 and 4). Evidently the previous repair shops missed the inner seal. The clutches weren't worn or damaged; the inner seal was just leaking.

After resealing the K2 clutch and reassembling the transmission, Daniel rechecked the K2 clutch and found it would apply with as little as 10 PSI. After installing the valve body and pan, the transmission was ready to be installed.
