# Honda/Acura

## 5-Speed

### 2-1 Coastdown Neutral or No 1st Gear

by Mike Souza  
[www.atra.com](http://www.atra.com)

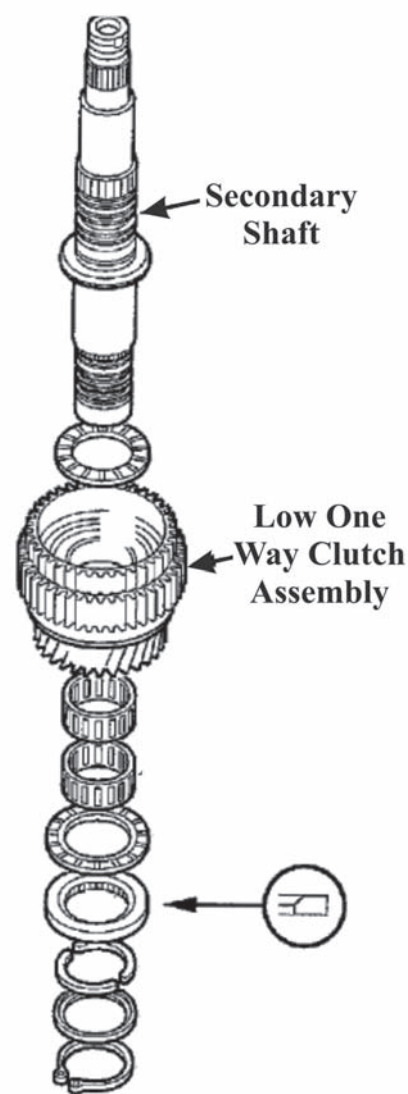
Figure 2

The cause of this complaint? A failed low one-way clutch (sprag) or inner sprag race, which is part of the 1<sup>st</sup> gear assembly. The outer sprag race (low clutch hub) seems to hold up well in most cases and may not need replacement. These components are located as an assembly on the secondary shaft (figure 2).

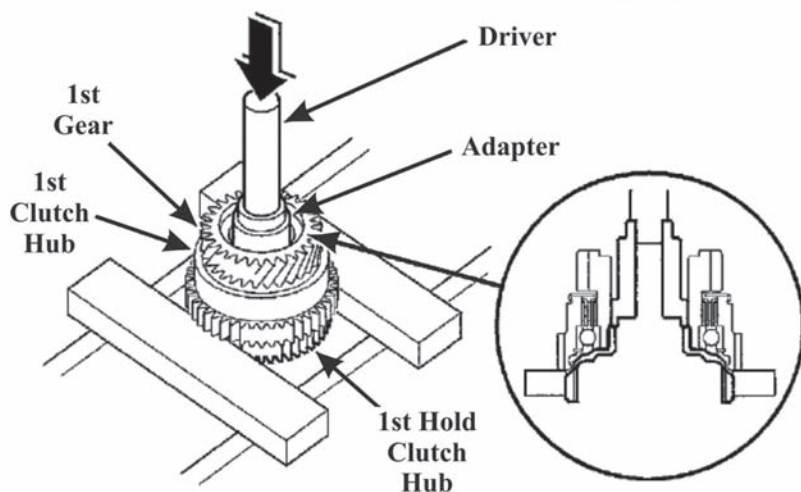
Figure 3

Checking the low one way clutch assembly by hand during a rebuild isn't sufficient to determine whether the sprag is capable of handling vehicle load. You need to press the 1<sup>st</sup> hold clutch hub out of 1<sup>st</sup> gear, with 1<sup>st</sup> gear facing up (figure 3).

## Turn Over With 1st Gear Facing Up

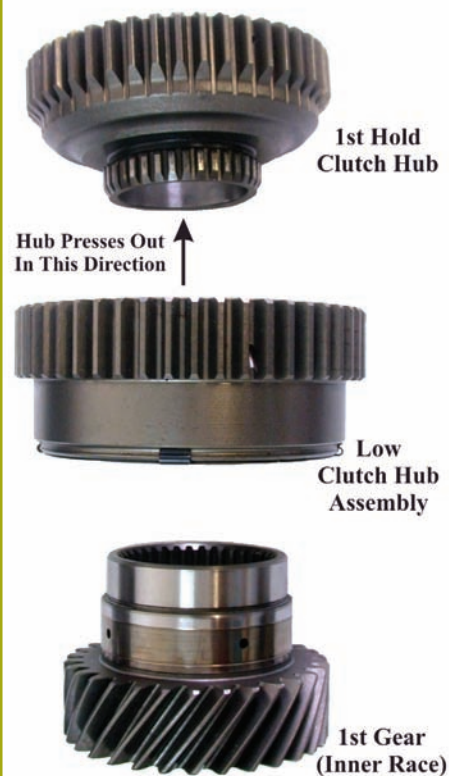
Figure 4

After you have the components disassembled (figure 4), you'll be able to inspect the 1<sup>st</sup> gear inner race. Replace

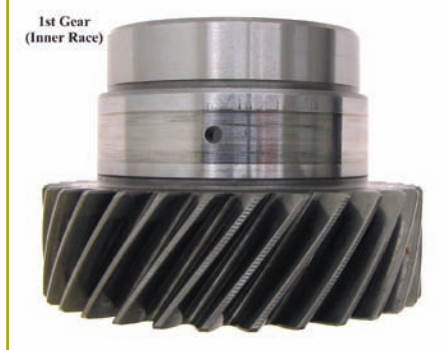
Figure 5

the 1<sup>st</sup> gear inner race if it has excessive wear (figure 5).

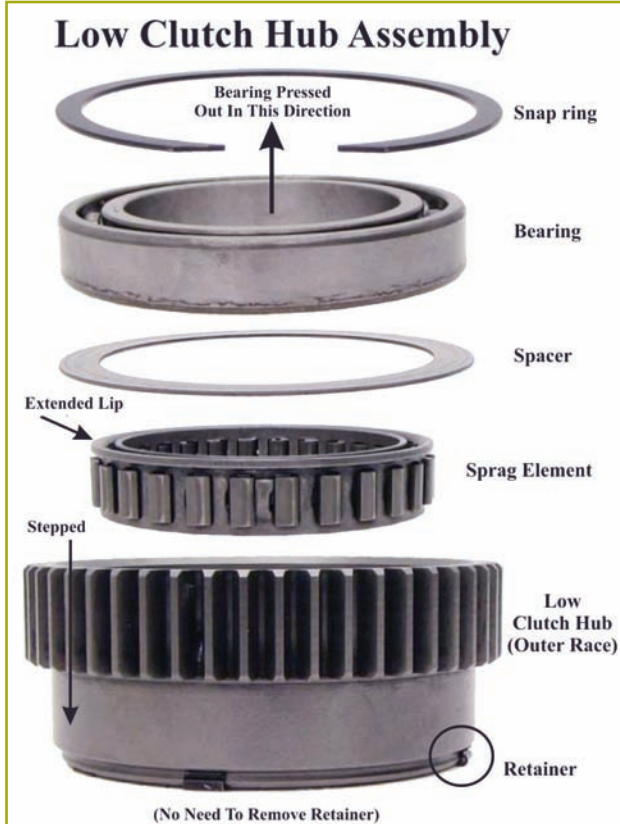
Figure 6

the bearing in place. There's no need to remove the retainer on the other side of the hub assembly (figure 6).

2. Press the bearing out in the direction of the snap ring. This is because the extended lip on the sprag element won't pass the stepped edge inside the outer race. The extended lip allows the sprag to be installed or removed in only one direction.

An alternative is to use an early 1982-86 4L60 (700R4) narrow sprag element without the two brass washers. This requires leaving out the spacer shown in figure 6 for the sprag to fit. The spacer isn't necessary because the sprag will rest next to the bearing outer race and won't move out of place.

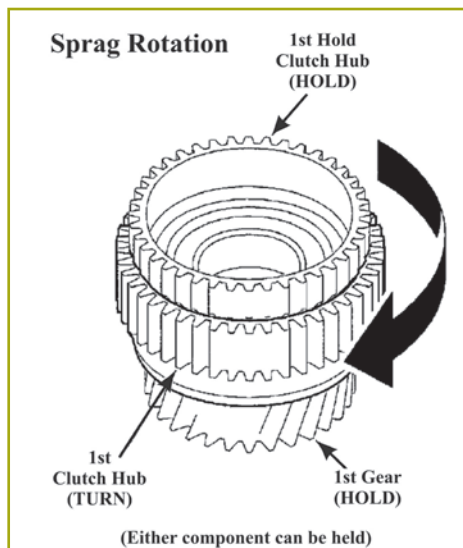
Figure 7

Because the 4L60 sprag has no extended lip, it's possible to install it backward. After you have the sprag in the low clutch hub, check the rotation with the 1st gear (inner race) before pressing the bearing back in place (figure 7). If the rotation is reversed, flip the sprag and check the rotation again.
