Diagnosing Chrysler PCI Communications

by Wayne Russell

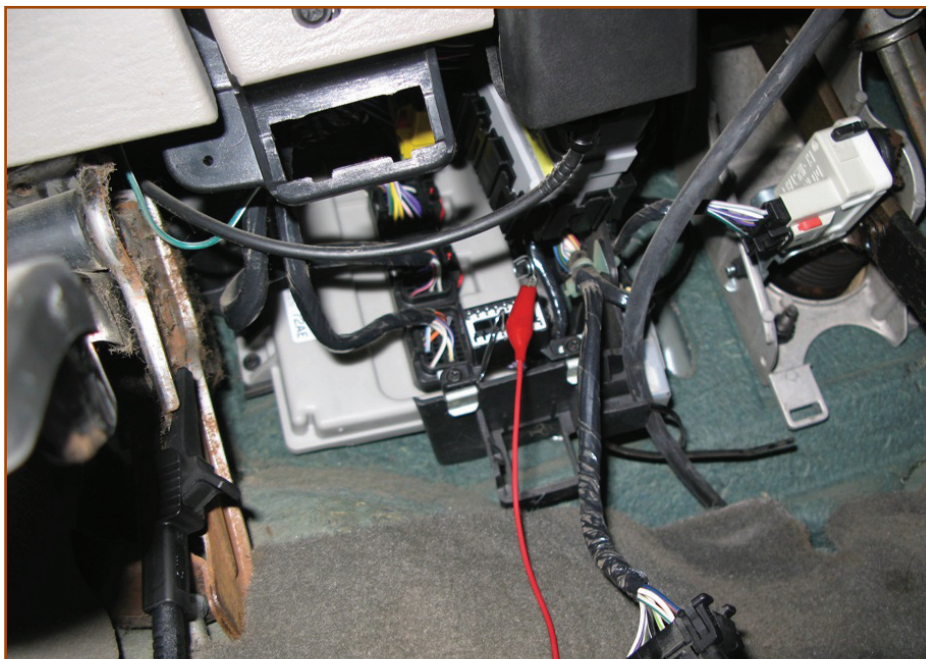
Figure 1

Next we began to look at the PCI path. With help from the ATRA 2007 seminar book, we had a good overview of the system. We found the Diagnostic Junction Port (DJP), which is where all PCI wires go and are connected to each other through the terminals in the cover (figure 1). From there we checked the continuity of the PCI circuits between the TCM, PCM and other modules. We didn't find any opens or shorts to ground.

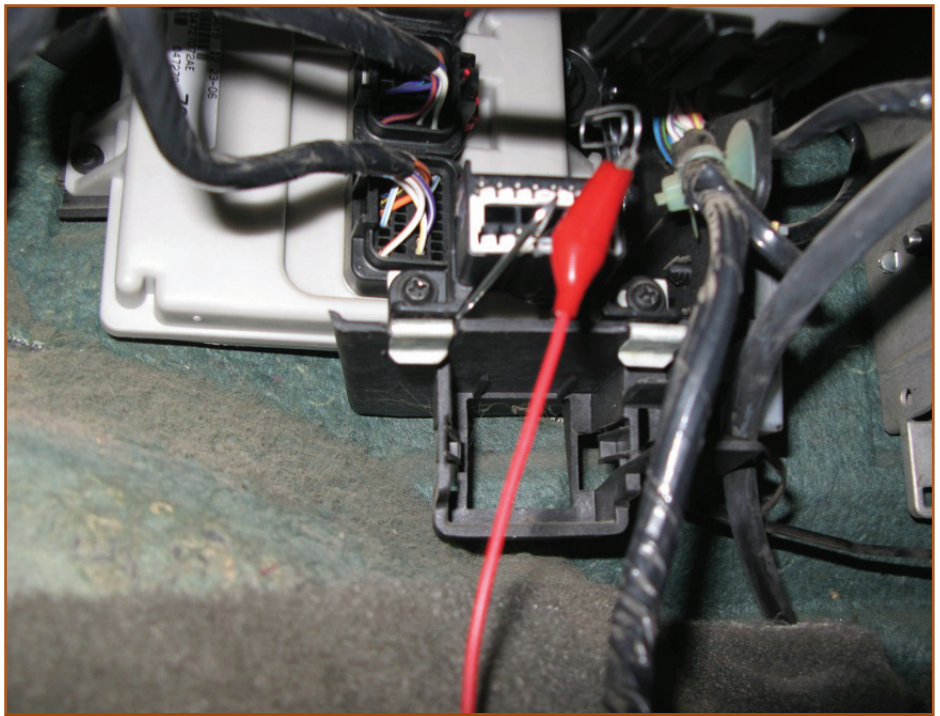
Figure 2

What we needed to look for at the Diagnostic Junction Port was "activity of about 7.5 volts" on the module PCI wire (figure 2). For example, when we looked at the HVAC module, the scope would be flatlined (0 volts) until we pushed a button on the heat control to cause the module to do something; then we observed activity. The body module was active all the time, so you have to keep activity in mind while observing the PCI wire for each respective module.

Knowing the TCM, ABS and Front Control Module are tied together, I cut the PCI wire near the TCM (from pin 43) and checked for PCI activity with the scope and found none! What a terrific discovery after numerous hours of anxiety.

I went back to previous years' wiring diagrams to learn that pin 43 is part of the SCI bus and the PCI bus didn't exist yet. In simple terms, we messed up by using the wrong TCM for this model year. We replaced the TCM with correct one and all issues resolved.

It took a lot of reading to learn that we were looking for 7.5-volt PCI signal on this Caravan. Now we know that we needed to verify the PCI signal from the TCM, knowing that the TCM, ABS and Front Control Module are tied together.
