TECHNICALLY SPEAKING

Getting a Firm Grip on the RE5R05A!

Nissan's RE5R05A is laced with traps waiting to snare you, but the corrections are fairly simple once you know where to look.

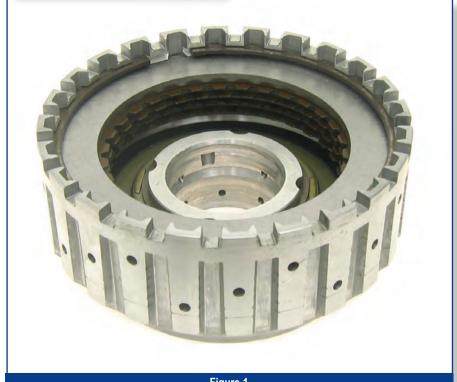
Figure 1

So here's the fix: set the high and low-reverse clutch clearance to 0.050" and the direct clutch to 0.060", or as close as humanly possible (Figure 1).

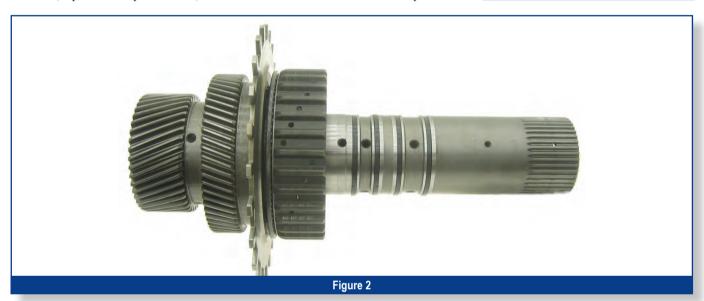
You can use AOD output shaft rings on the mid-sun gear shaft if you choose (Figure 2). You can also use a 4L60E servo ring (Teflon) on the support-to-direct drum. You'll have to butt cut the rings to fit. The combination of these changes will solve your problem.

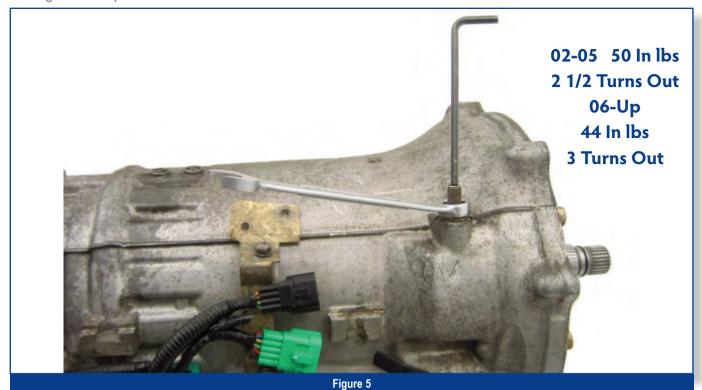
(Figure 4) The band adjustment has been in question: (Figure 5)

Bottom line? Make sure you have the right adjustment for the specific year and a quality brown band. You can't make this adjustment in the vehicle without some serious imagination.
