# Unbalanced Regulation:

## **47-48RE Valve Bodies**

by Mark Puccinelli members.atra.com www.atra.com

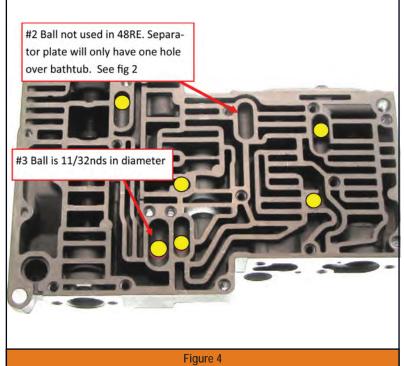
3<sup>rd</sup> gear circuit. The #3 checkball was in place and it was the correct diameter (figure 4).

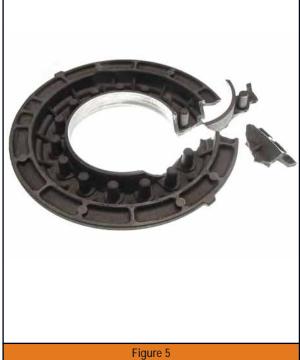
When the technician air checked the direct drum on the pump, it leaked excessively. The sealing rings looked okay and fit properly in the drum bore.

So he removed the frictions and steels, and there was the leak (figure 5). The piston broke because there was no

pressure regulation in reverse. Without the balance oil, line pressure will run away until something gives.

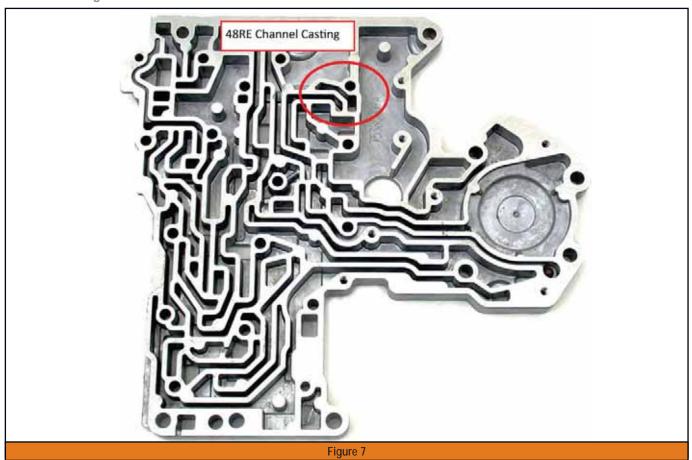
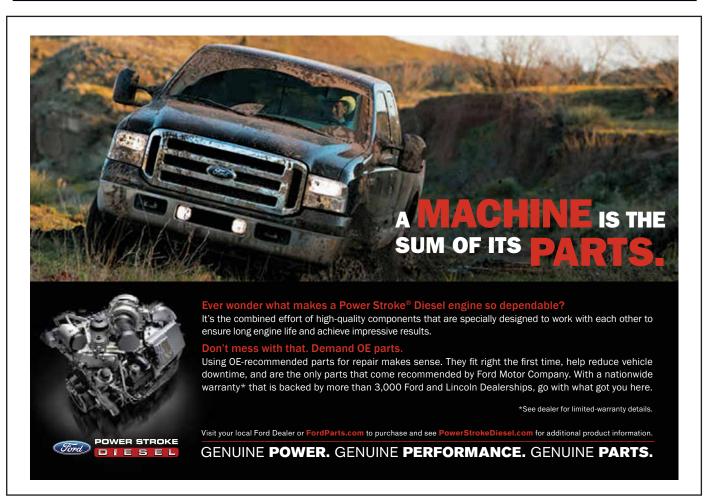
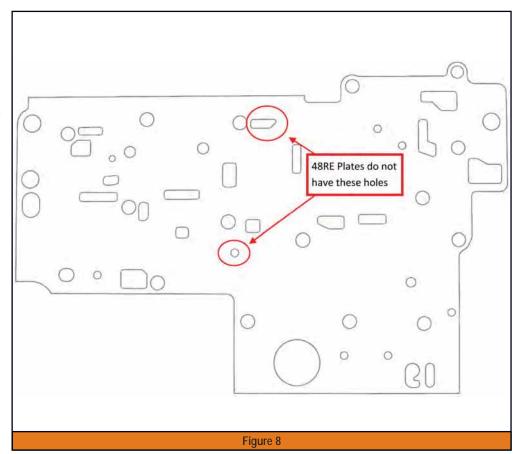
There are other differences between these valve body components you should be aware of (figures 6, 7, and 8).

Remember, these units have been around the block a few times. When working on RE units, be diligent during your valve body inspections and repairs to avoid potential problems such as this one.

Parts, cores and rebuilt units are in abundance; that's good, but it's also a source for building in your own potential problems. Careful comparison can make the difference between a long, difficult diagnosis and a successful repair.
