# 2005 TECHNICAL SEMINAR

## ***Automatic Transmission Rebuilders Association***

This manual has been developed by the Automatic Transmission Rebuilders Association (ATRA) Technical Department to be used by qualified transmission technicians in conjunction with ATRA's technical seminars. Since the circumstances of its use are beyond ATRA's control, ATRA assumes no liability for the use of such information or any damages incurred through its use and application. Nothing contained in this manual is to be considered contractual or providing some form of warranty on the part of ATRA. No part of this program should be construed as recommending any procedure which is contrary to any vehicle manufacturer's recommendations. ATRA recommends only qualified transmission technicians perform the procedures in this manual.

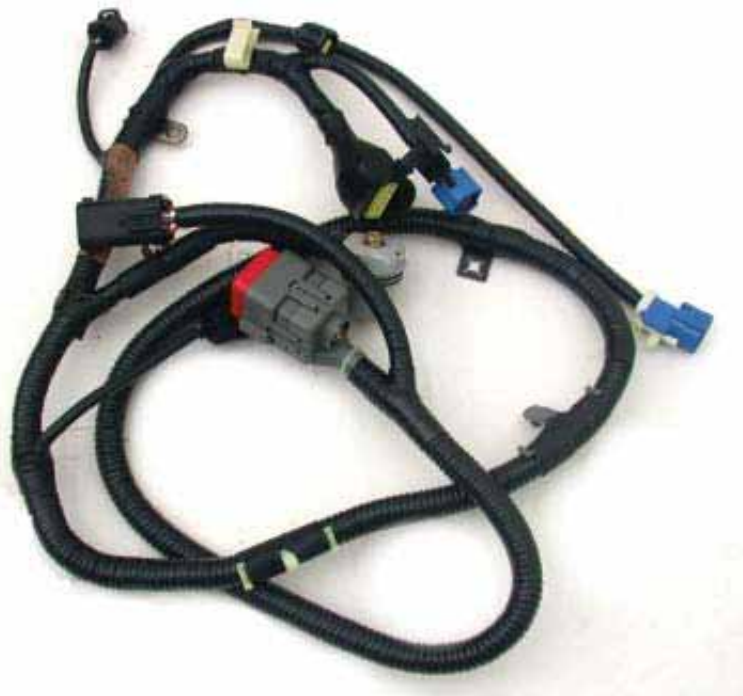
Check the transmission solenoid body connector for signs of water intrusion. If water intrusion is present, replace the Transmission Wiring Harness with part number 1L2Z-7C078-AB. A new harness has been released to prevent this condition.

***1L2Z-7C078-AB      Transmission Wiring Harness***

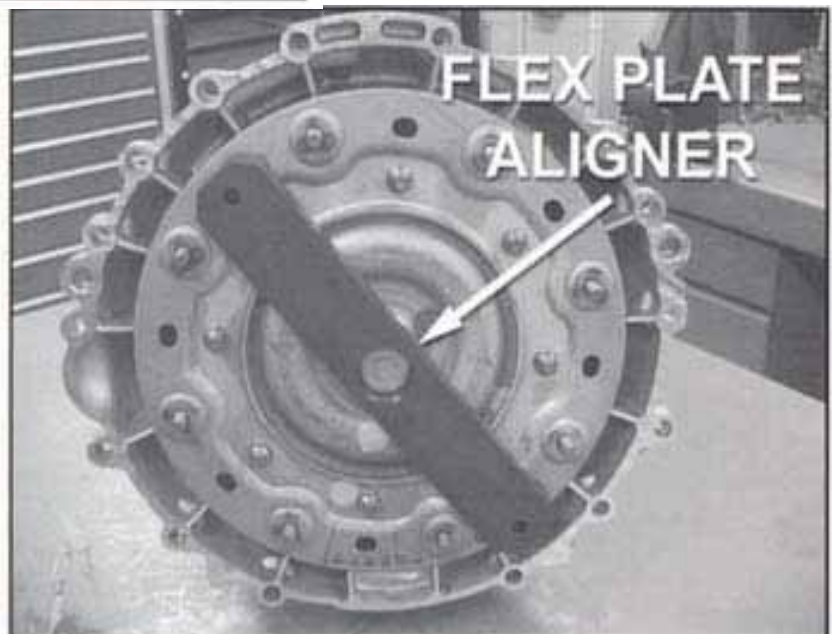
A special tool must be used when installing the adapter plate to the torque converter. In order to correctly install the special service tool, use one round hole and one oblong hole. Rotunda Part #307-403

***Using two oblong holes will cause damage to the transmission***

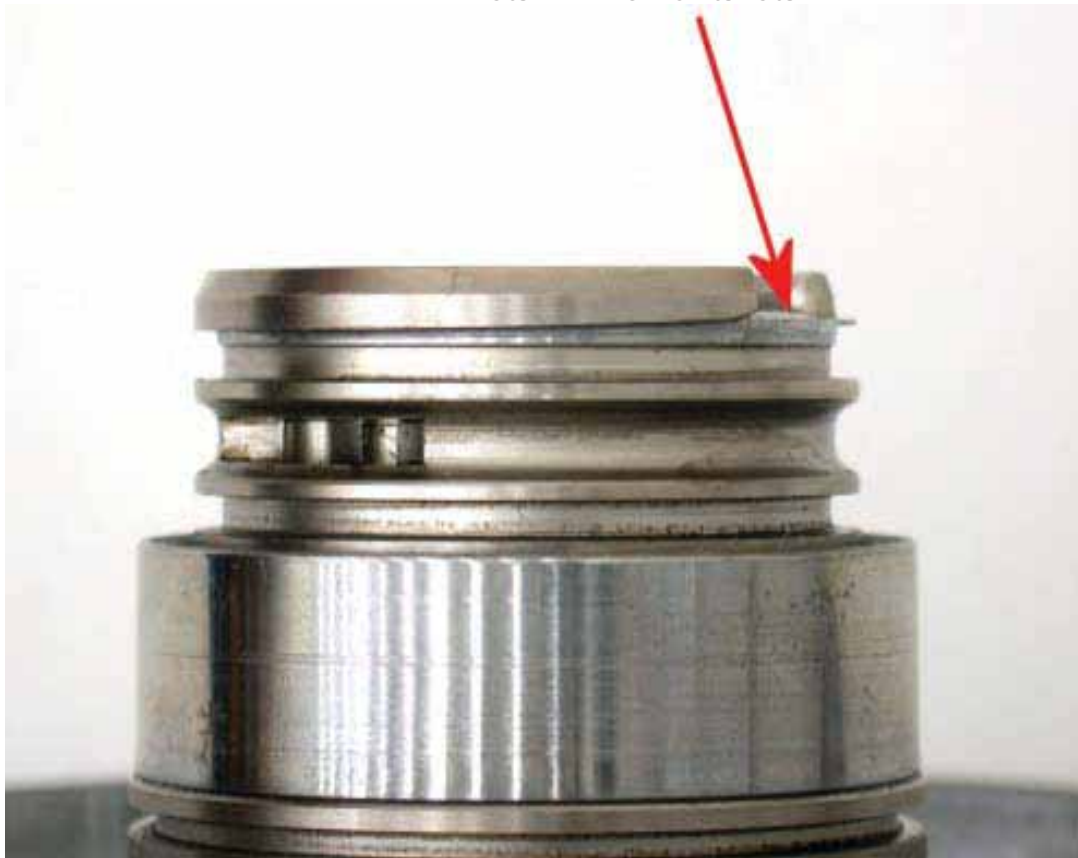
***Hard Coat Anodized  
Aluminum Ring Lands  
wear in this area***

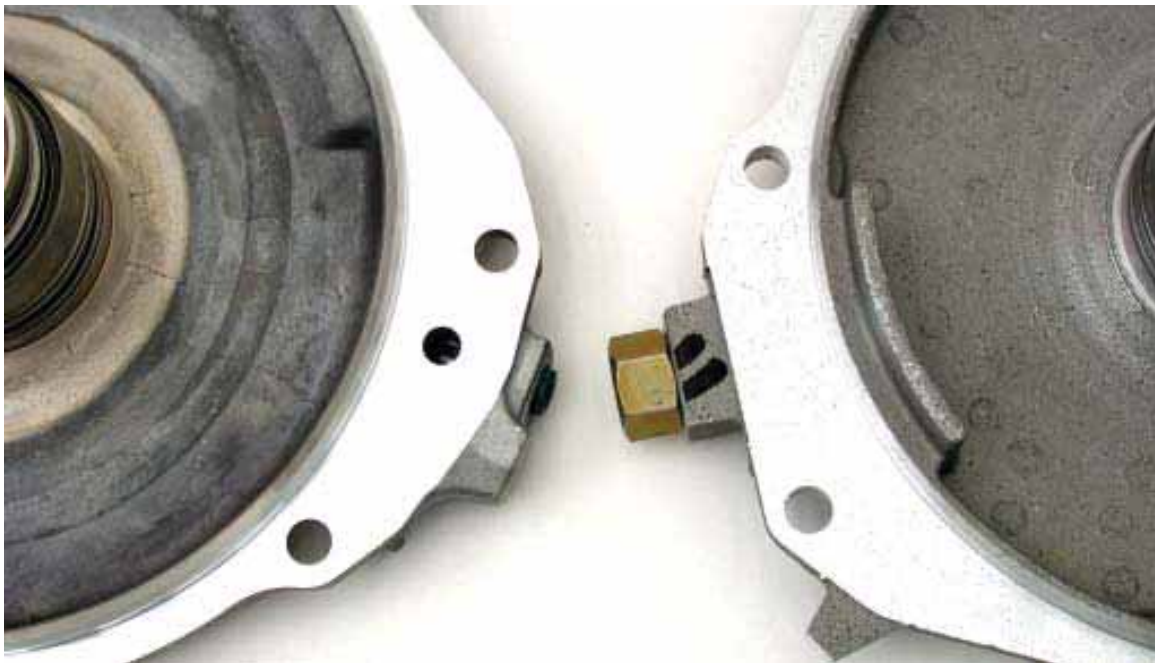
***Ford cover***

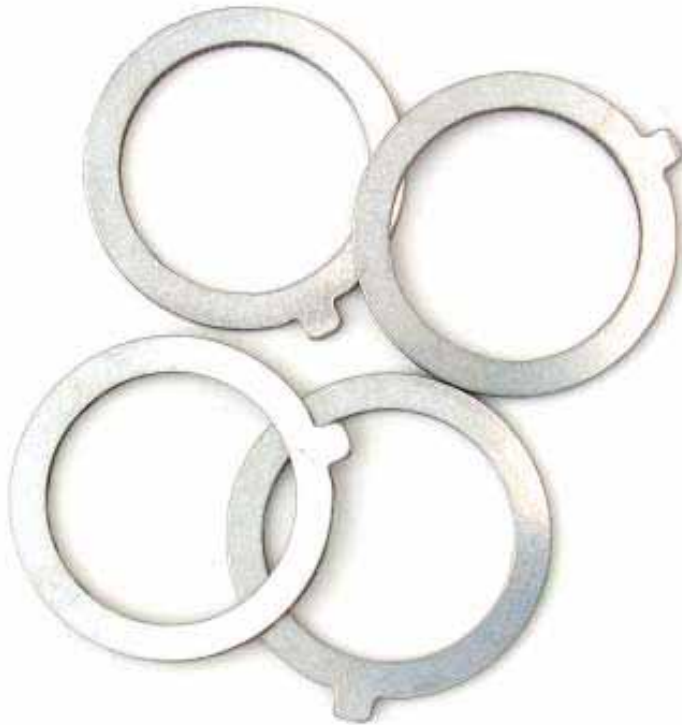
***End Play -0.010"-0.019"***

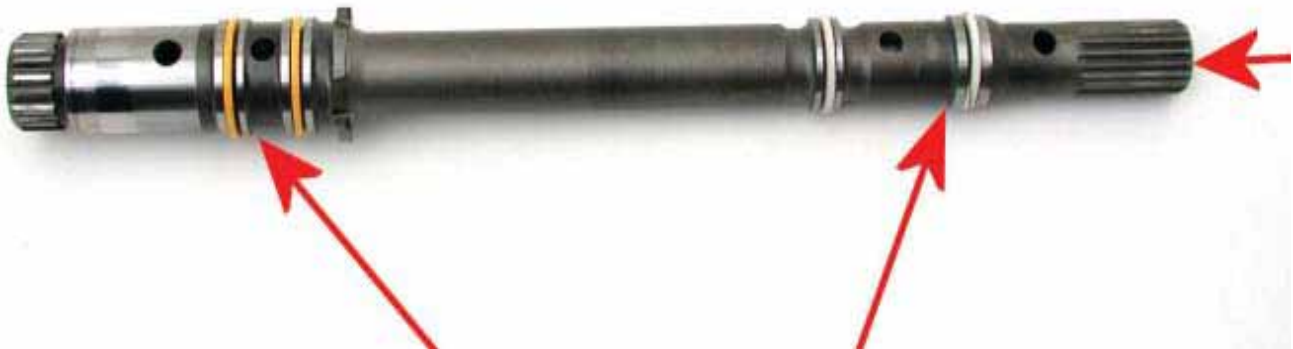
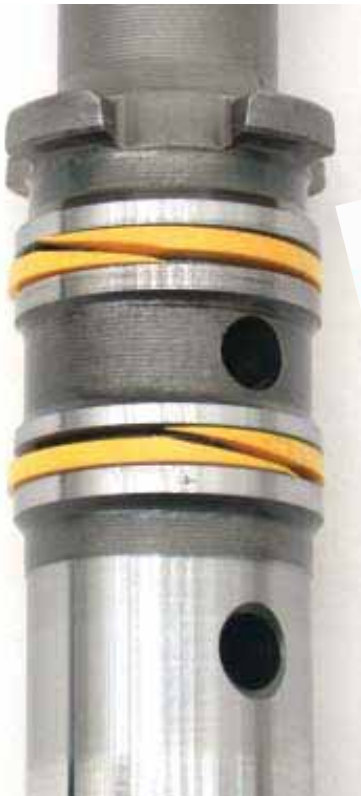
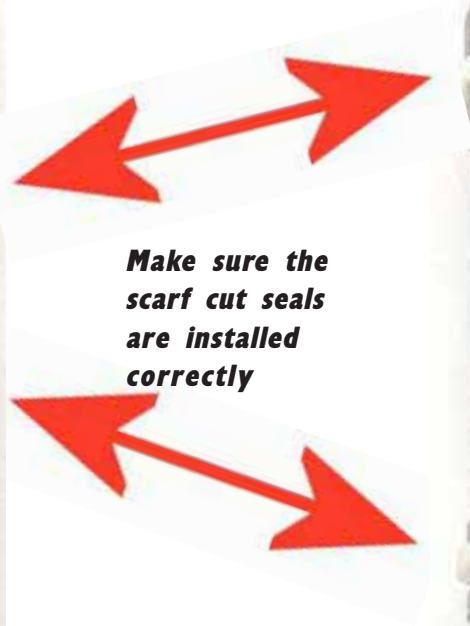
Always inspect the pump shaft ring area, also look inside the shaft and make sure it has a inner tube and plug.

***Make sure the  
scarf cut seals  
are installed  
correctly***

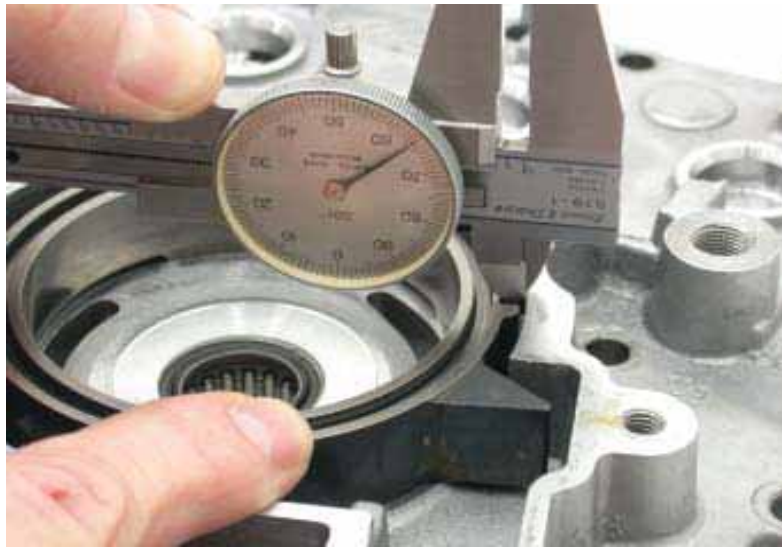
The distance between the wiper groove in the slide and the wiper surface of the pump body changes depending on the position of the slide. Always replace the rubber spring and Teflon wiper during rebuild.

***Measurement of the slide in the max position of its travel***

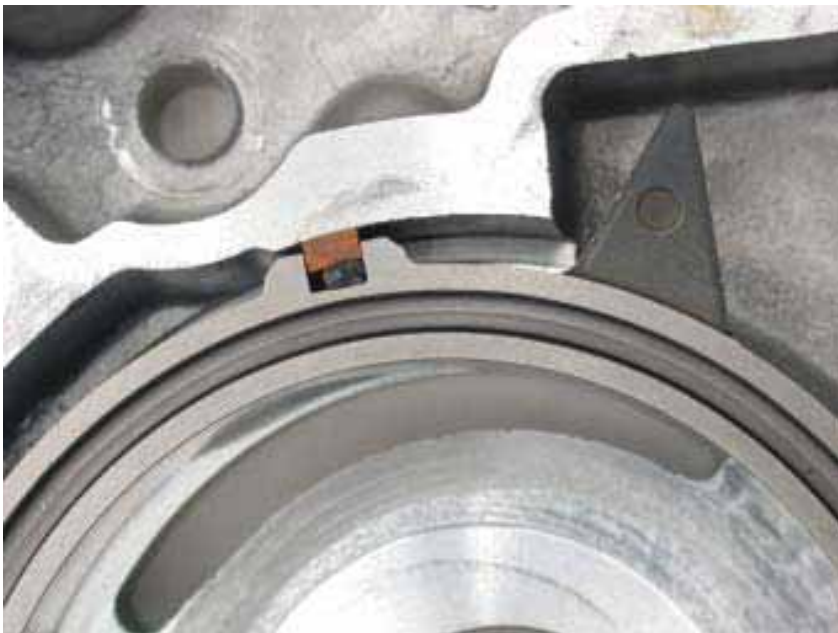
As the slide moves, the angle of the wiper surface changes. This causes the Teflon wiper to flex the rubber spring. Over time this becomes loose.

***Slide in the max  
position of its  
travel***

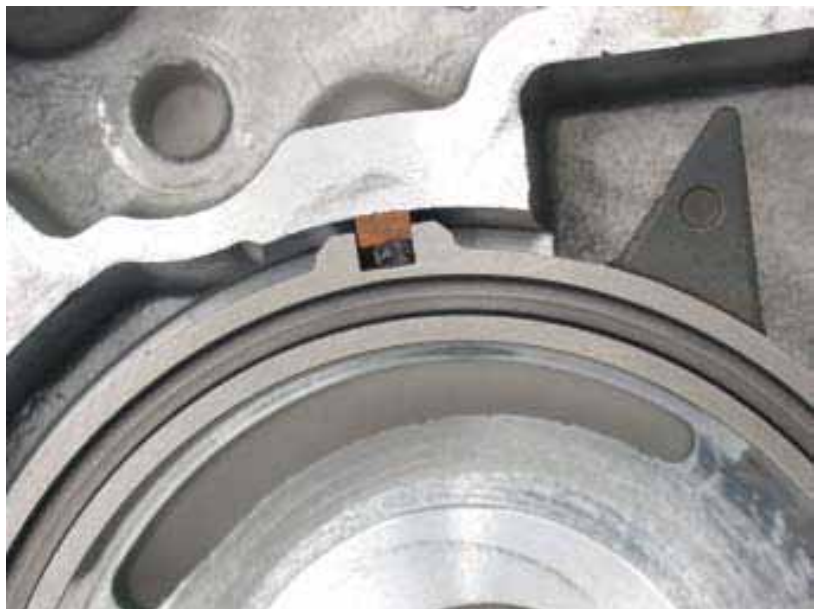
***Slide in the  
center position  
of its travel***

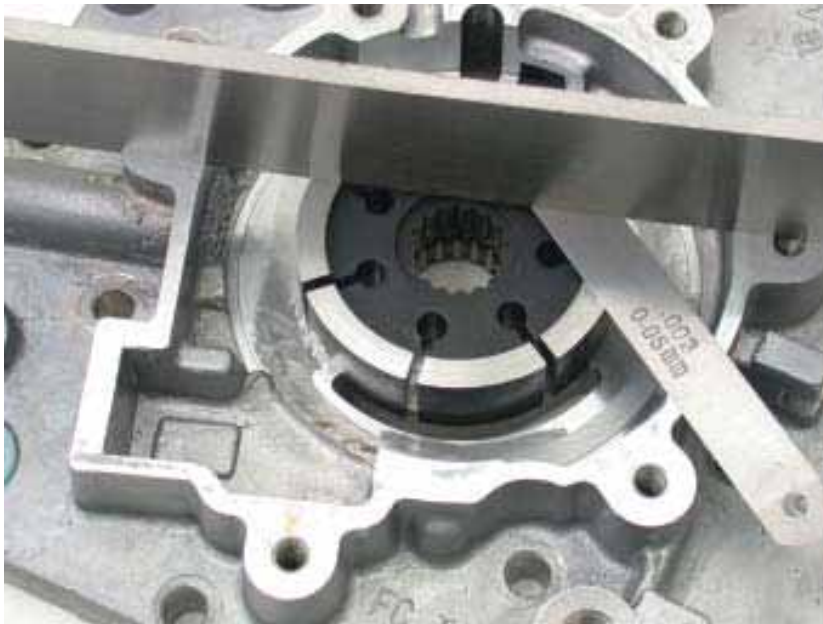
***Rotor clearances should be 0.0015"–0.003"***

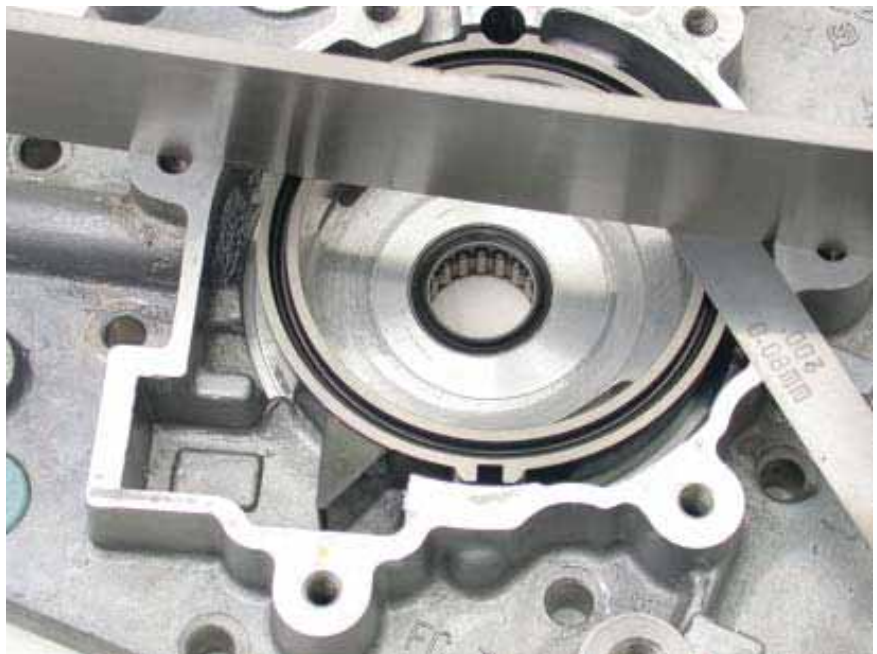
***Slide clearance should be 0.002"–0.004"***
