# 2005 TECHNICAL SEMINAR

***The***

## ***Automatic Transmission Rebuilders Association***

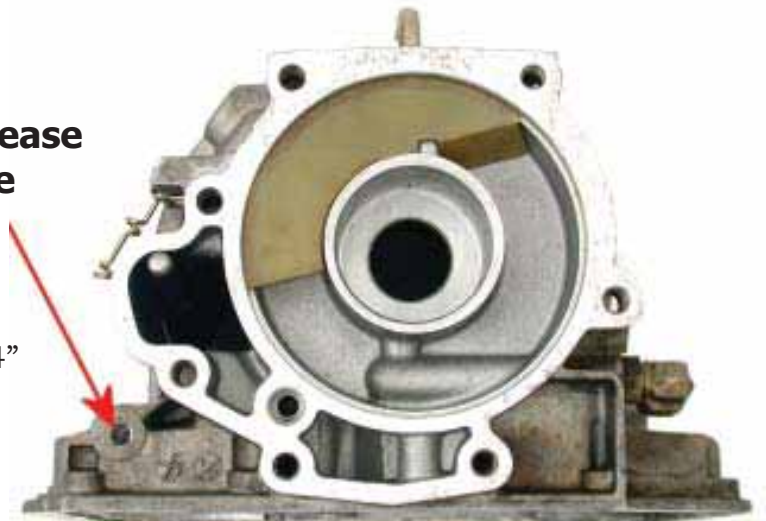
## Servo Release Pressure

Pilot Drill: 1/8"  
Tap Drill: "Q" or 21/64"  
Tap: 1/8" NPT

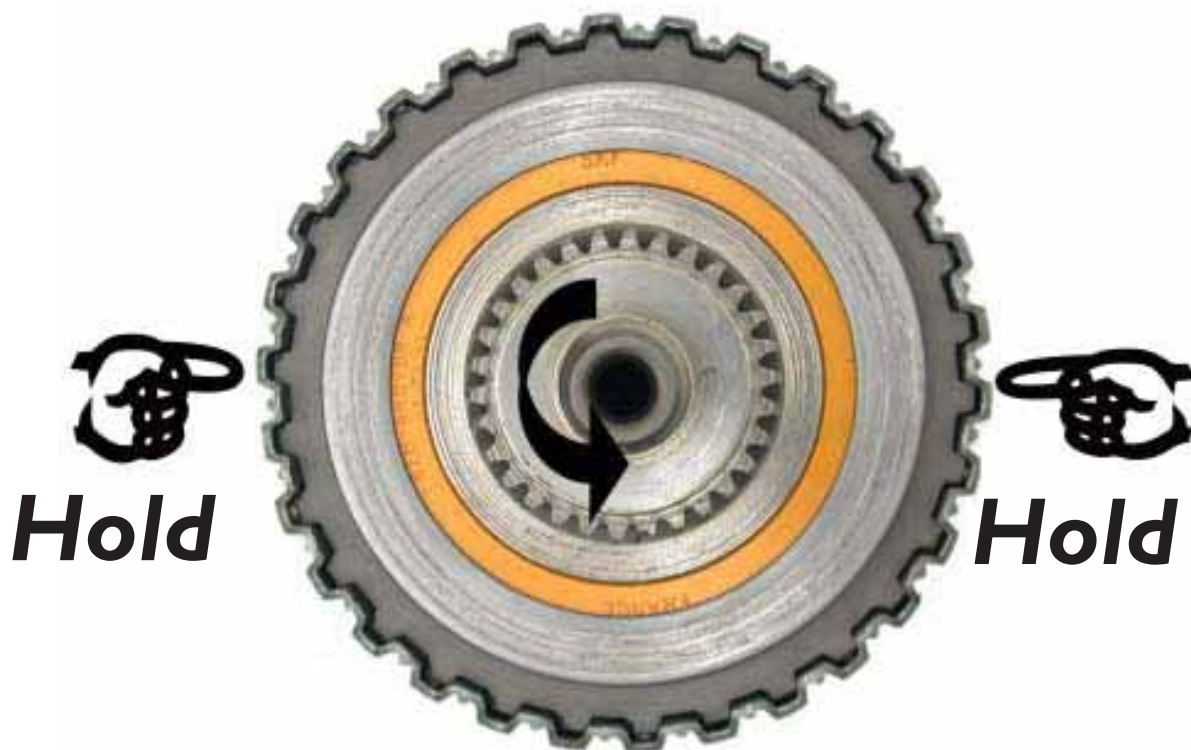
## *No Reverse, No Drive Engagement, Bind in 2nd Gear*

If you install the Input Sprag incorrectly or if the sprag has failed; the symptoms that will follow are no reverse, no drive engagement and a bind in 2nd gear. Check the transmission in all ranges, if you have Manual Low, look for the Sprag as the root of the problem.

**Sun Gear Freewheels  
Counter Clockwise**

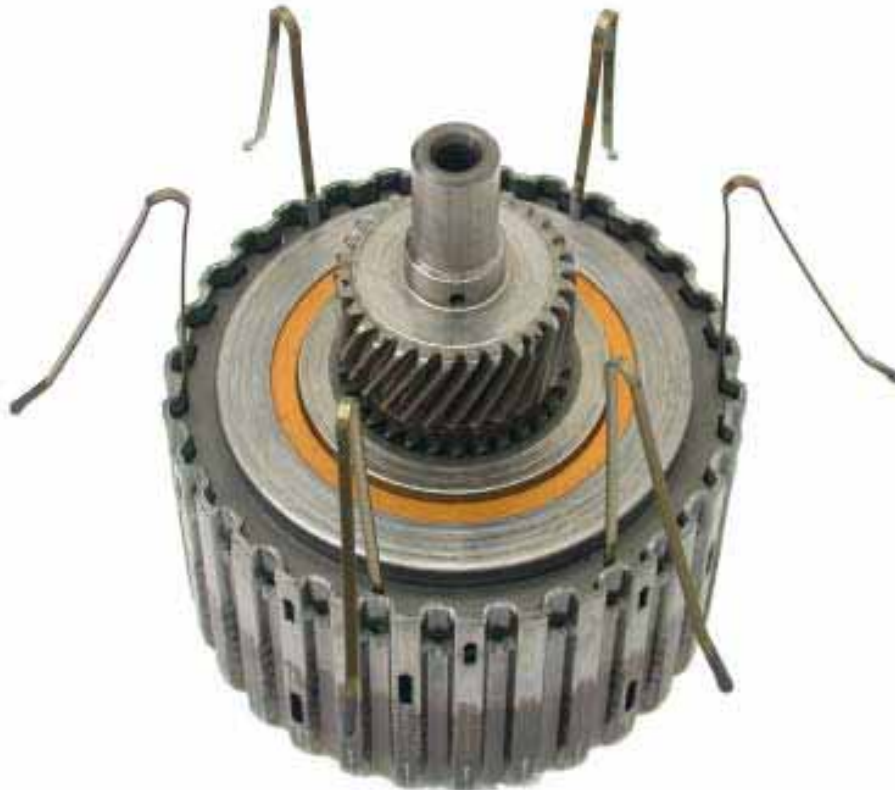
**Install several Bobby pins around the 3rd Clutch Drum.**

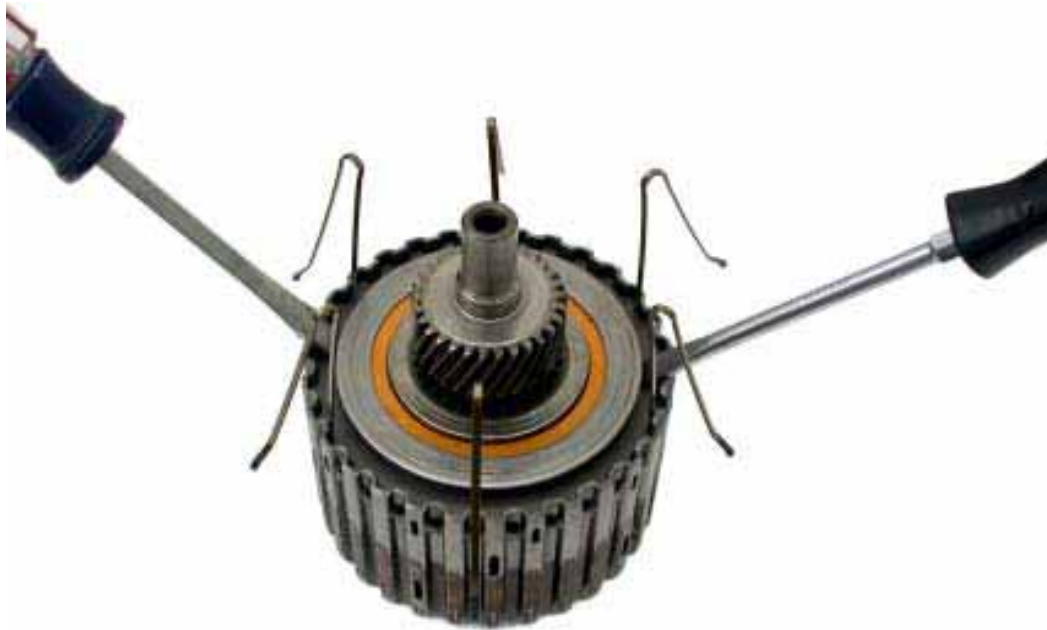
Once you have all of the Bobby pins in place, simply use two screw drivers to pop the race out of the drum.

**Pry the Sprag Race out with two screw drivers.**

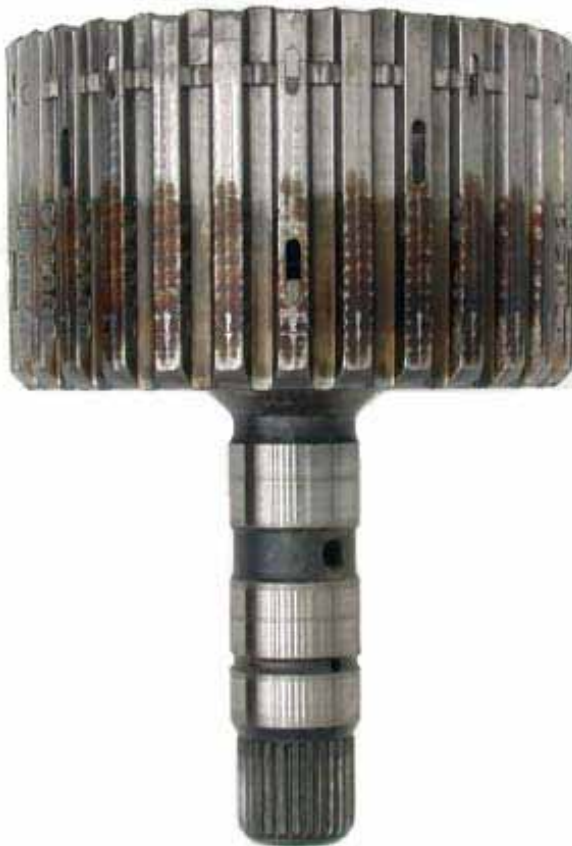
The 3rd Clutch Cushion Plate should be installed as shown for proper operation. If the 3rd Clutch Cushion Plate is installed incorrectly a harsh 3rd gear will occur. There is no factory specifications for clutch clearance.

Try to maintain 0.008"-0.010" per disc.

**3rd Clutch Cushion  
Plate is beveled as  
shown**

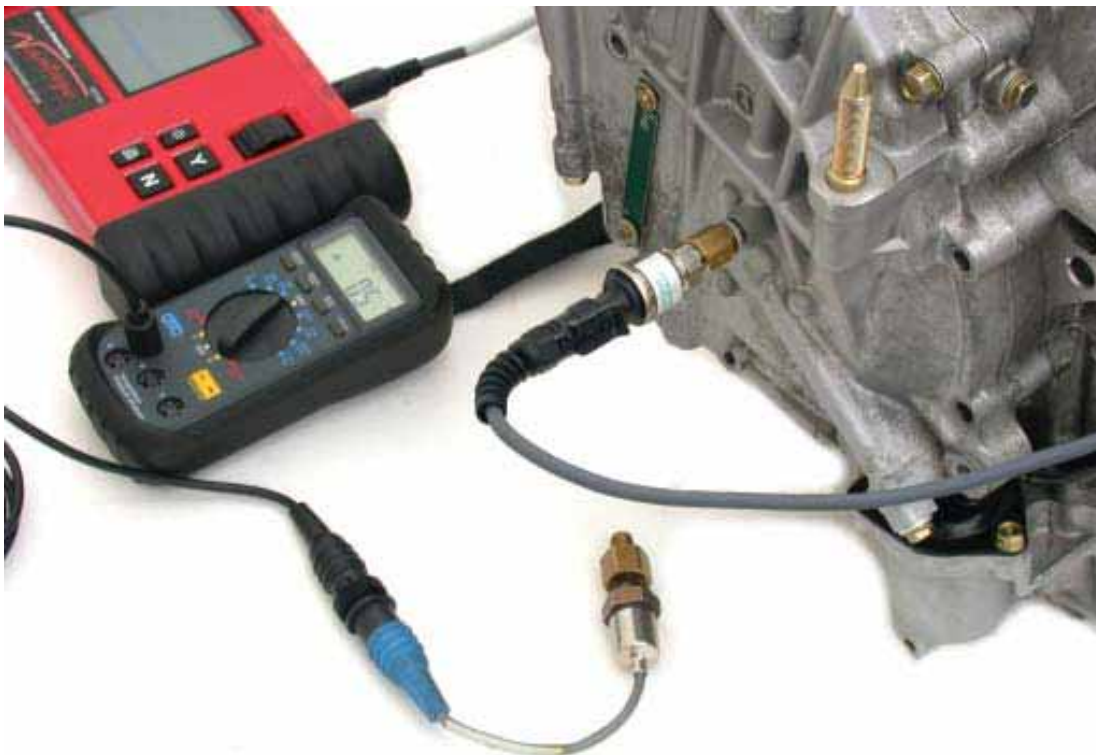
Standard mechanical gauges will work for checking line pressure, however if you use a mechanical gauge, the accumulation effect of the gauge and rubber hose can cause flares or mask harsh shifts when connected to a clutch pressure port. It is best to use transducer type electronic gauges for clutch pressures.

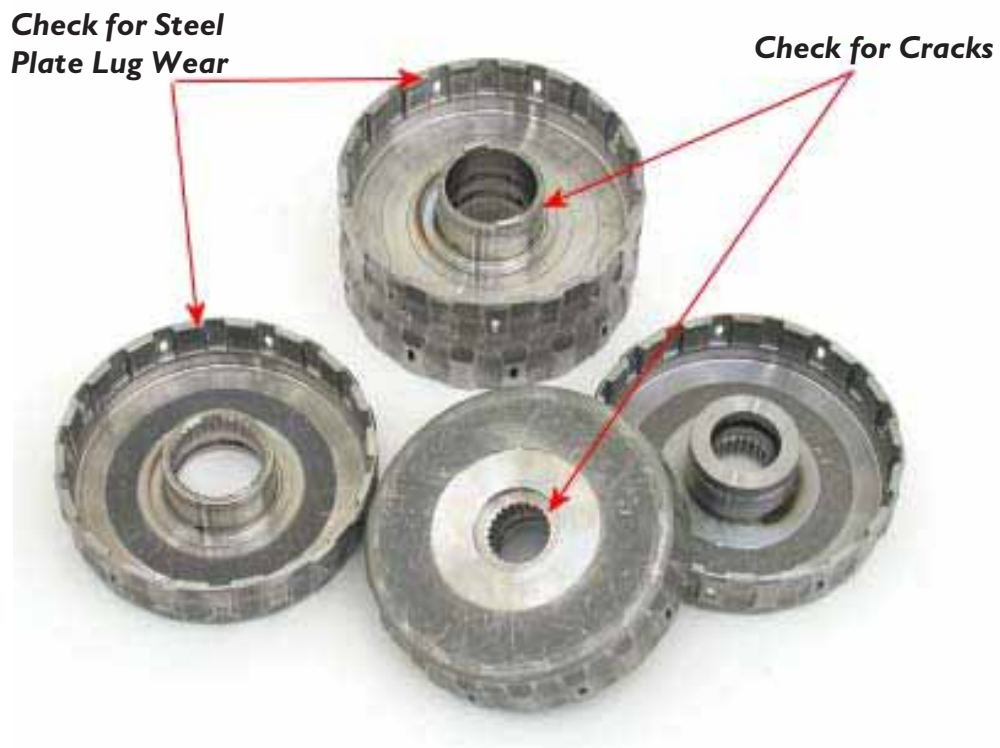
Drum cracks are a common failure on many units and are most common on Civic units. Inspect the Drums for cracks and Steel Plate lug wear.

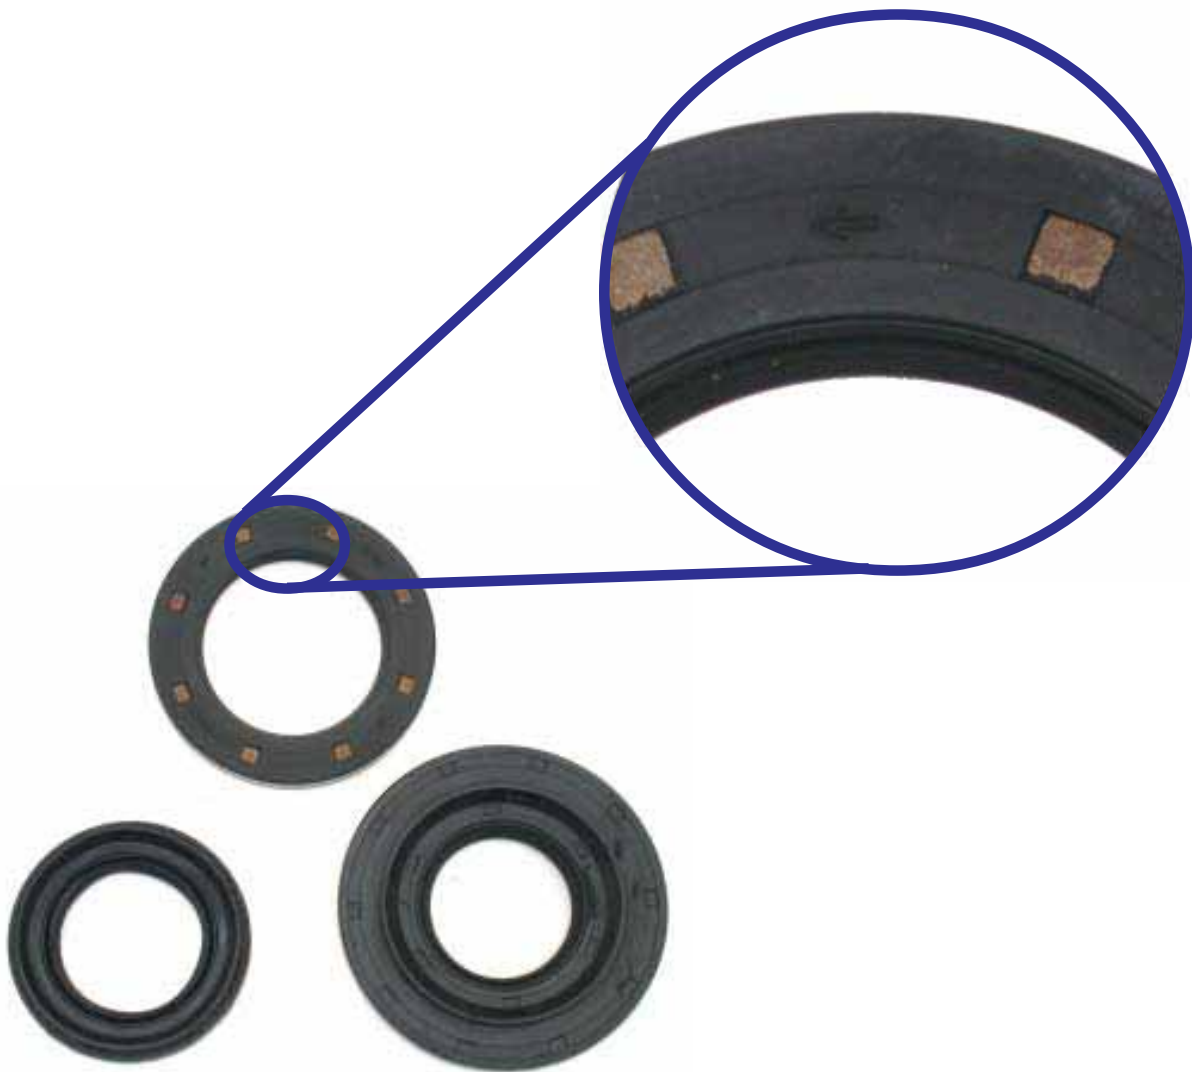
## *Torque Converter and Axle Seals are Directional*

Most Honda seals have an arrow showing the correct rotation. On 4-cylinder applications the torque converter seal has an arrow pointing counter clockwise, on V6 applications the arrow points clockwise.

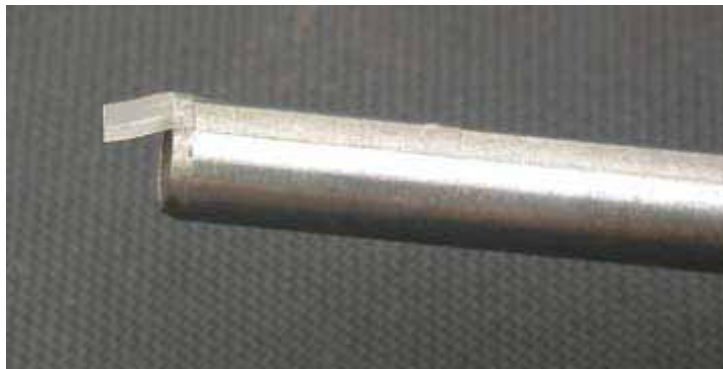
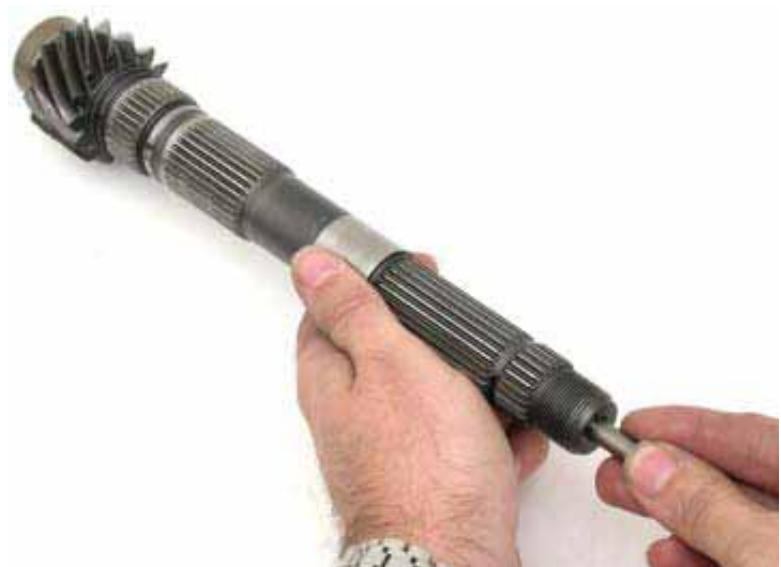
1. With a pair of scissors, cut a narrow (1/16") strip of “Scotch” or similar type plastic tape (about 0.002" thick).
2. Lay the piece of tape lengthwise at the end of the tube, leaving some of the tape hanging off of the end of the tube.
3. Fold the loose end of the tape in slightly so it will lead itself into the shaft bushing.
4. Insert the tube into the shaft, taped end first.

The tube should not fit into the bushing with the piece of tape on it. If it will fit into the bushing (without excessive force), the bushing or tube are worn and need to be replaced.

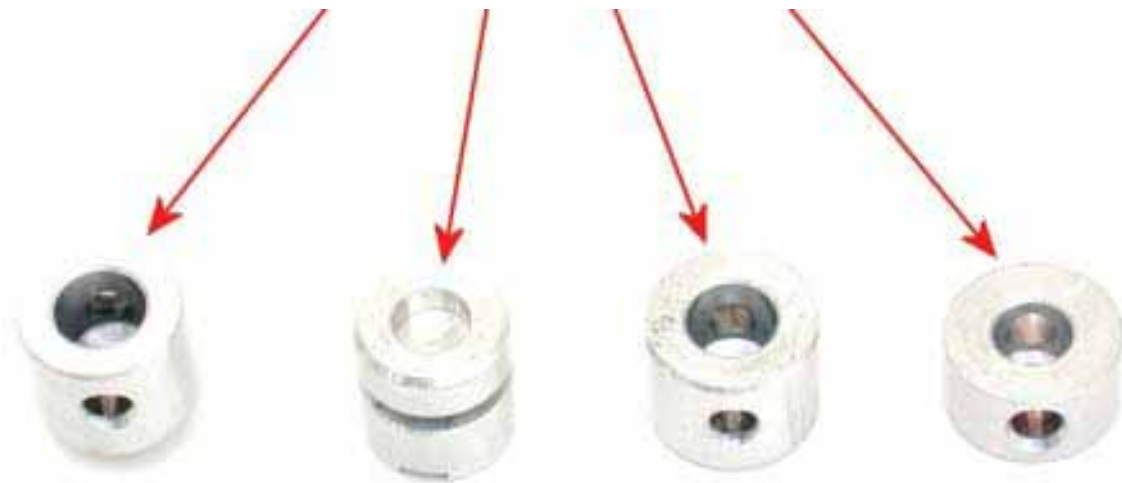
Be very careful during disassembly and reassembly of the valve body. If these plugs are installed incorrectly many different shift concerns will occur depending on what plug is installed incorrectly.

*This end faces out (away from the valve)*

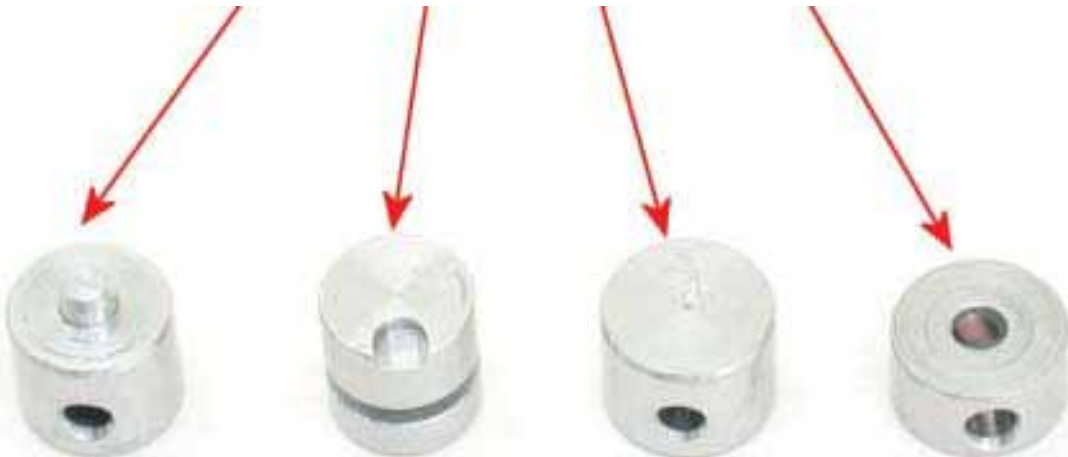
*This end faces in (towards valve/spring)*

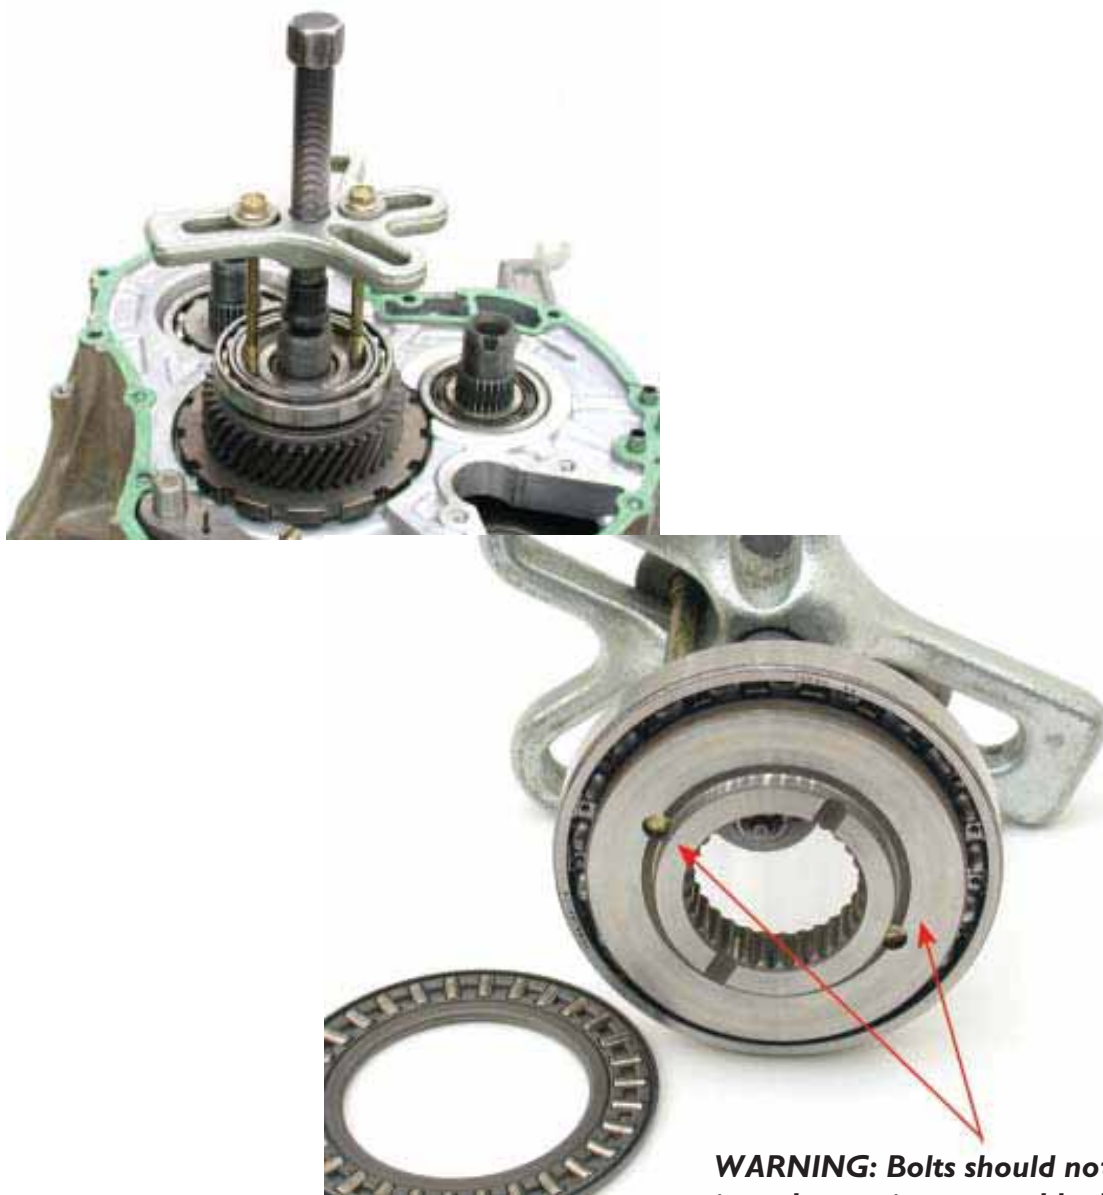
Be careful when pulling the retainer assembly. If the puller bolts are installed too deep they can damage the thrust bearing surface below the ball bearing.

**WARNING:** Bolts should not be impacted into the retainer assembly. Impacting your puller bolts into the retainer will cause the lip of the retainer to rise at the arrow points shown. This will cause bearing damage.

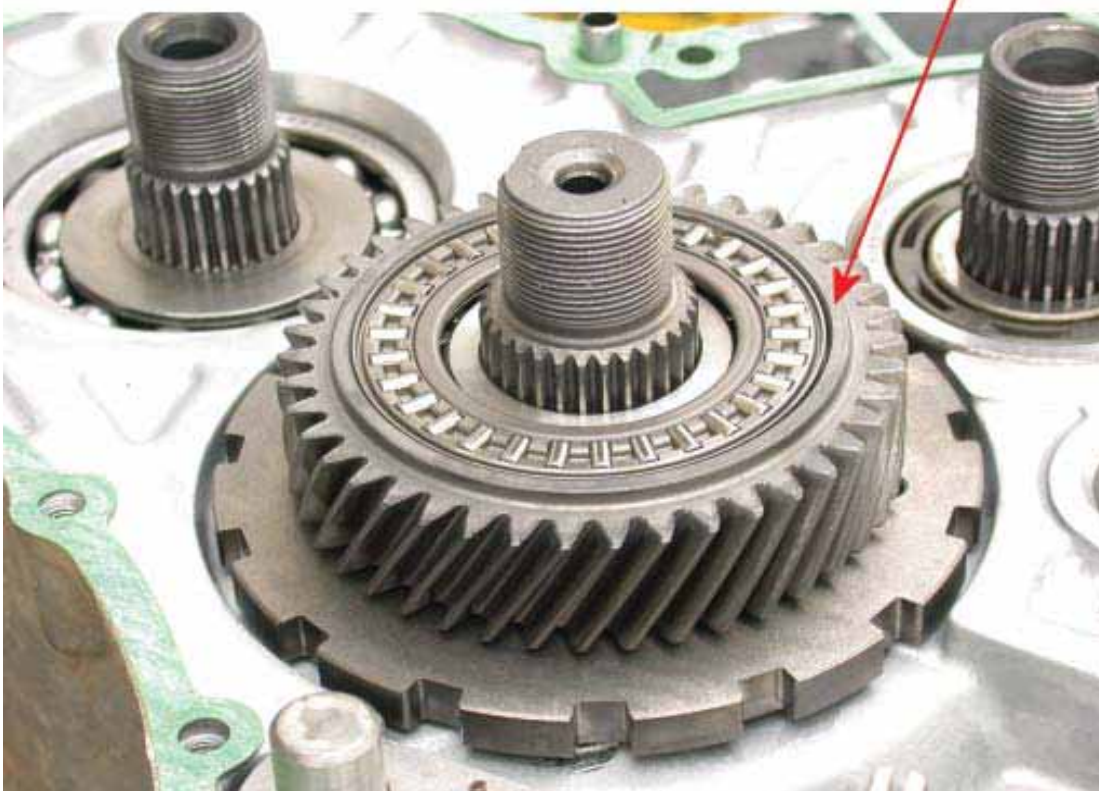
Make sure the transfer gear is installed correctly. The step on the gear needs to be installed towards the threaded end of the shaft.

*The step must face the threaded end of the shaft*

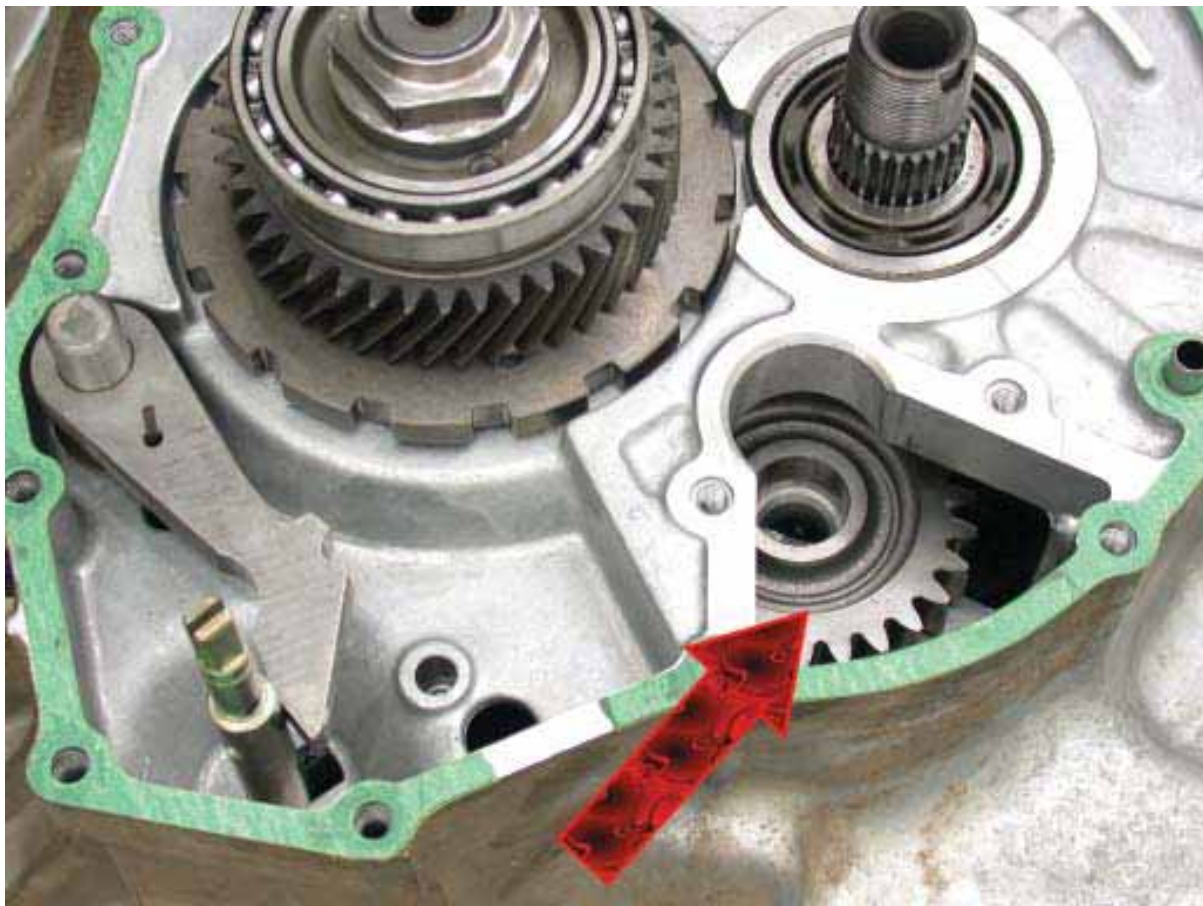
Make sure the Reverse Idler Gear is installed correctly. The ridge on the gear must face up during installation as shown in the picture below.

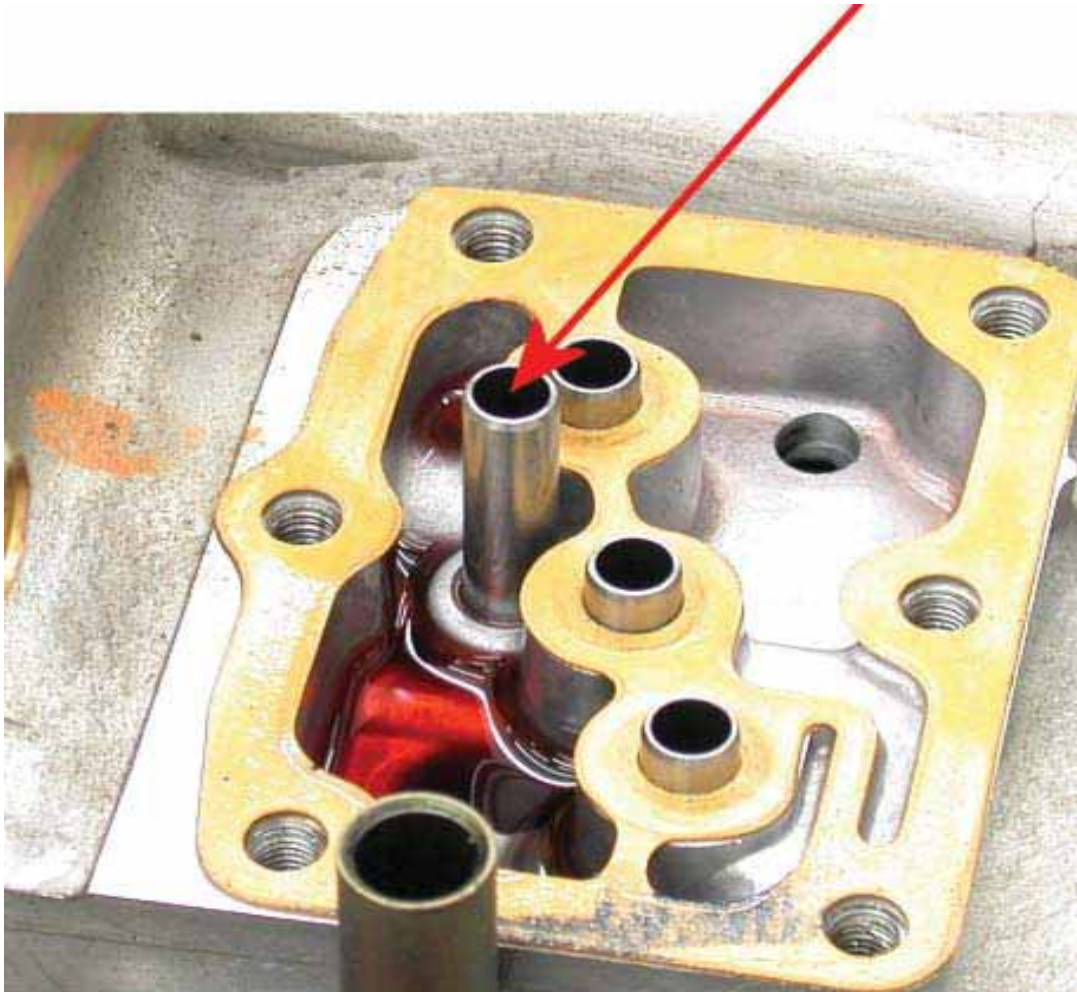
During the rebuild make sure you install all of the pipes in there proper locations. Often times during the rebuild the CPC Solenoid feed pipe is not installed correctly or not installed at all.

*CPC Feed Pipes*

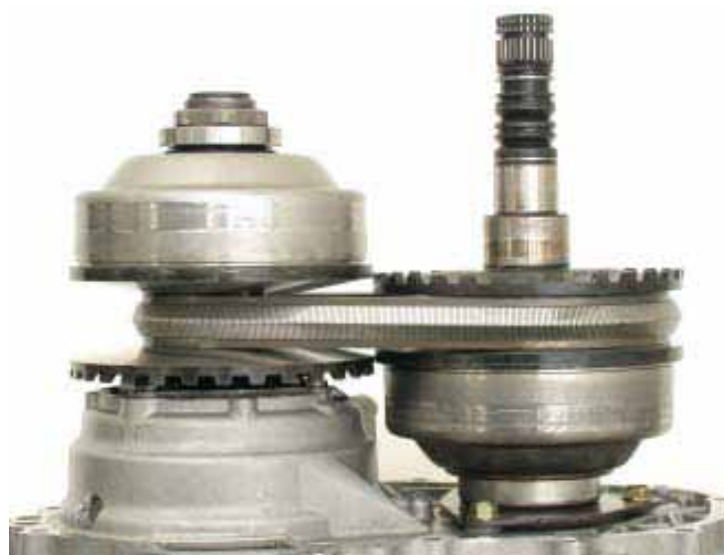
Air test the pulleys before disassembling the unit, check the sheave finish. Make sure there is no polishing, dishing, or scoring. All of these concerns will cause multiple problems.

The finish you're looking for is an even ground finish similar to a brand new roller bearing outer race.

*Inspect the pulley  
Sheave for rough  
surfaces*

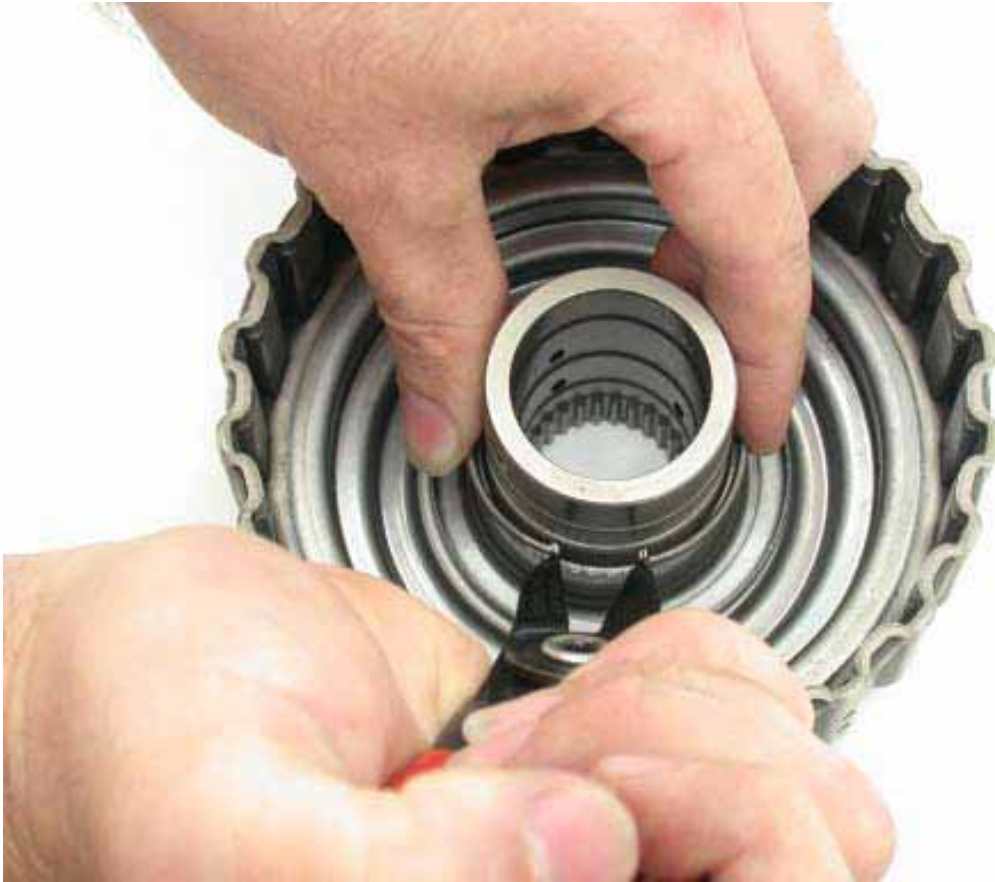
After removing the spring and retainer, there is another snapping that must be removed before the piston will come out of drum.

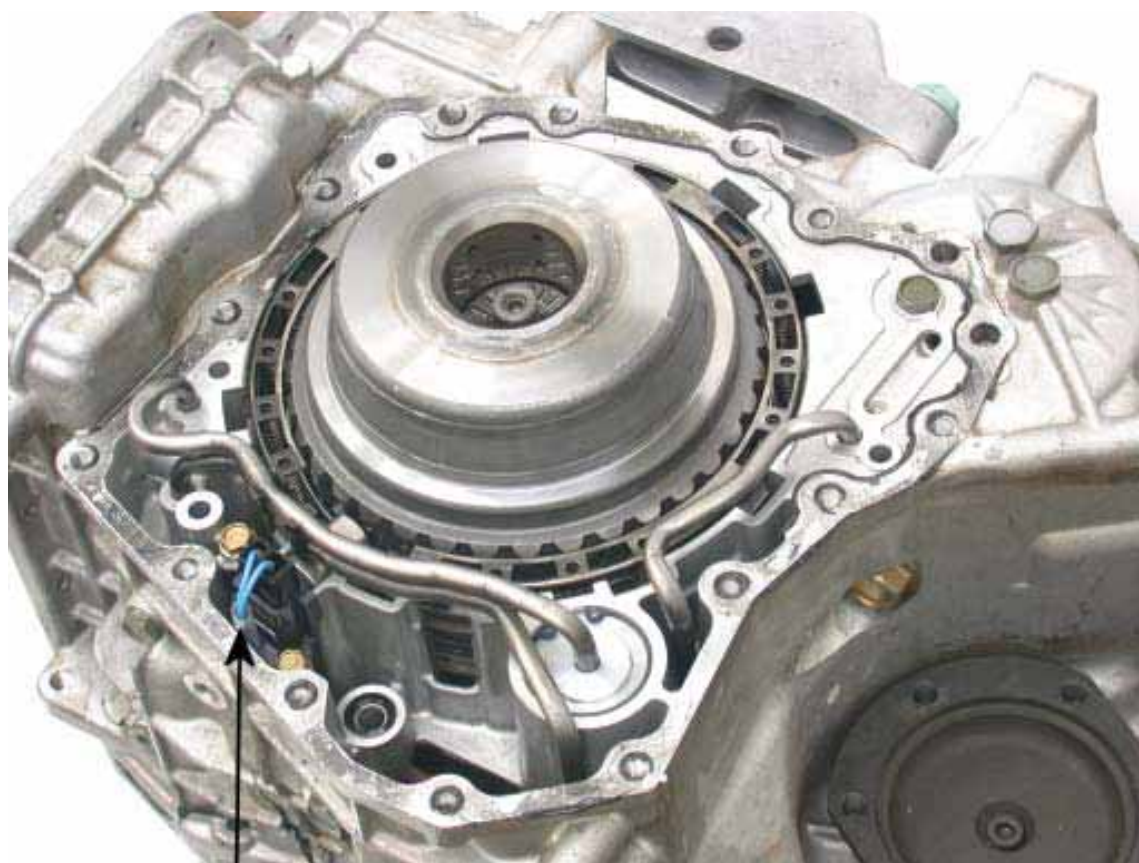
**Input Speed Sensor  
(blue wires)**

The Input speed sensor can be removed in the vehicle. Remove the End cover and locate the speed sensor for diagnosing.

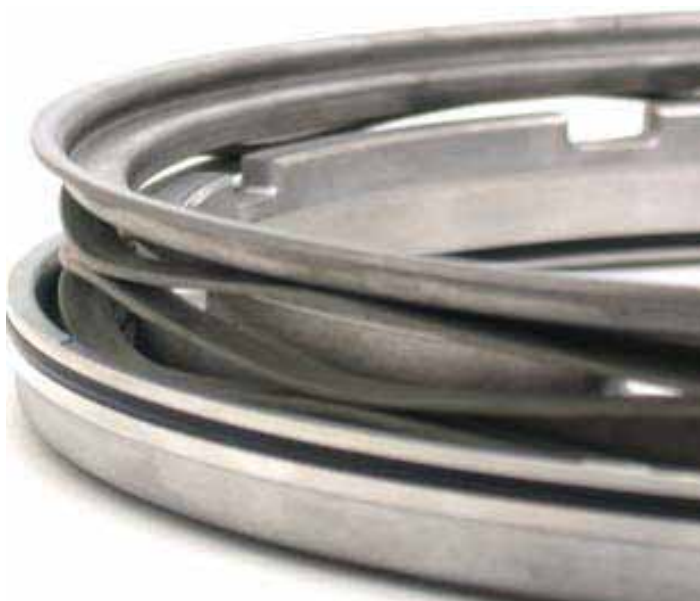
***Correct return spring  
seat installation***

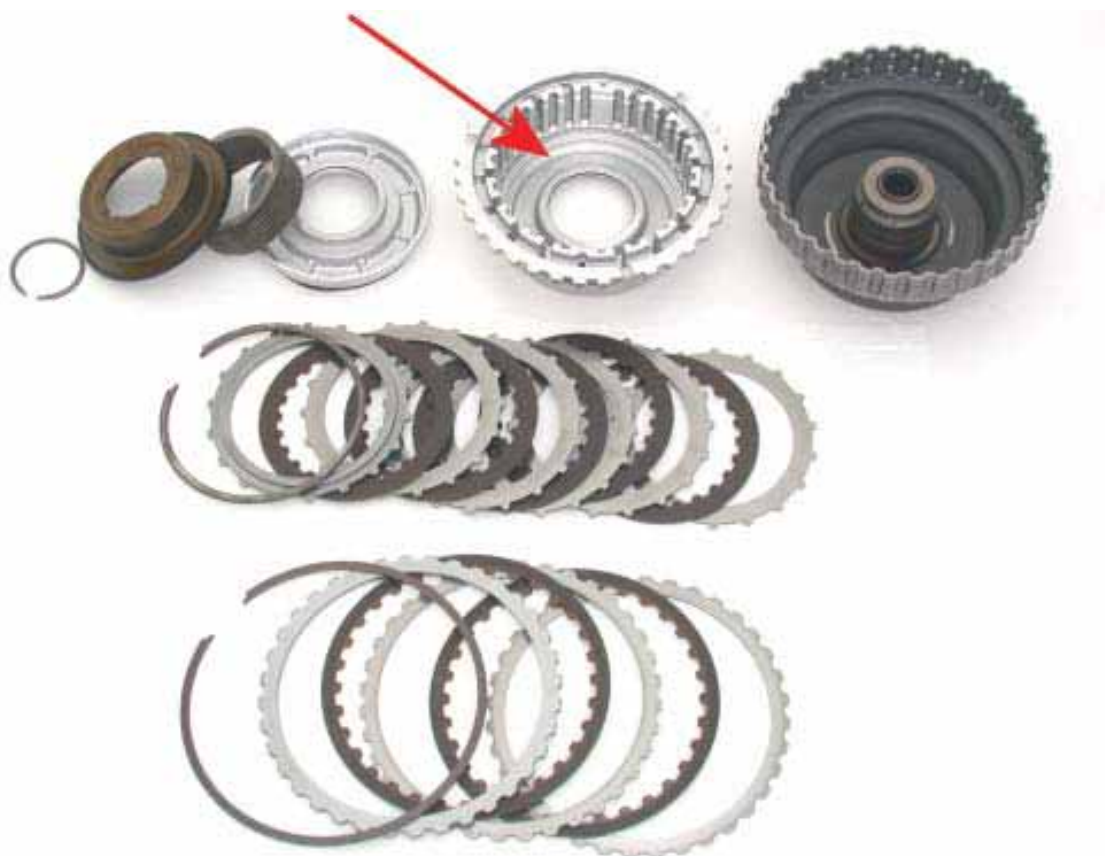
Piston cracks can be caused by crossleaks between the forward and reverse clutches. Inspect closely when there is a burnt/welded clutch failure. To check for crossleaks while in the vehicle, install a pressure gauge in the reverse clutch pressure tap. There should be 0 psi when in all of the forward ranges.

*Check for cracks in this area*

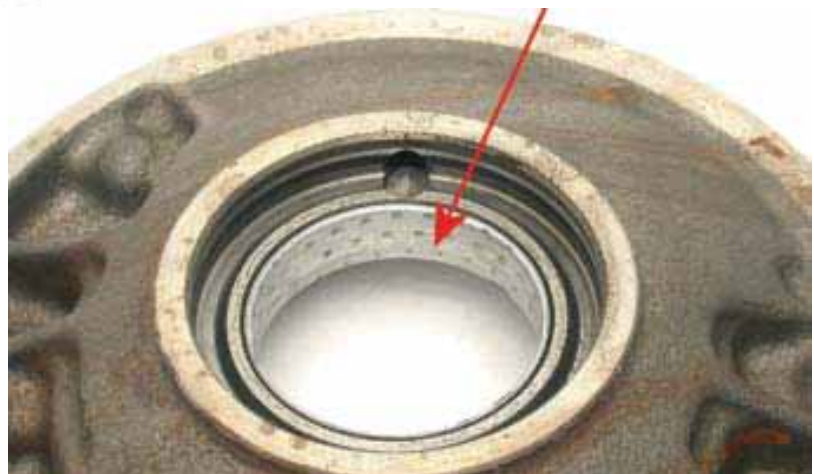
**Bushing Installation:**  
Step is installed towards  
the gear
