Honda 5spd

2-1 Coast Down Neutral when Cold or No Forward

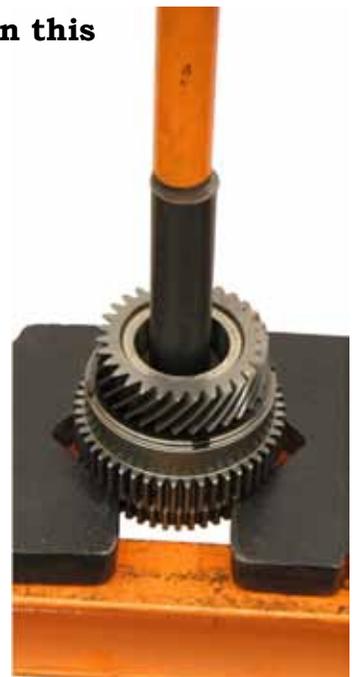
Inner race inspection: The 1st hold clutch hub must be pressed out from 1st gear with 1st gear facing up. After the components are disassembled, 1st gear (inner race) can be inspected. Excessive wear on the 1st gear inner race will require replacement.

**1st Gear
(Inner Race)**

Check for wear here

**Low Clutch Hub
Assembly**

**Hub presses out in this
direction**

**First Hold Clutch
Hub**

Failure usually occurs in the low one way clutch (sprag) and/or inner sprag race (part of 1st gear). The outer sprag race (low clutch hub) in most cases may not need replacement.

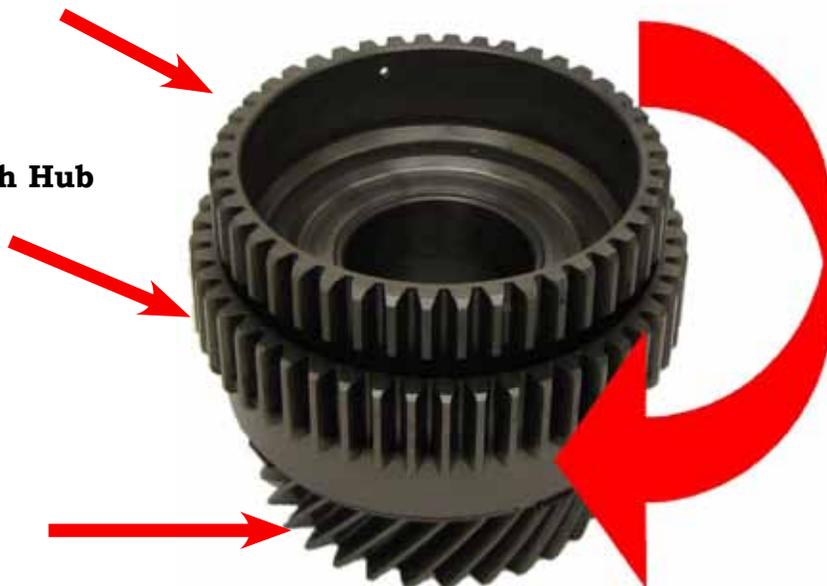
The 4L60 sprag has no extended lip, it can be installed incorrectly. After the sprag is placed into the low hub assembly; check the rotation with the 1st gear (inner race) before pressing the bearing back in place.

**1st Hold Clutch Hub
(HOLD)**

**1st Clutch Hub
(TURN)**

**1st Gear
(HOLD)**

Outer race and sprag inspection: Removing the sprag element from the low clutch hub requires the snap ring holding the bearing in place. There is no need to remove the retainer on the other side of the hub assembly. The bearing must be pressed out in the direction towards the snap ring. The reason for this procedure is the extended lip on the sprag element shown will not pass by the stepped edge inside the outer race. The extended lip will only allow the sprag to be installed or removed in one direction.

Replace components as needed. If both races are fine then only the sprag element needs to be replaced.

The sprag element is only available from the dealer as a complete assembly with the low clutch hub and bearing (Low Clutch Hub assembly). An alternative is to use an early 1982-86 4L60 (700R4) narrow sprag element without the two brass washers. This will also require leaving out the spacer to allow the sprag to fit. The spacer will not be needed because sprag will rest next to the bearing outer race and not move out of place.
