# 4L60E

## No 2nd Gear, Shifts 1-3-4 (continued)

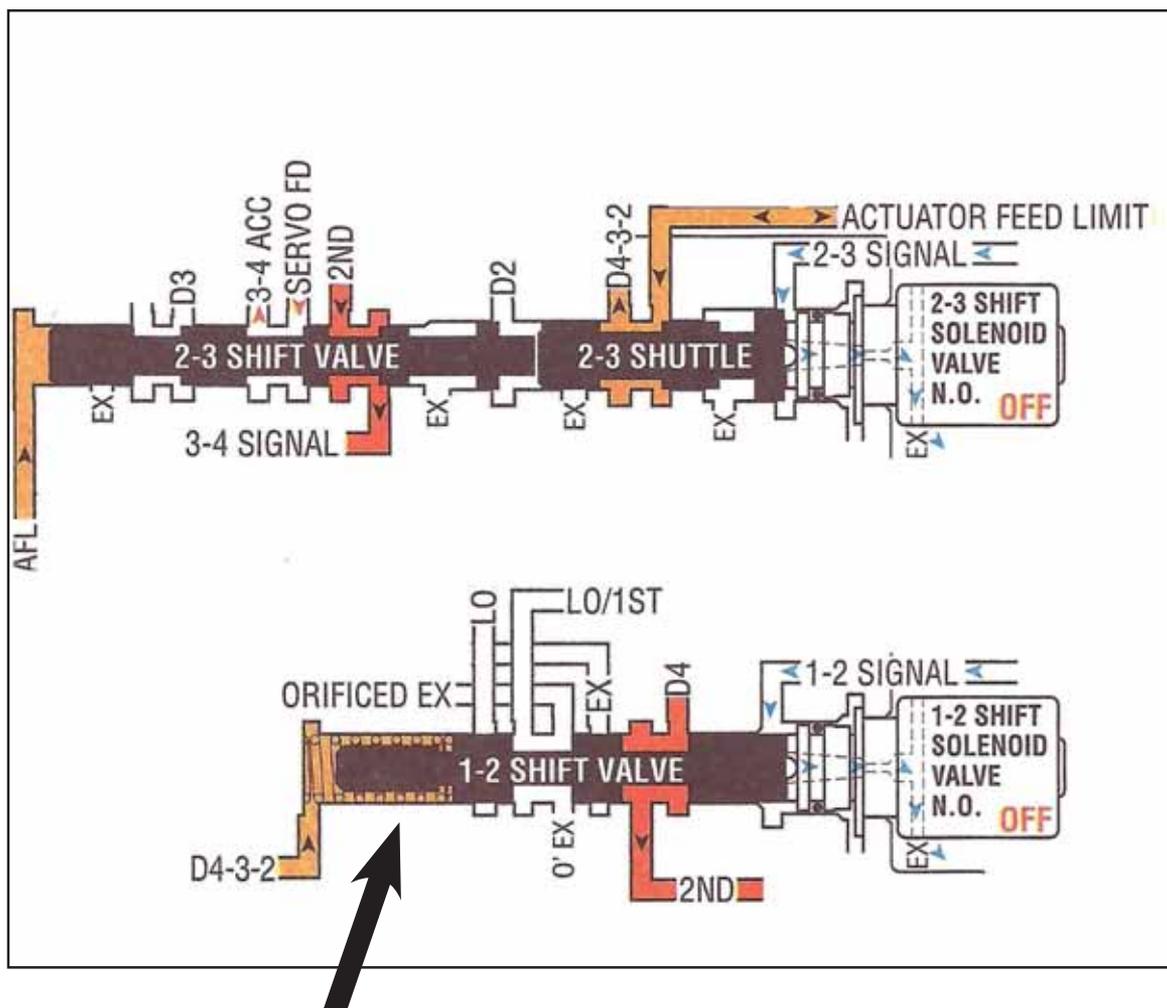
### 3rd Gear

The 3rd gear oil schematic reveals that when the 2-3 valve opens, actuator feed oil is routed to the spring end of the 1-2 valve. This oil forces the 1-2 valve into the 2nd gear position, even if the 1-2 signal oil has not been exhausted by the solenoid.

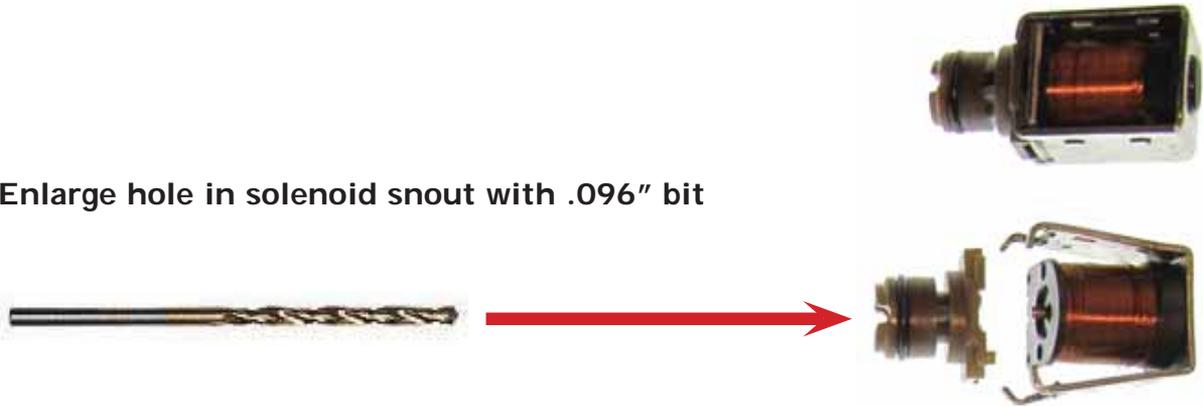
This test will verify if the solenoid or oil flow into the solenoid is the cause of no 2nd. Modify an old solenoid as shown below.

Enlarge hole in solenoid snout with .096" bit

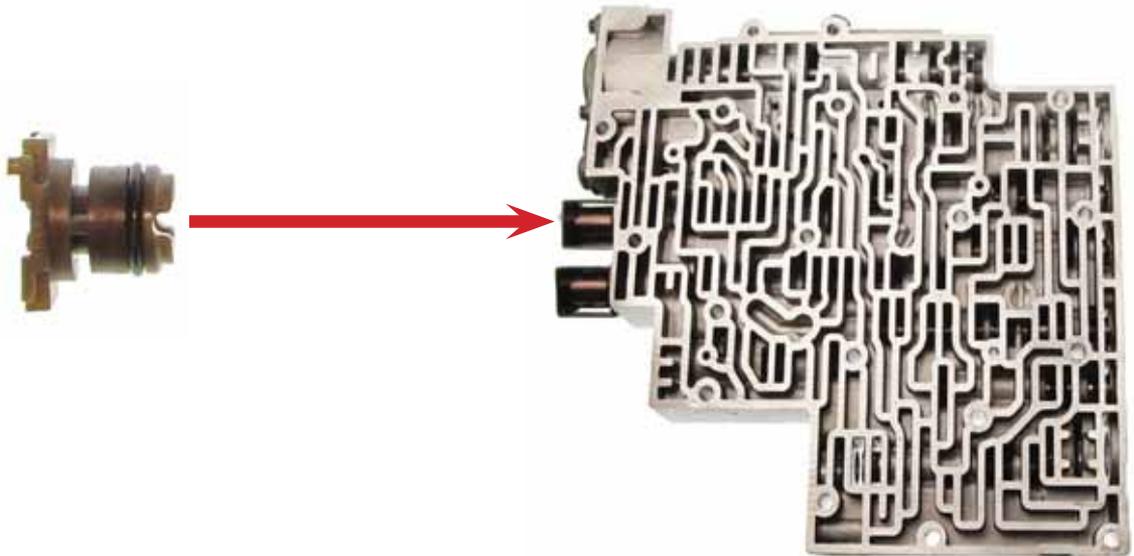
Install the modified solenoid snout and retainer clip into the "A" solenoid location. Leave internal harness plugged into the existing shift solenoid "A" so the ECM will not set a code and command both solenoids off (fail safe).

During the road test, the transmission should make 2nd gear starts in all forward positions. If transmission now has 2nd gear starts, there's no problem with the band or servo! This leaves either a defective shift solenoid "A" or a solenoid over feed problem. Corrective actions would be to: Install a new solenoid "A", measure solenoid "A" feed hole diameter, double up on valve body gaskets and check the case for warpage.

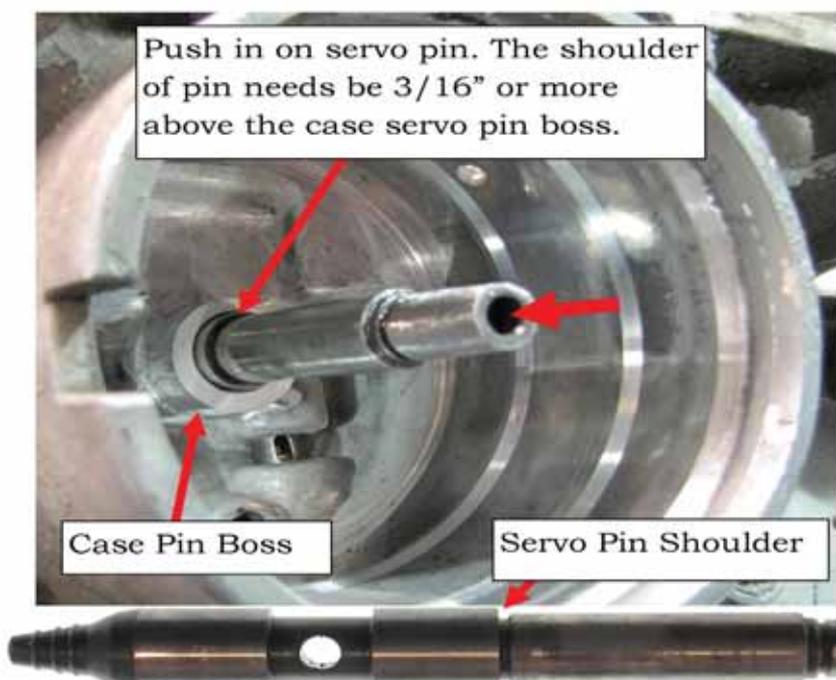
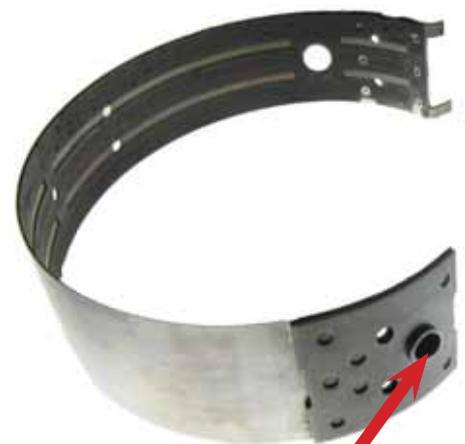
If the transmission still has no 2nd with test snout installed. Inspect the servo pin length (too short), the band anchor hole for wear or an elongated anchor hole, a mismatch between 2nd gear piston and housing or the servo sealing rings are damaged or undersized.
