Nissan/Jatco CVT Internal

RE0F10D

Presented by:
Mike Souza
ATRA Senior
Research Technician

Nissan CVT Internal Webinar ©2016 ATRA. All Rights Reserved.

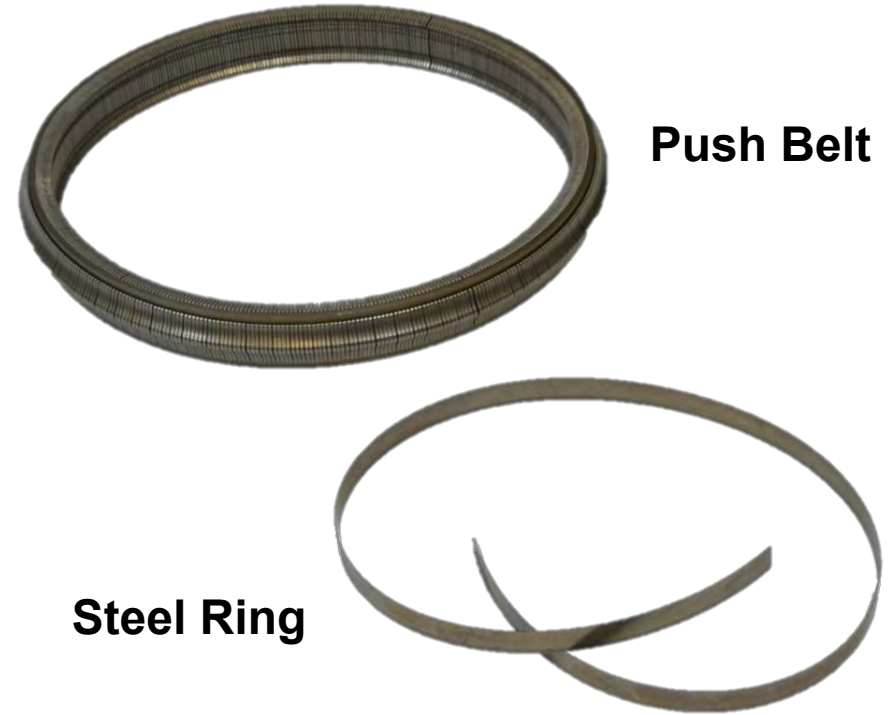
Here is an example of only one Steel Ring failing.

Push Belt

Steel Ring

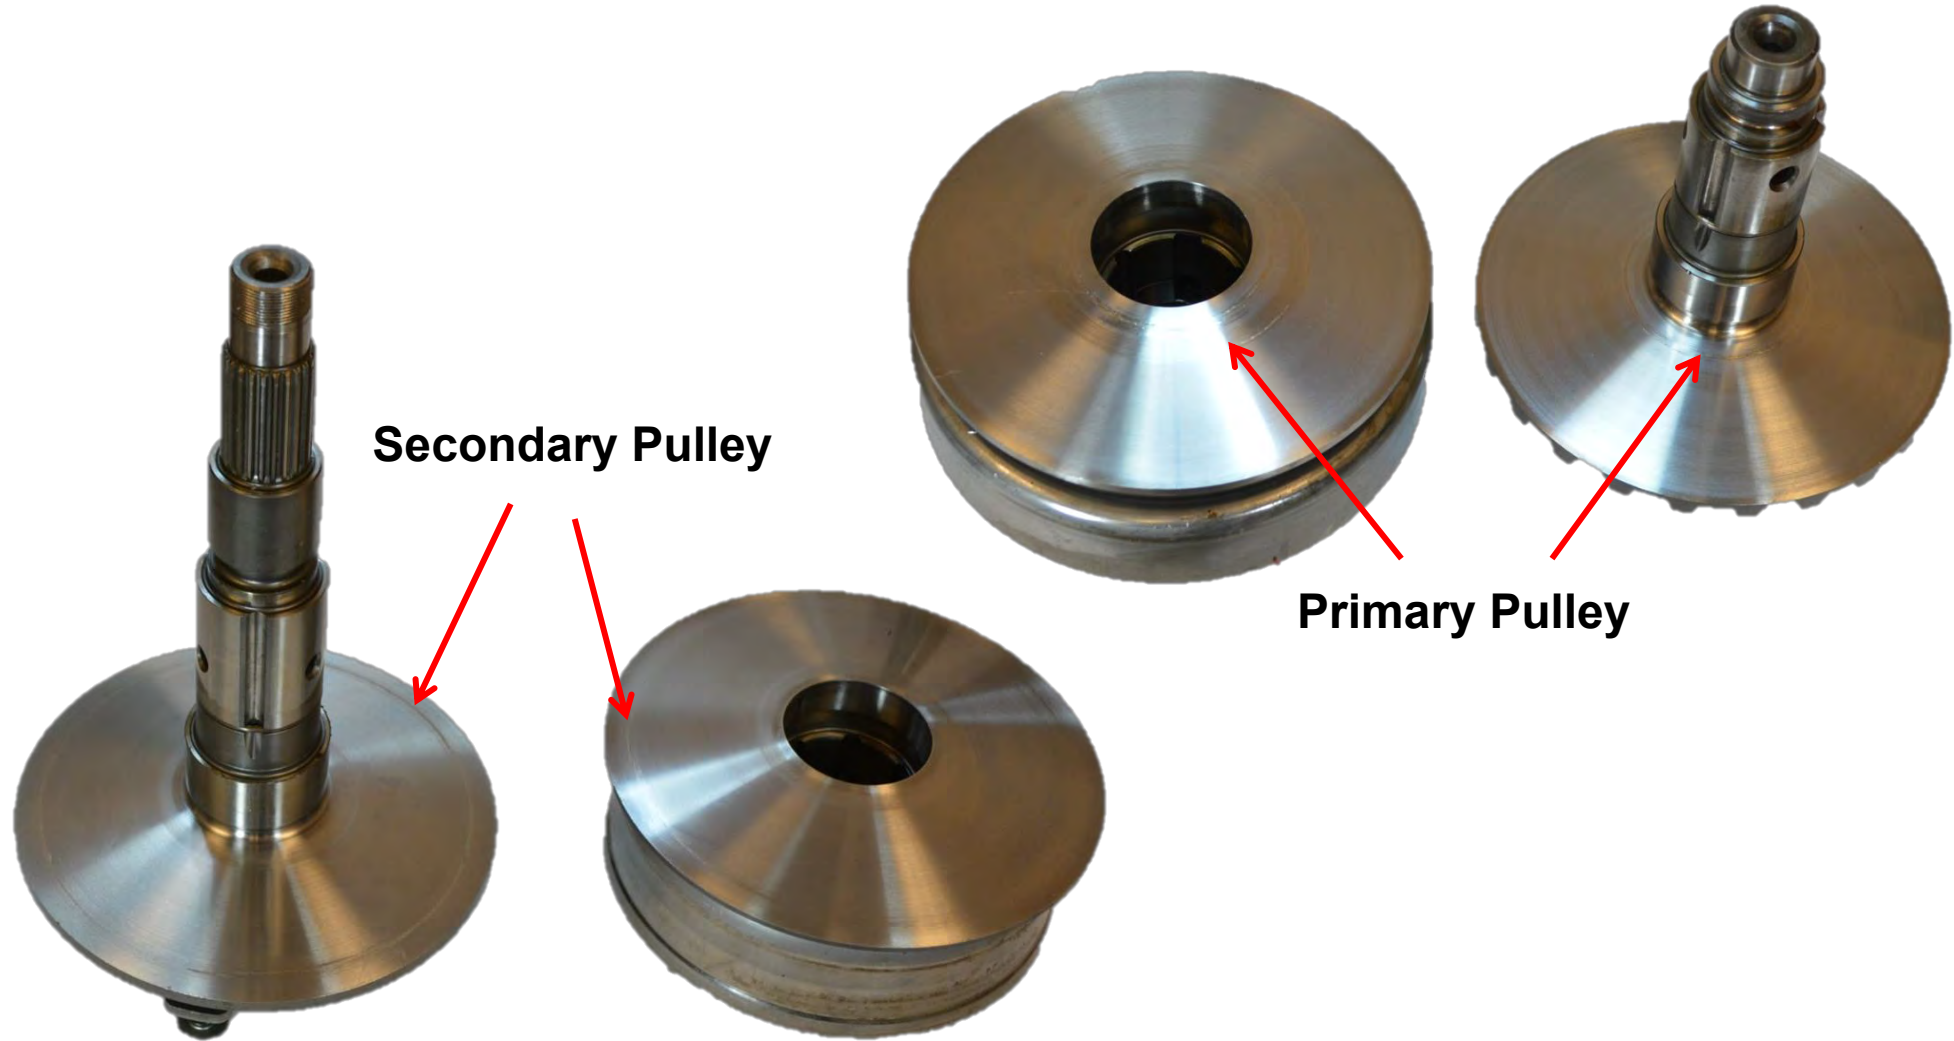
The pulleys sustained minimal damage and were reusable.

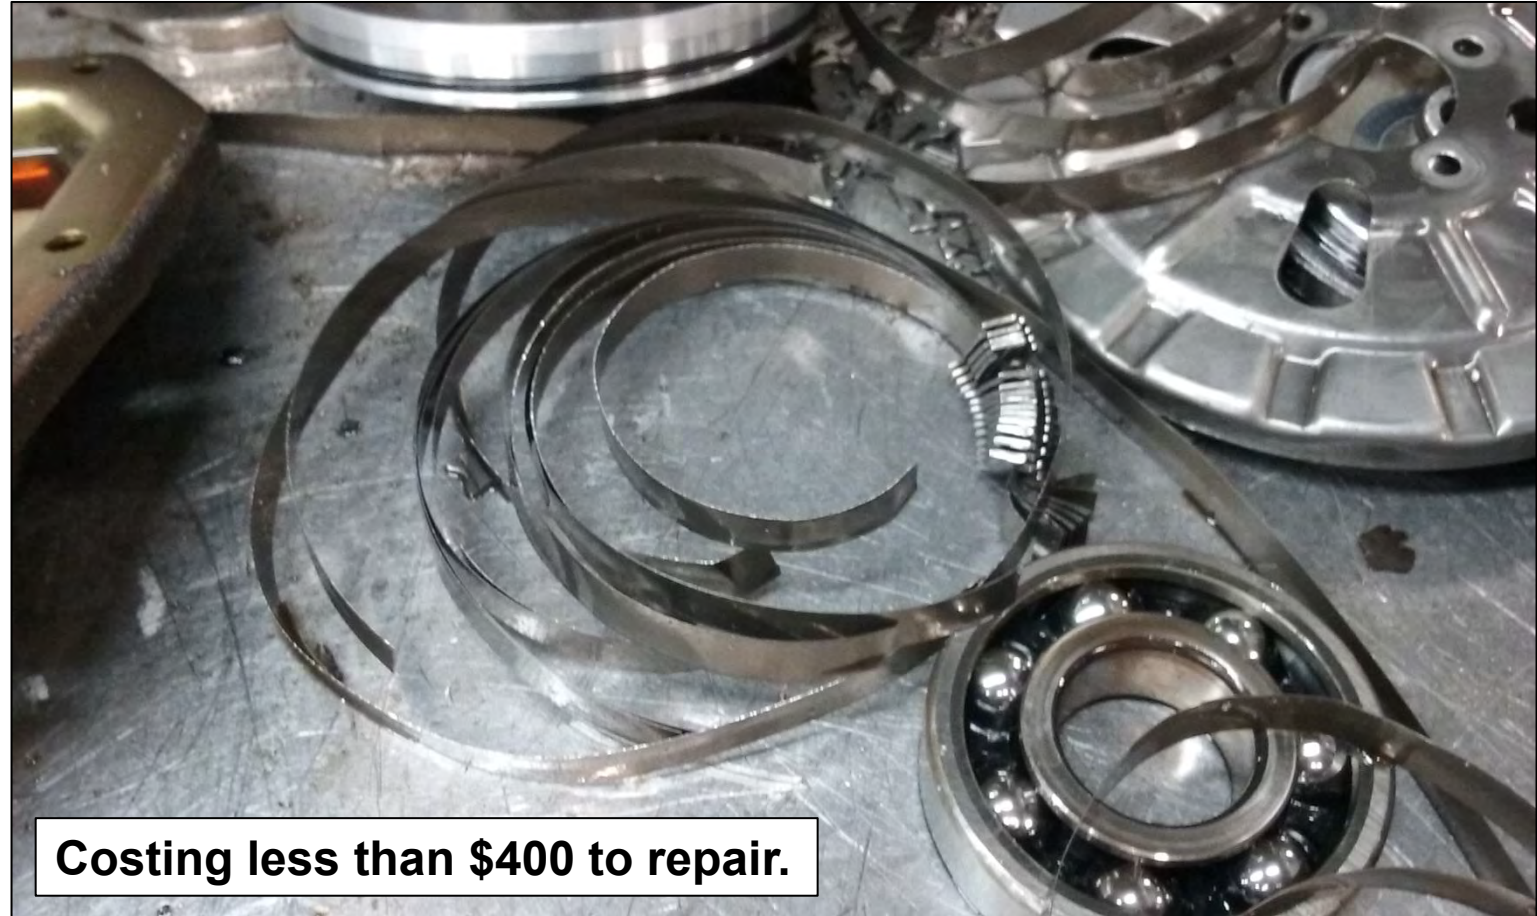
This belt came completely apart on this Mini Cooper VT1F CVT without any damage to the pulleys.

The belt is basically the same as some Nissan/Jatco CVTs.

Costing less than \$400 to repair.

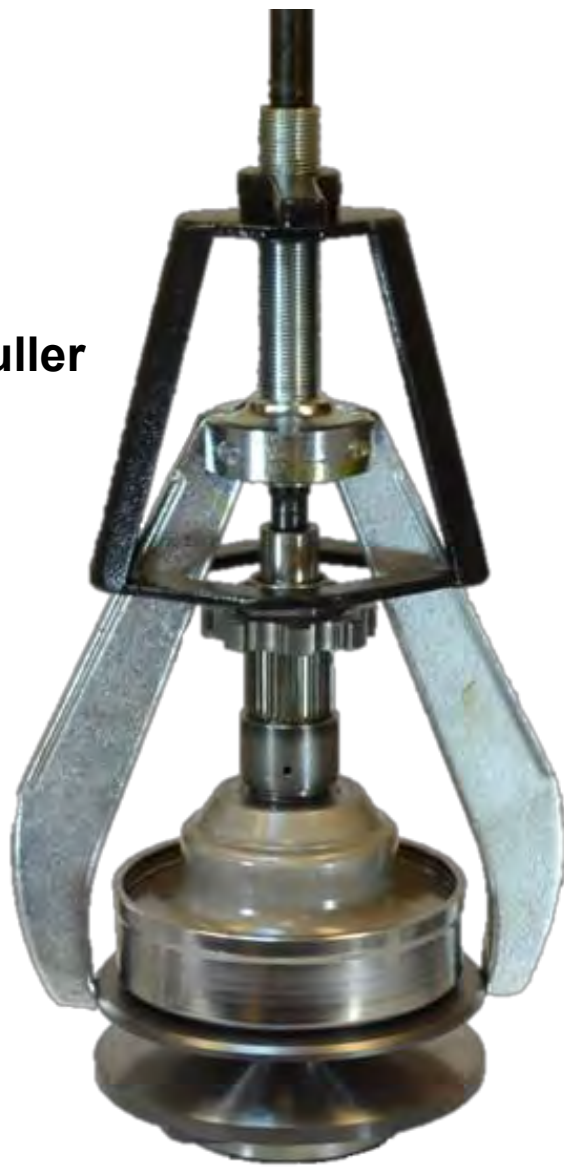
2 Jaw Puller

The only tool necessary that will work on almost all CVT transmissions is a 2 jaw gear puller.

Found on eBay
for **\$180.00**
Tool #11054

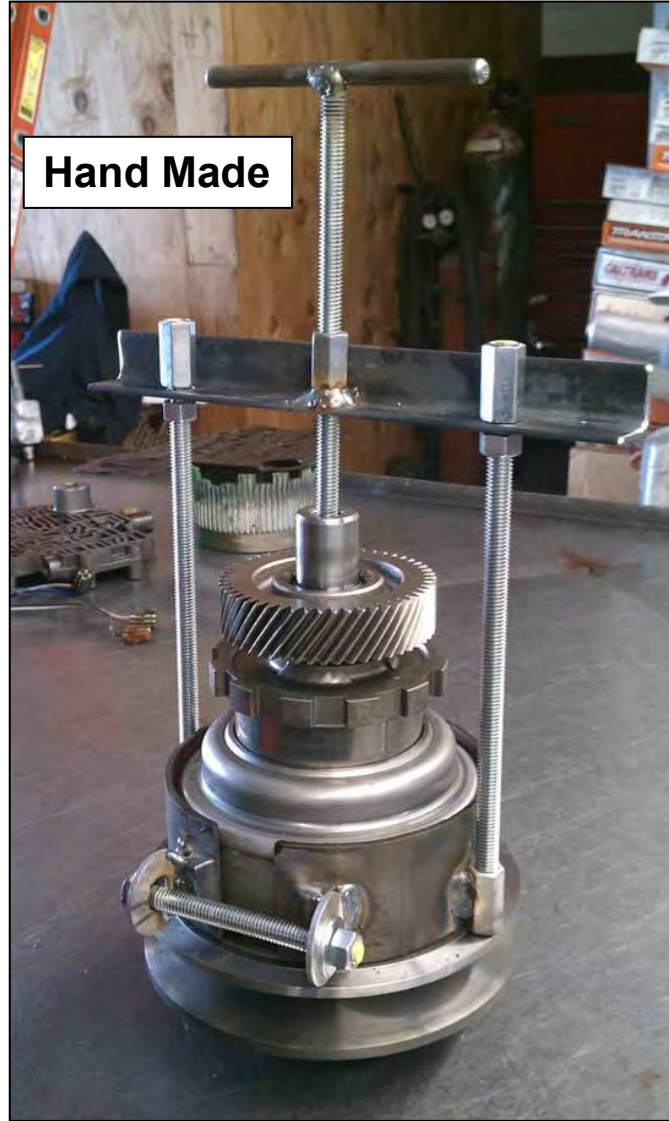
To remove the Pulleys from any Jatco/Nissan CVT simply remove the rear cover. The Pulley assemblies are attached to the rear cover with retainer bolts.

Evenly pry the cover and pulleys out of the case.

Always use at least two Nylon Tie Wraps on the Push Belt before removing the belt from the pulleys.

Retainer Bolts
Installed

Nylon Ties

Push Belt

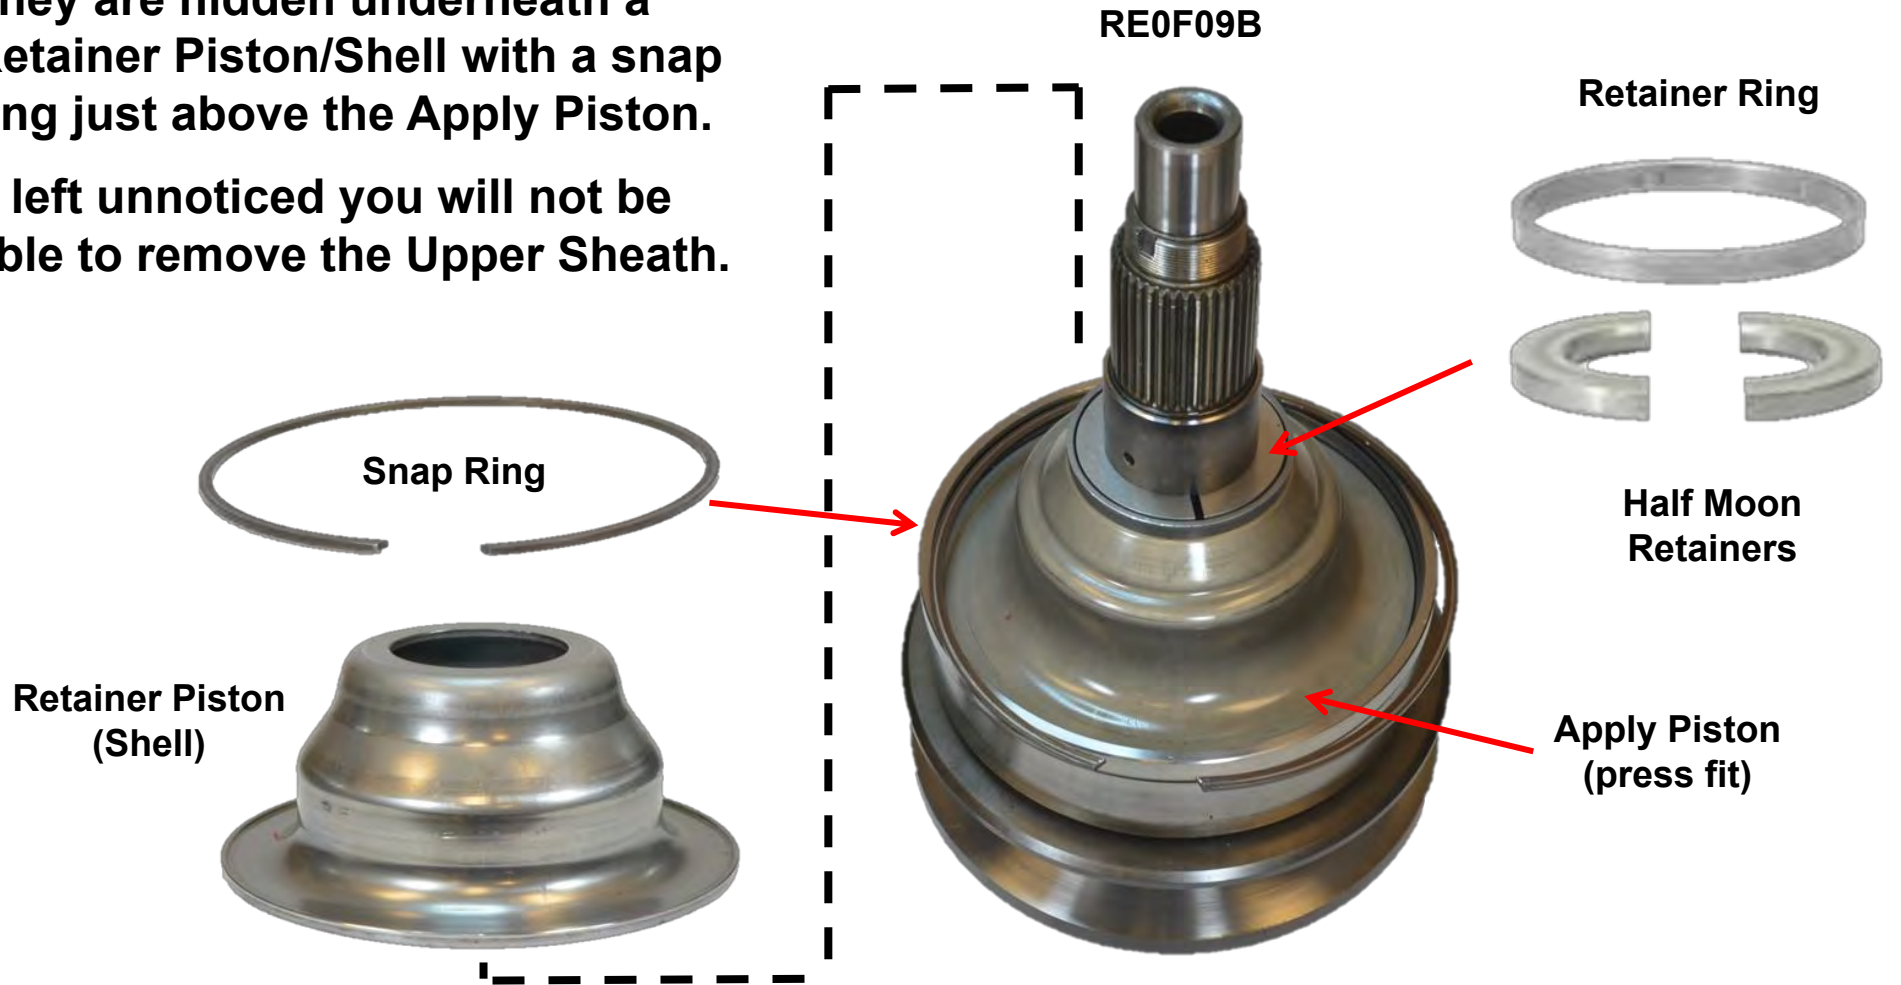
Be aware that some pulleys may have some Half Moon Retainers just above the Apply Piston not found in all units.

They are hidden underneath a Retainer Piston/Shell with a snap ring just above the Apply Piston.

If left unnoticed you will not be able to remove the Upper Sheath.

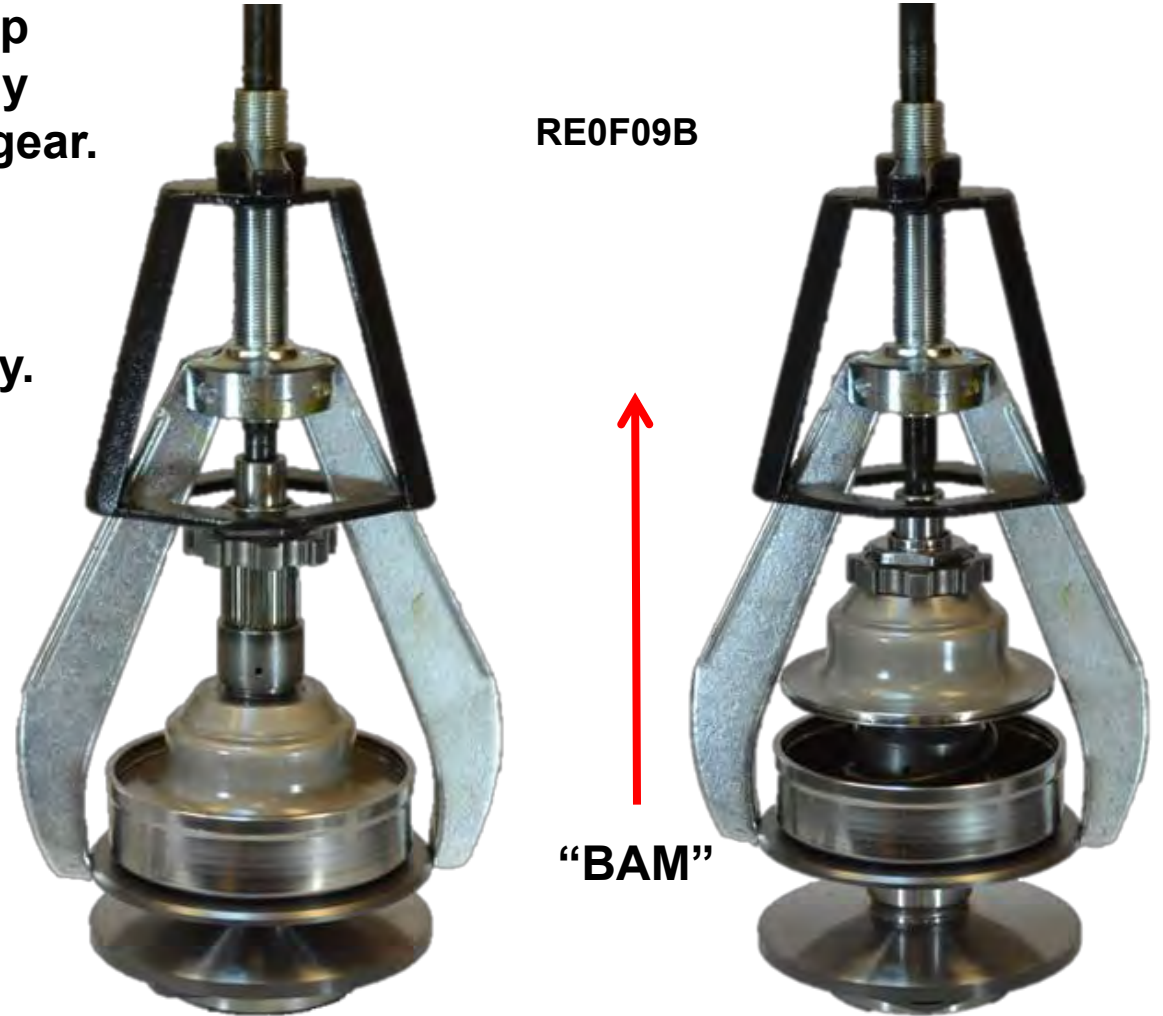
After removing the Retainer Piston/Shell, Half Moon Retainers and Snap Ring; place the Park Gear and Retainer Nut (left hand thread) back onto the pulley.

Now with the two jaw puller pull up on the upper sheath until the apply piston pops up and hits the park gear.

Retainer Nut
(left hand thread)

Park Gear

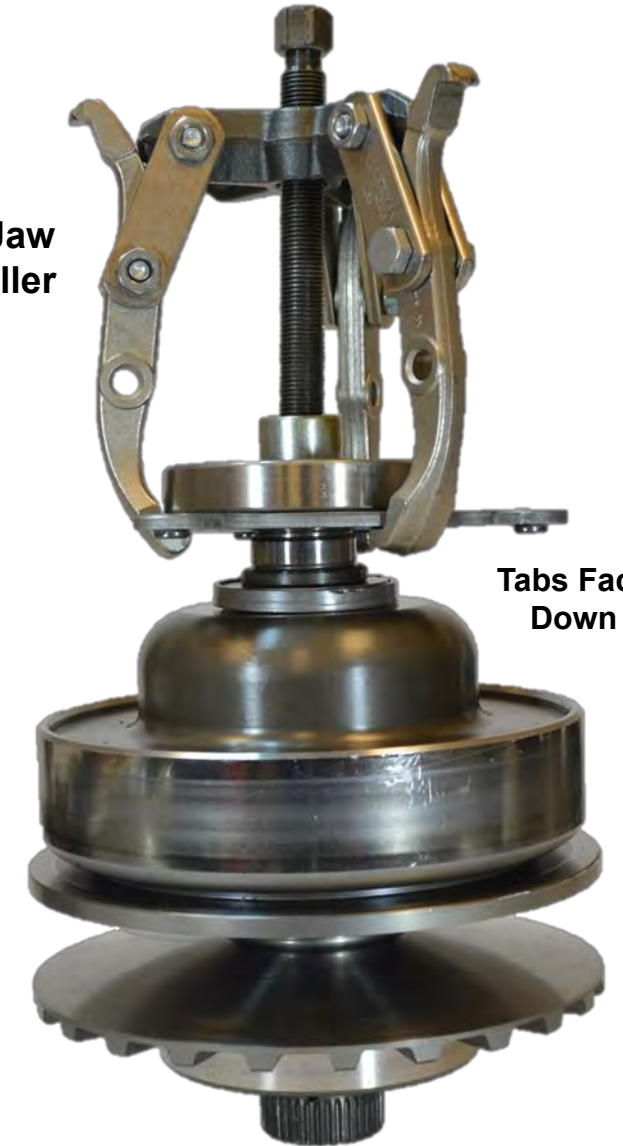
The Primary Pulley shown here is from an RE0F09B with a Return Spring.

After removing the Retainer Nut (right hand thread) use a 3 Jaw Puller to remove the Bearing and Pulley Retainer.

Tabs Face Down

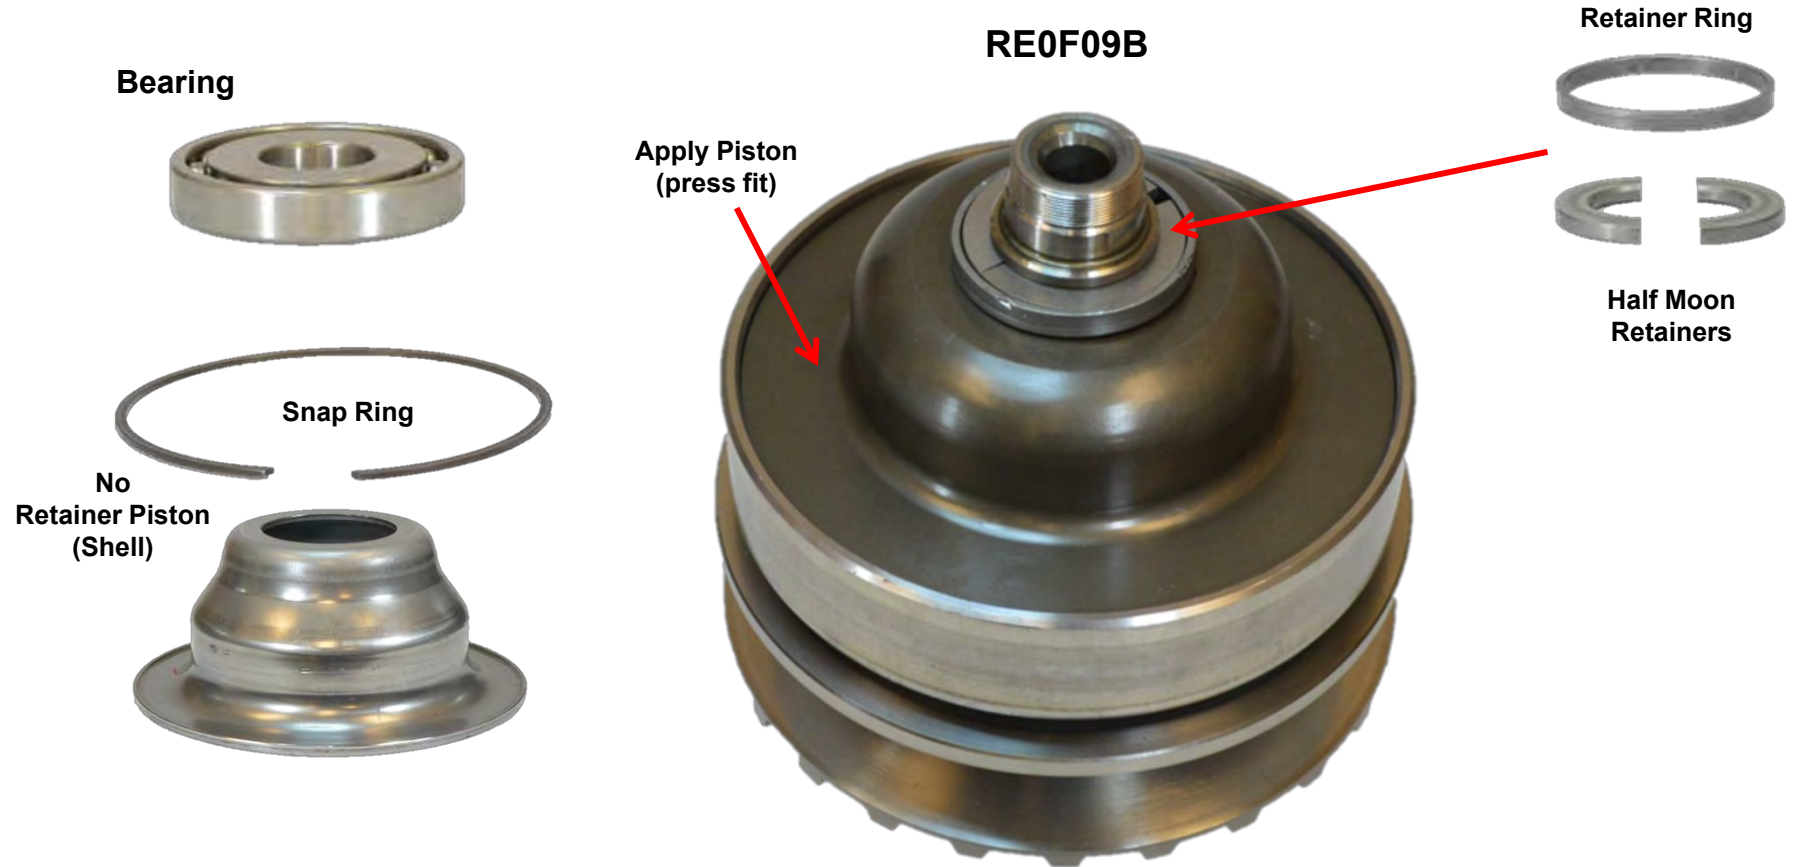
There is no Retainer Piston or Snap Ring, the Half Moon Retainers are kept in place by the Bearing.

The Apply Piston just like the Secondary Pulley is a press fit.

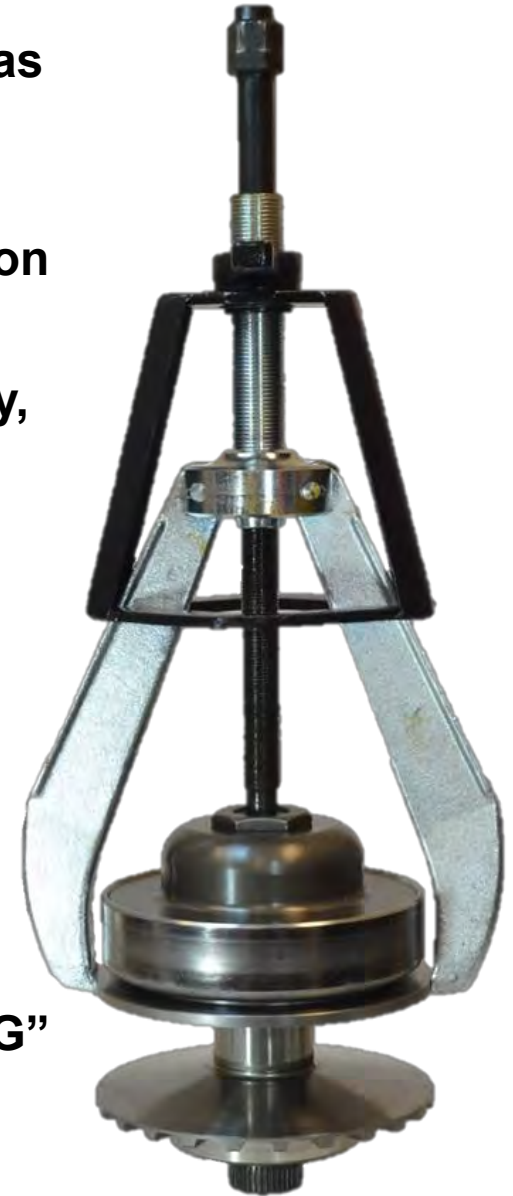
After removing the Half Moon Retainers, re-install the Retainer Nut and using the 2 Jaw Puller tool pull up until the Apply Piston pops up.

This one will not spring up as abruptly as the Secondary Pulley, the Spring (not found in all units) is weaker.

Retainer Ring

Half Moon Retainers

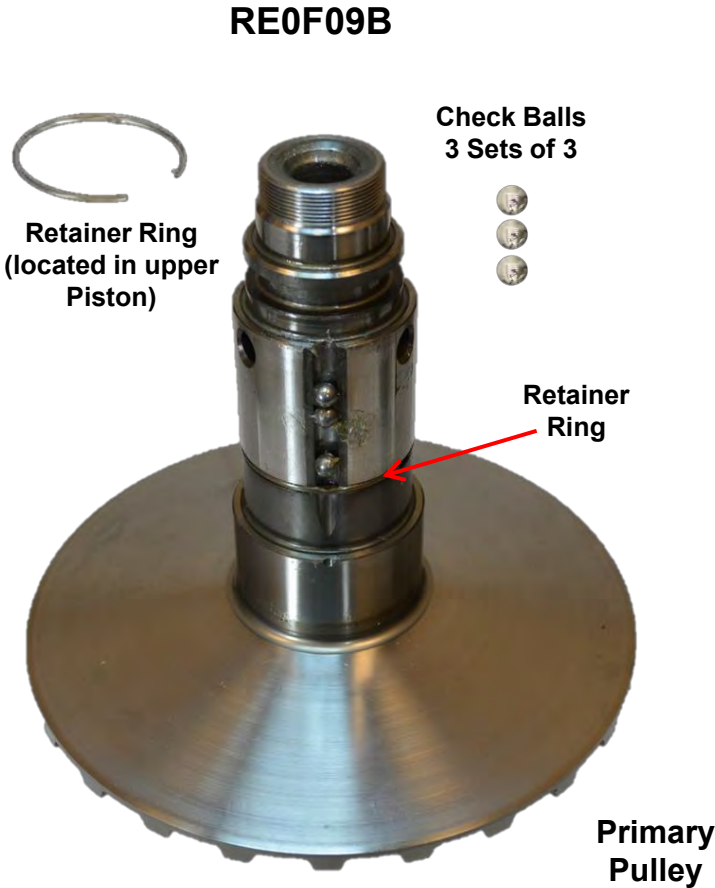
Other models will use a roller bearing and square retainer instead of check balls with retainer rings.

Single Roller Bearing With A Square Retainer

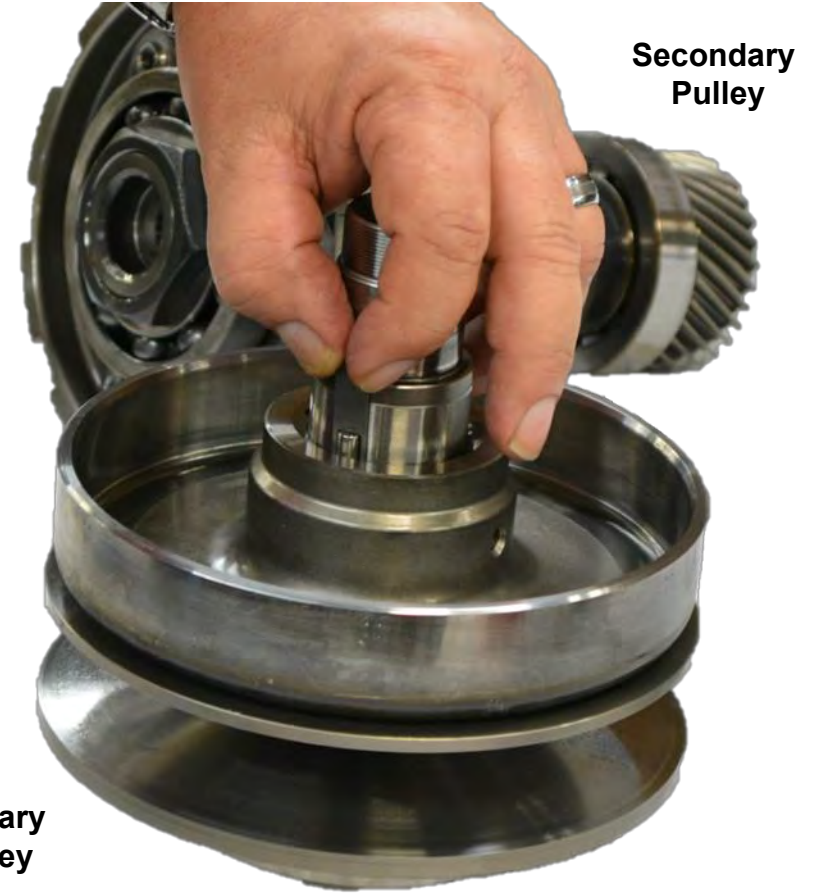
There are 3 roller bearings without retainers on the RE0F10D Secondary Pulley

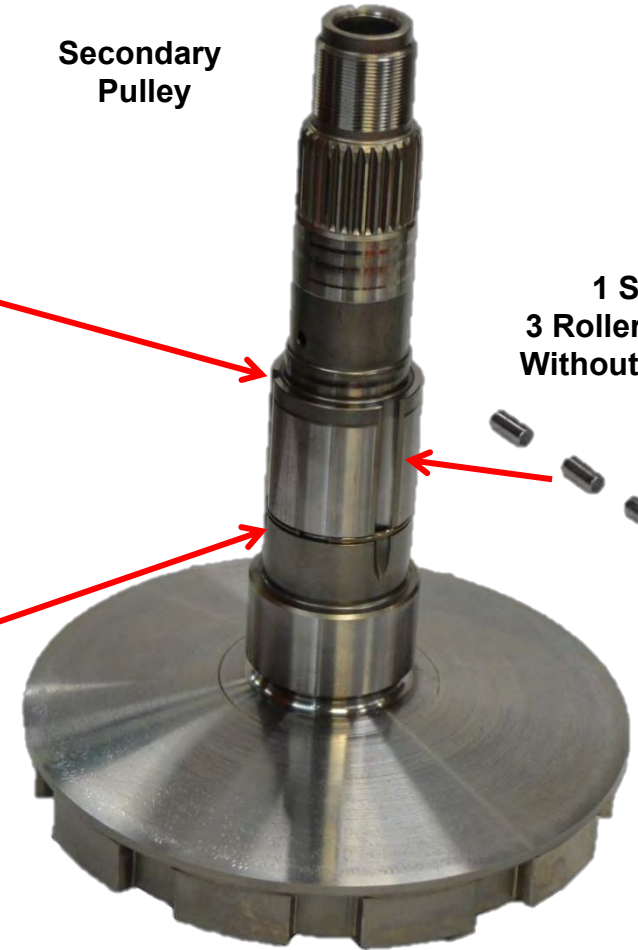
Some Pulleys may have only 1 set of 3 roller bearings without the square retainers. They will have the same type retainer rings used in earlier models.

1 Set Of
3 Roller Bearings
Without Retainers

Retainer Ring

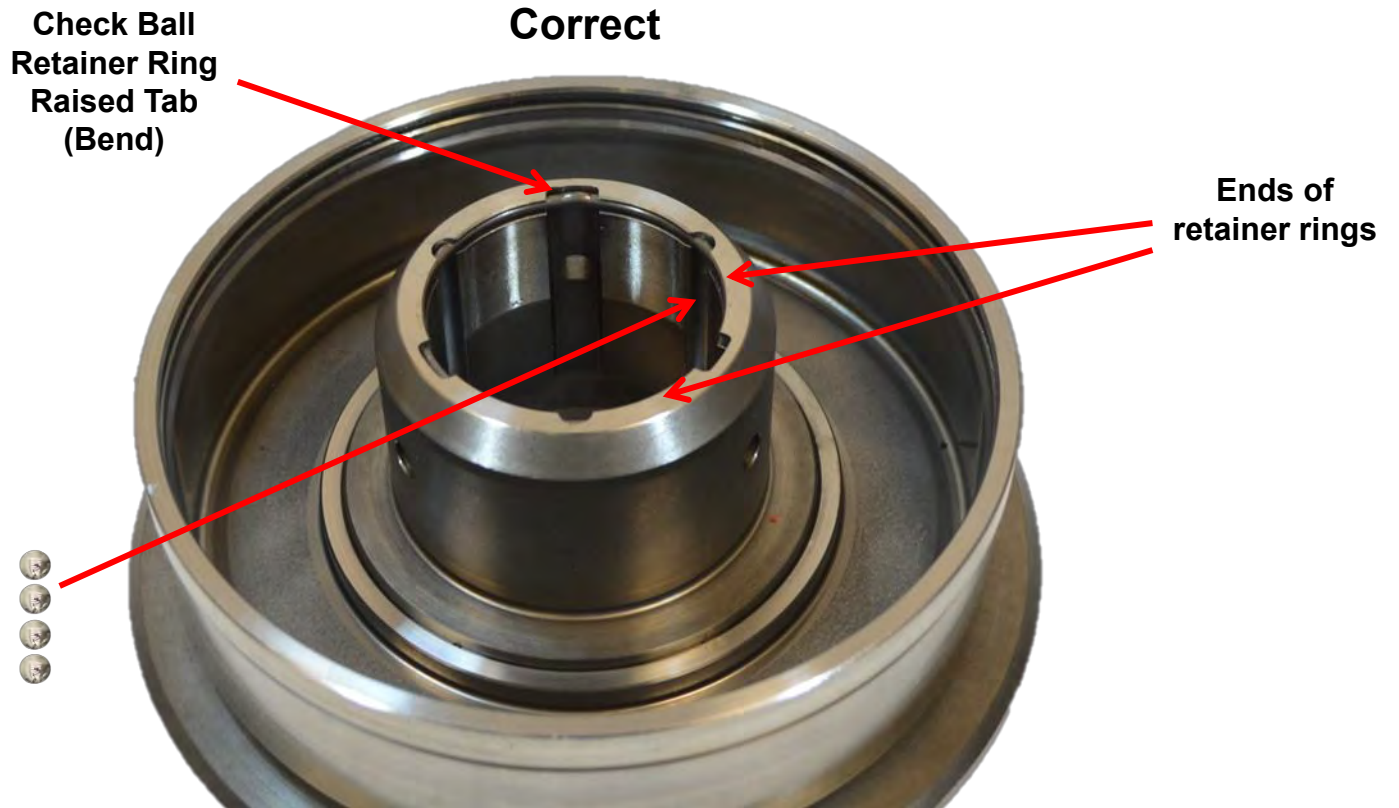
The raised tab (bend) on the check ball retainer ring must be placed into one of the square grooves in the Primary and Secondary Pulley as shown below.

If not placed into one of the square grooves, one of the round grooves will be left open and allow the check balls to fall out of the pulley (shown on next slide).

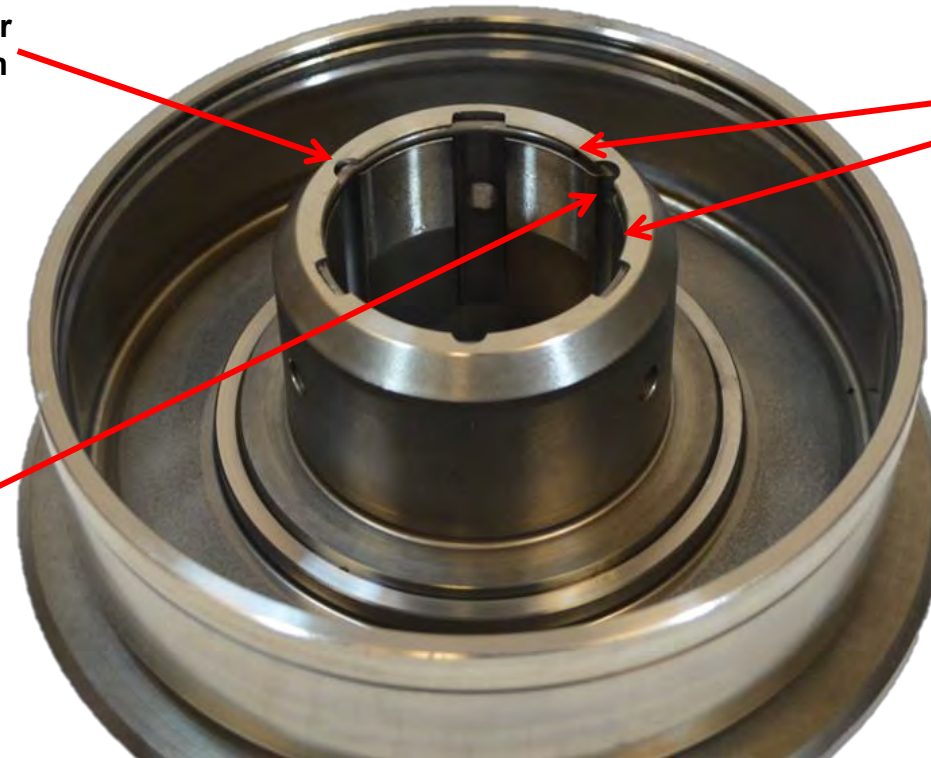
As you can see here the bend in the retainer ring was placed at one of the round grooves leaving one of the other round grooves open without retaining the check balls.

Wrong

Left Open No Retainer Ring

This is another reason to disassembly the pulleys to check for damage to the check balls and the groove.

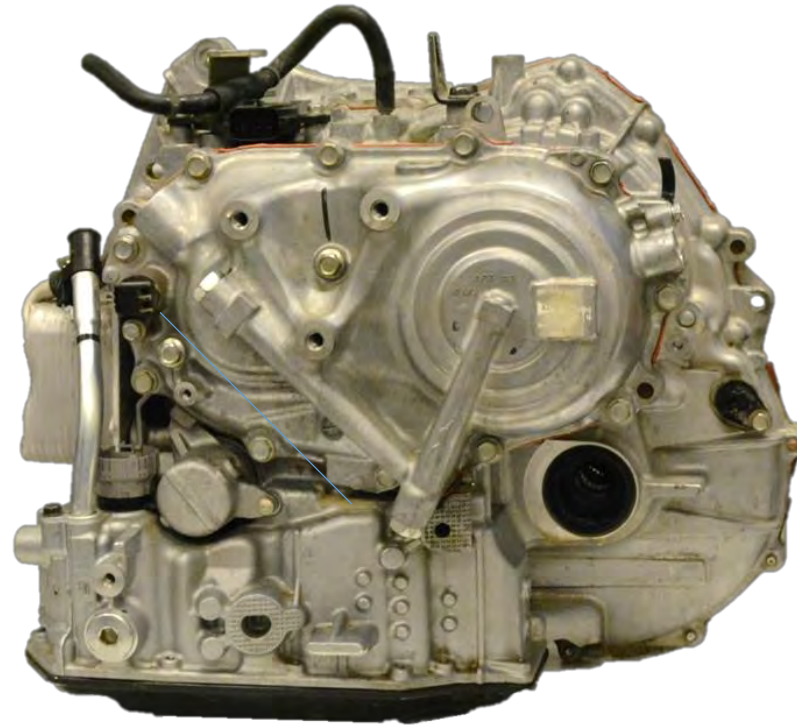
RE0F11A

Let's look at the latest JF015E Jatco CVT (RE0F11A) pulleys compared to the earlier models. The pulley assemblies (Variator) are located above the area of the case that holds oil.

This was designed for less frictional drag on smaller engine vehicles and to help prevent aeration of the fluid.

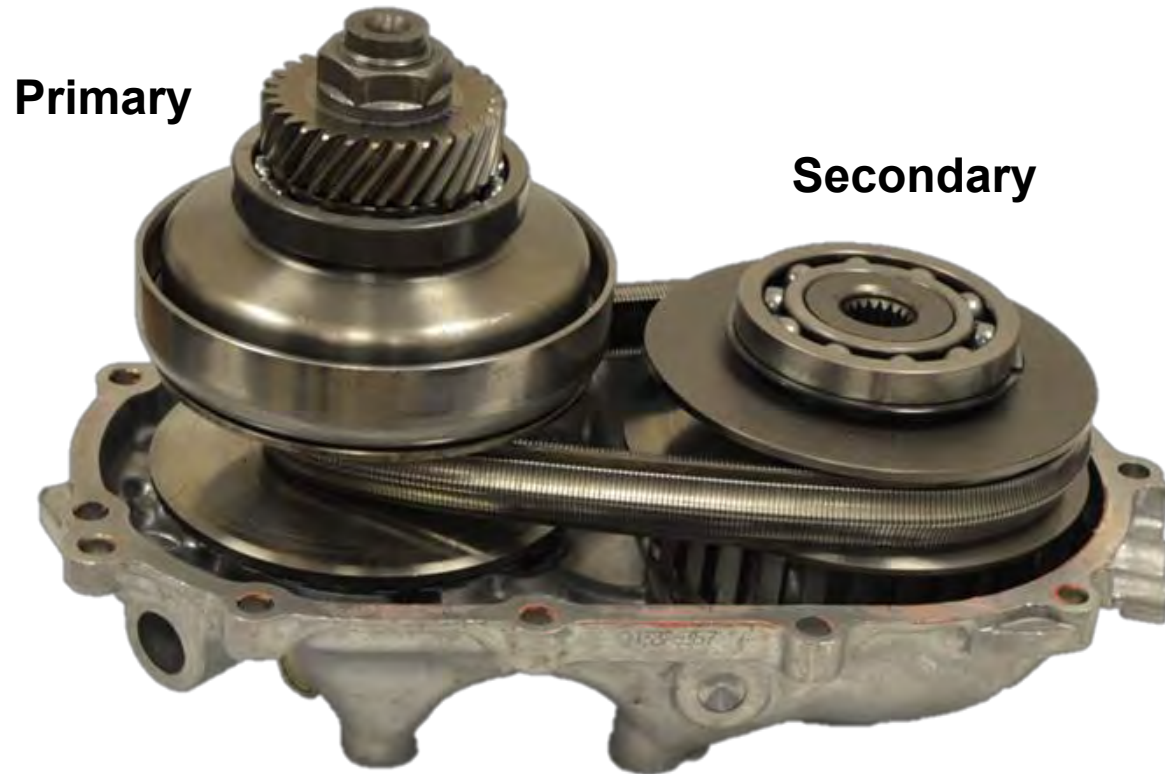
Unlike the other Jatco CVT's the Primary Pulley is taller and has the drive gear attached. The Secondary Pulley is shorter with no gear the opposite of what we've seen previously.

Keep in mind this CVT has the clutches in front of the Secondary pulley not the Primary, which will be covered later in the presentation.

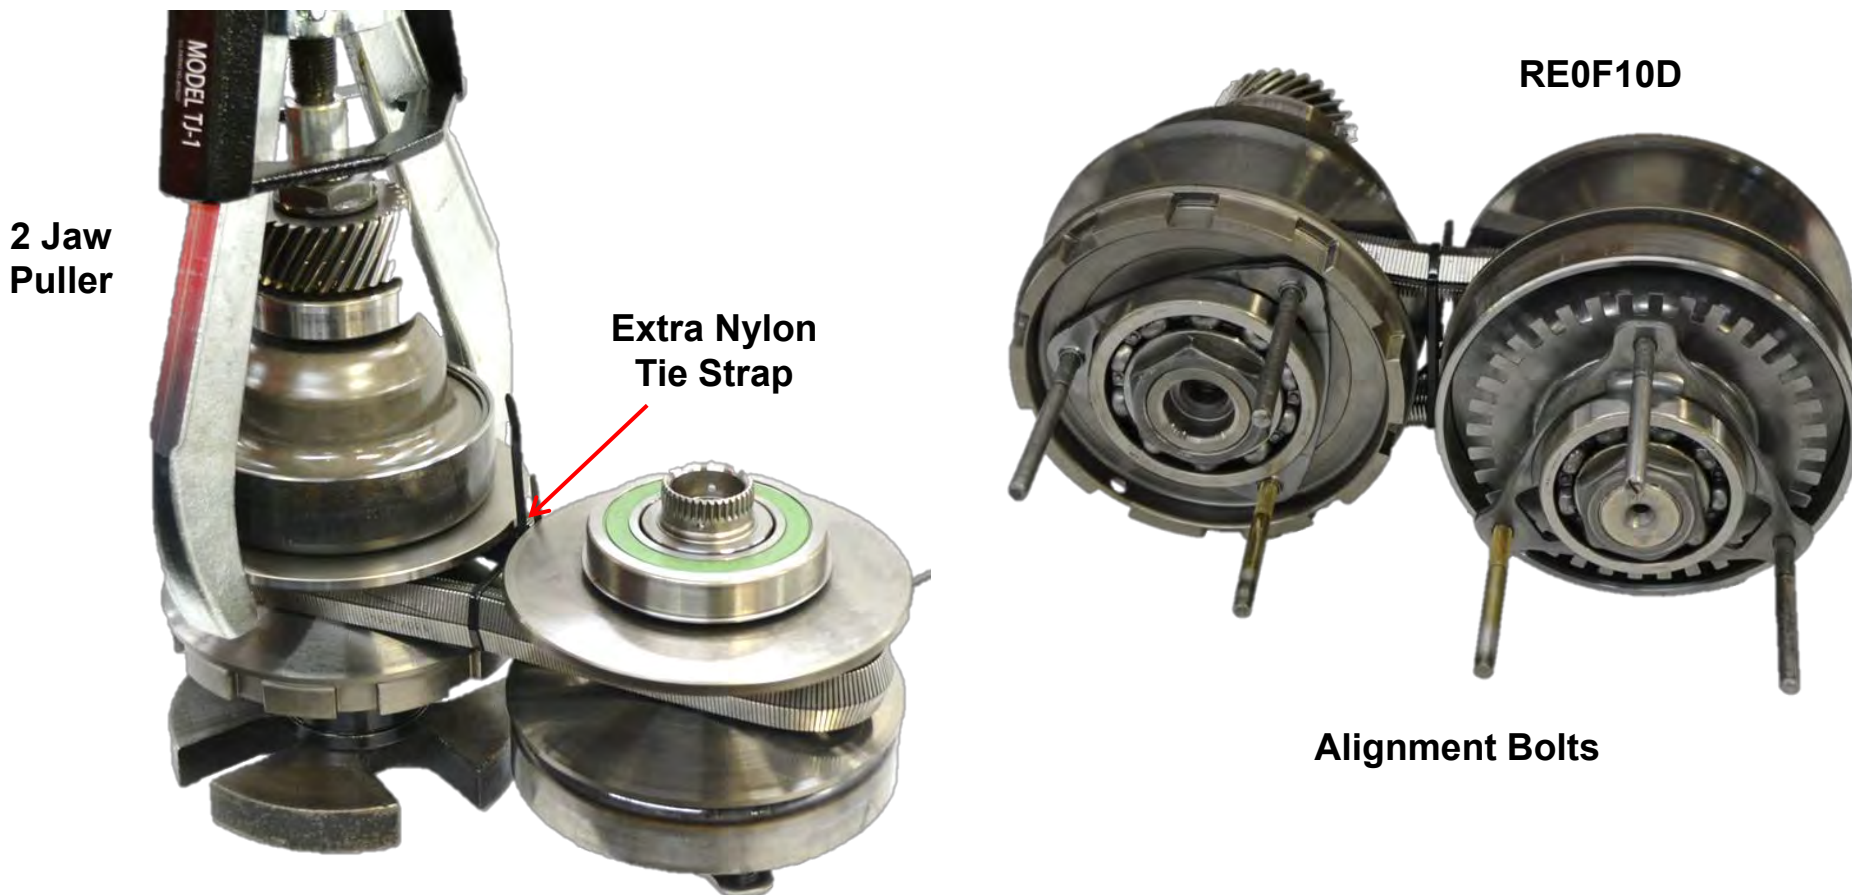
Using the 2 jaw puller to compress the Secondary Pulley Spring wrap another nylon tie strap across the entire belt. This will keep the Secondary Pulley Spring compressed.

It is now possible to move either pulley during installation into the rear cover without difficulty.

Install some alignment bolts with the head ground off before installing the pulley assemblies into the rear cover.

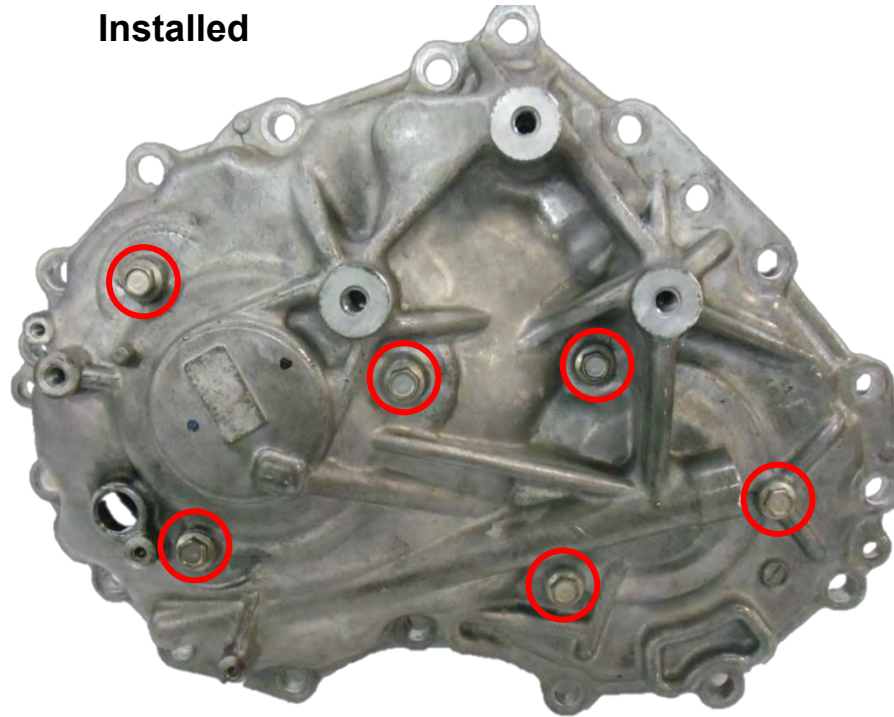
Once installed into the rear cover with the retainer bolts in place.

Retainer Bolts Installed

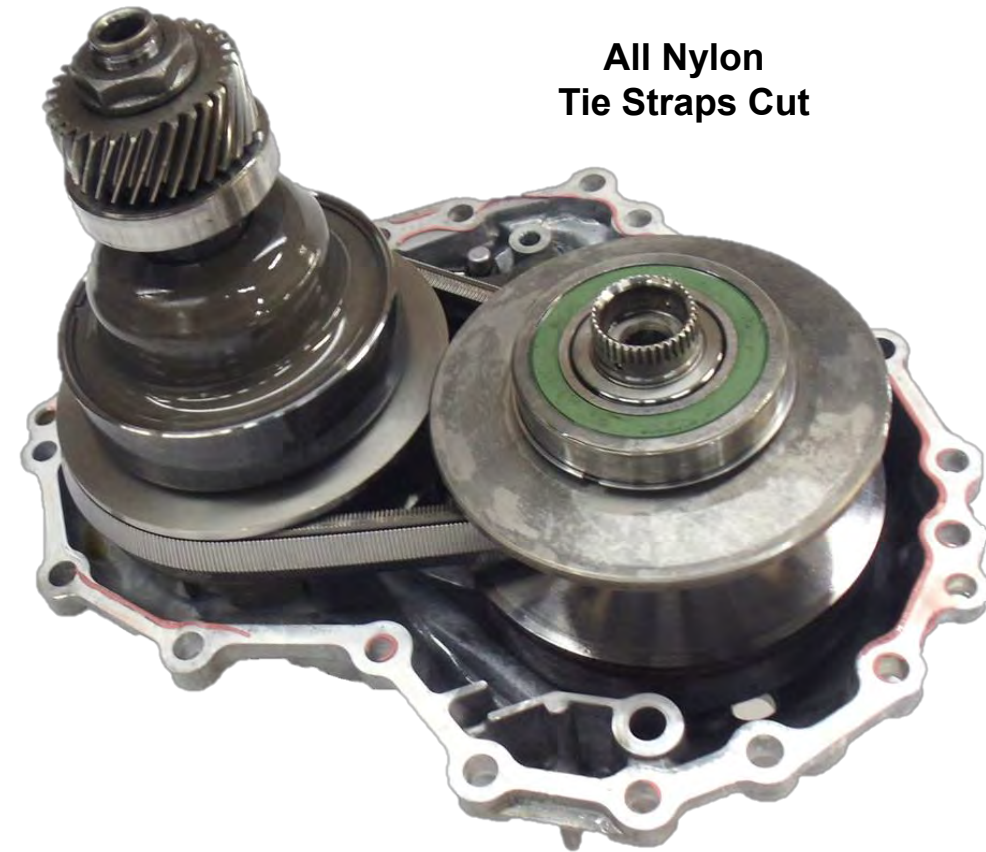
All the nylon ties can be cut allowing the Secondary Pulley Spring to decompress putting tension back onto the Push Belt.

All Nylon Tie Straps Cut

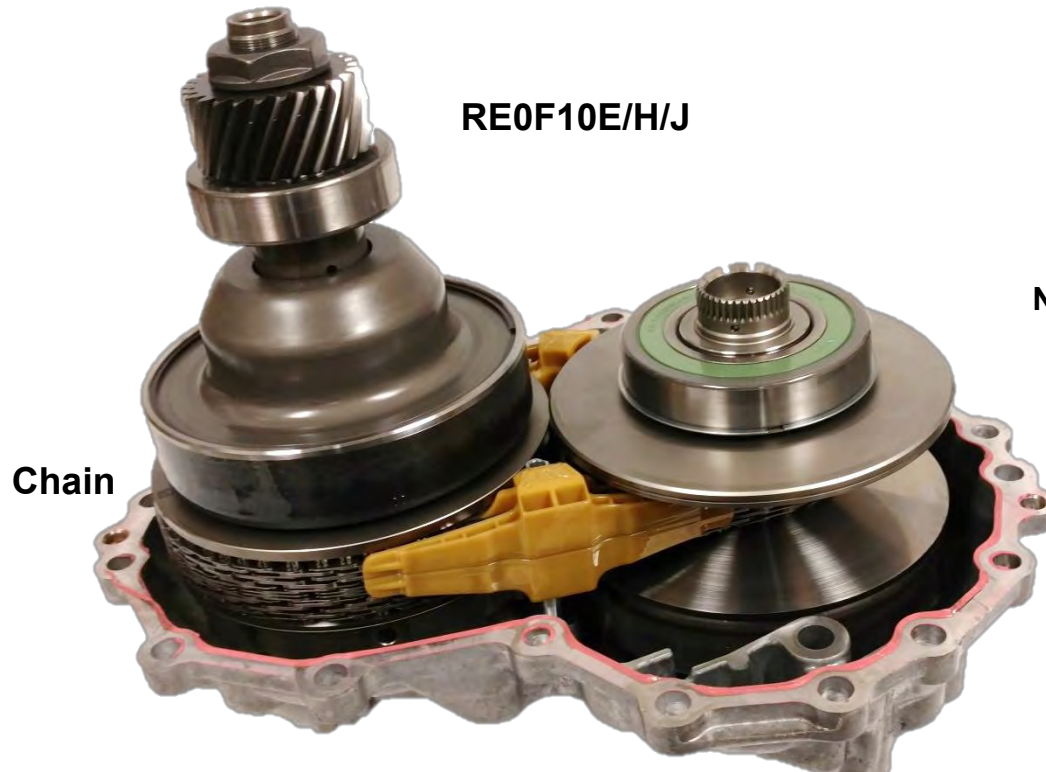
The RE0F10E/H/J use a chain with plastic guides very similar to the Subaru Lineartronic, so it's not necessary to use any tie wraps when removing the chain. It won't come apart like the Push Belt.
